Performance of Underground Electricity Cables during the 2010-2011 Canterbury Earthquake Sequence: Insights for assessing Criticality and Resilience

Ebad Ur Rehman University of Auckland
Peter Elliott Orion New Zealand
Matthew Hughes University of Canterbury
Liam Wotherspoon University of Auckland
Nirmal Nair University of Auckland

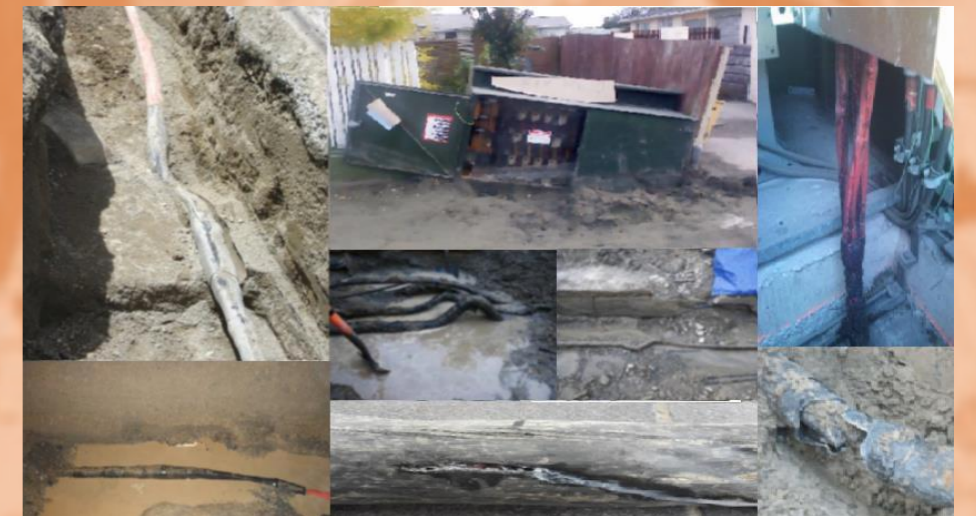
Fig. 2: Examples of damage to the Orion network in 2010 and 2011

1. Bending
2. Stretching
3. Insulation damage
4. Joint Breaks
5. Connections pulled-off equipment

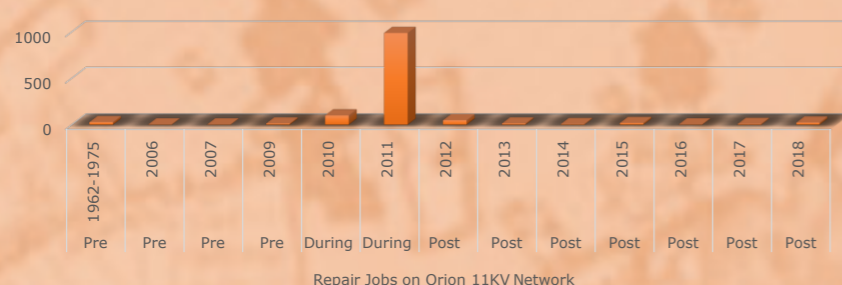
Fig. 3: Temporal distribution of repairs on the 11kV network

- Following the 2010 and 2011 earthquakes, 1066 repairs jobs were carried out on the 11kV network. The temporal repair characteristics are summarised in Figure 3 and the geospatial characteristics of the repairs during 2010 and 2011 are summarised in Figure 4.

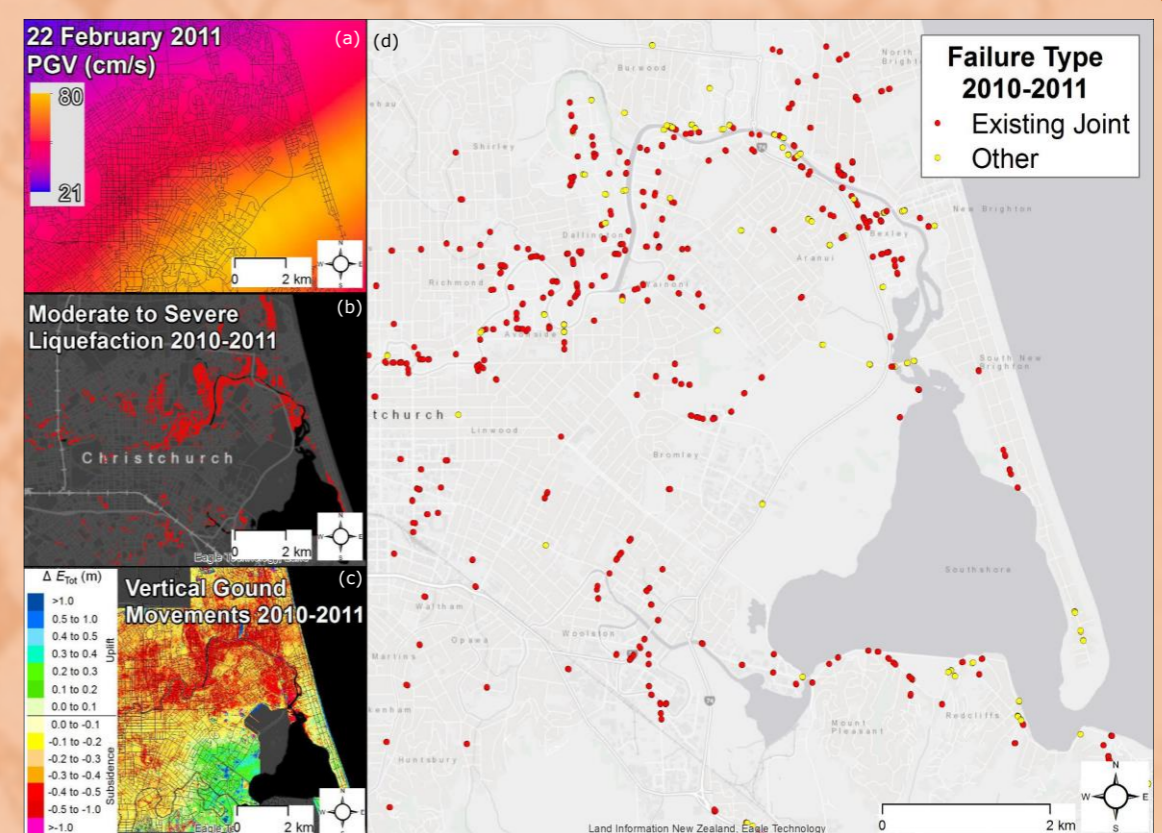
Fig. 4: (a). Peak ground velocity, (b). Liquefaction, (c). Vertical ground movement, (d). Repair jobs in 2010-2011 on the 11kV network (combined)

- The repair jobs were greater around Avon River due to severe liquefaction manifestation and lateral spreading.
- The majority of these repair jobs were due to the failure of existing joints across the network.
- The cables passing through bridge abutments were damaged due to differential movement between the bridge and the approach.
