Blenheim liquefaction reconnaissance

Overview of liquefaction damage in Blenheim

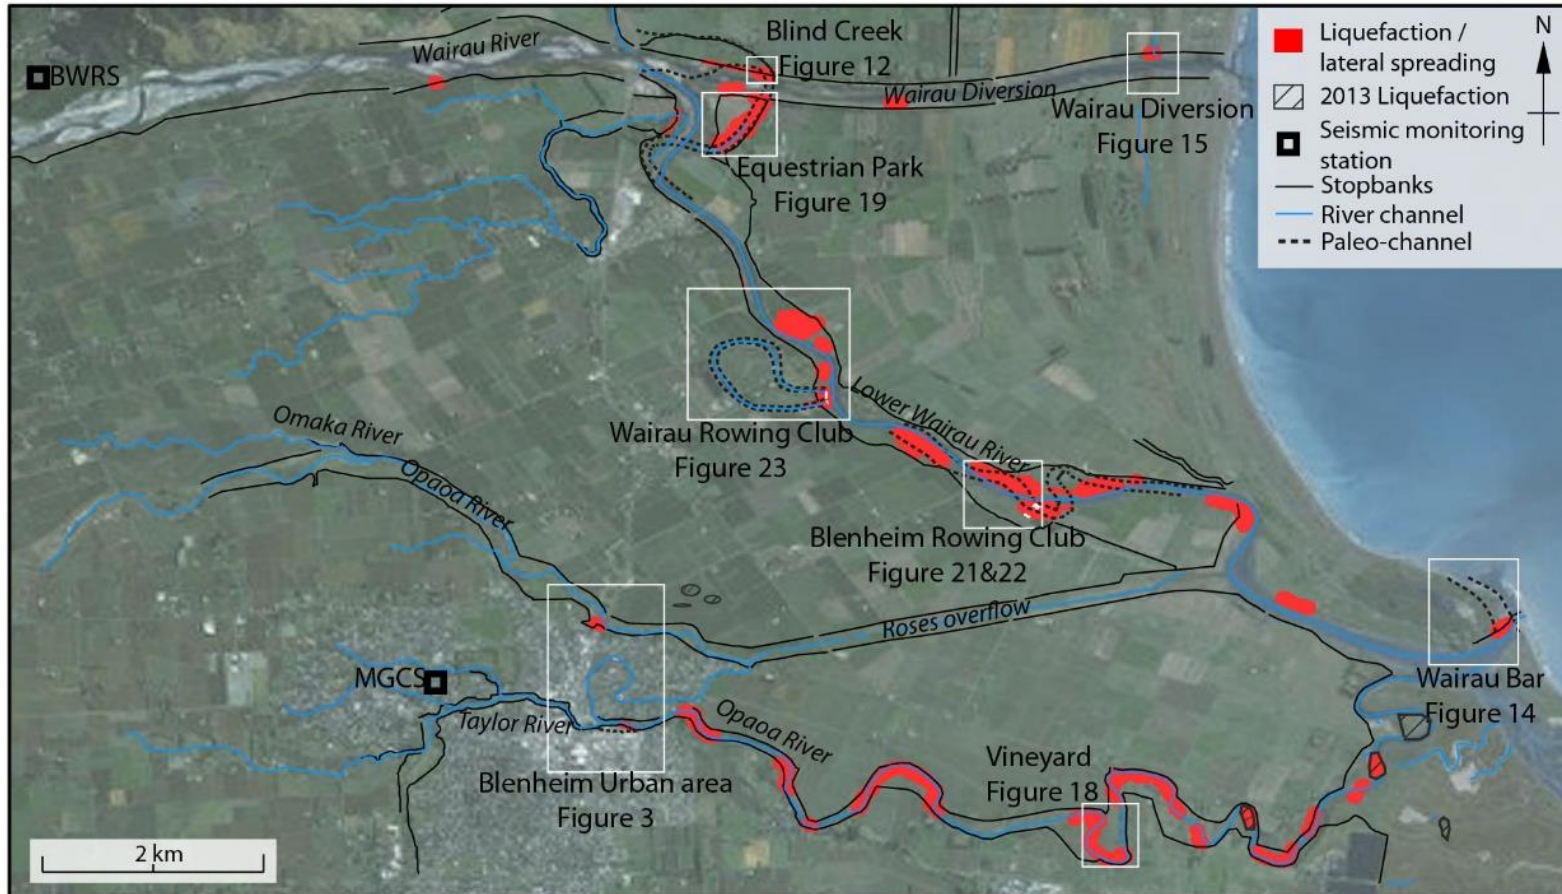
Liquefaction and lateral spreading observed adjacent to the Wairau, Taylor, and Opaoa Rivers to the east of Blenheim

Distribution closely linked to the current and paleo- river morphology i.e. inner meander bends and paleo-channels

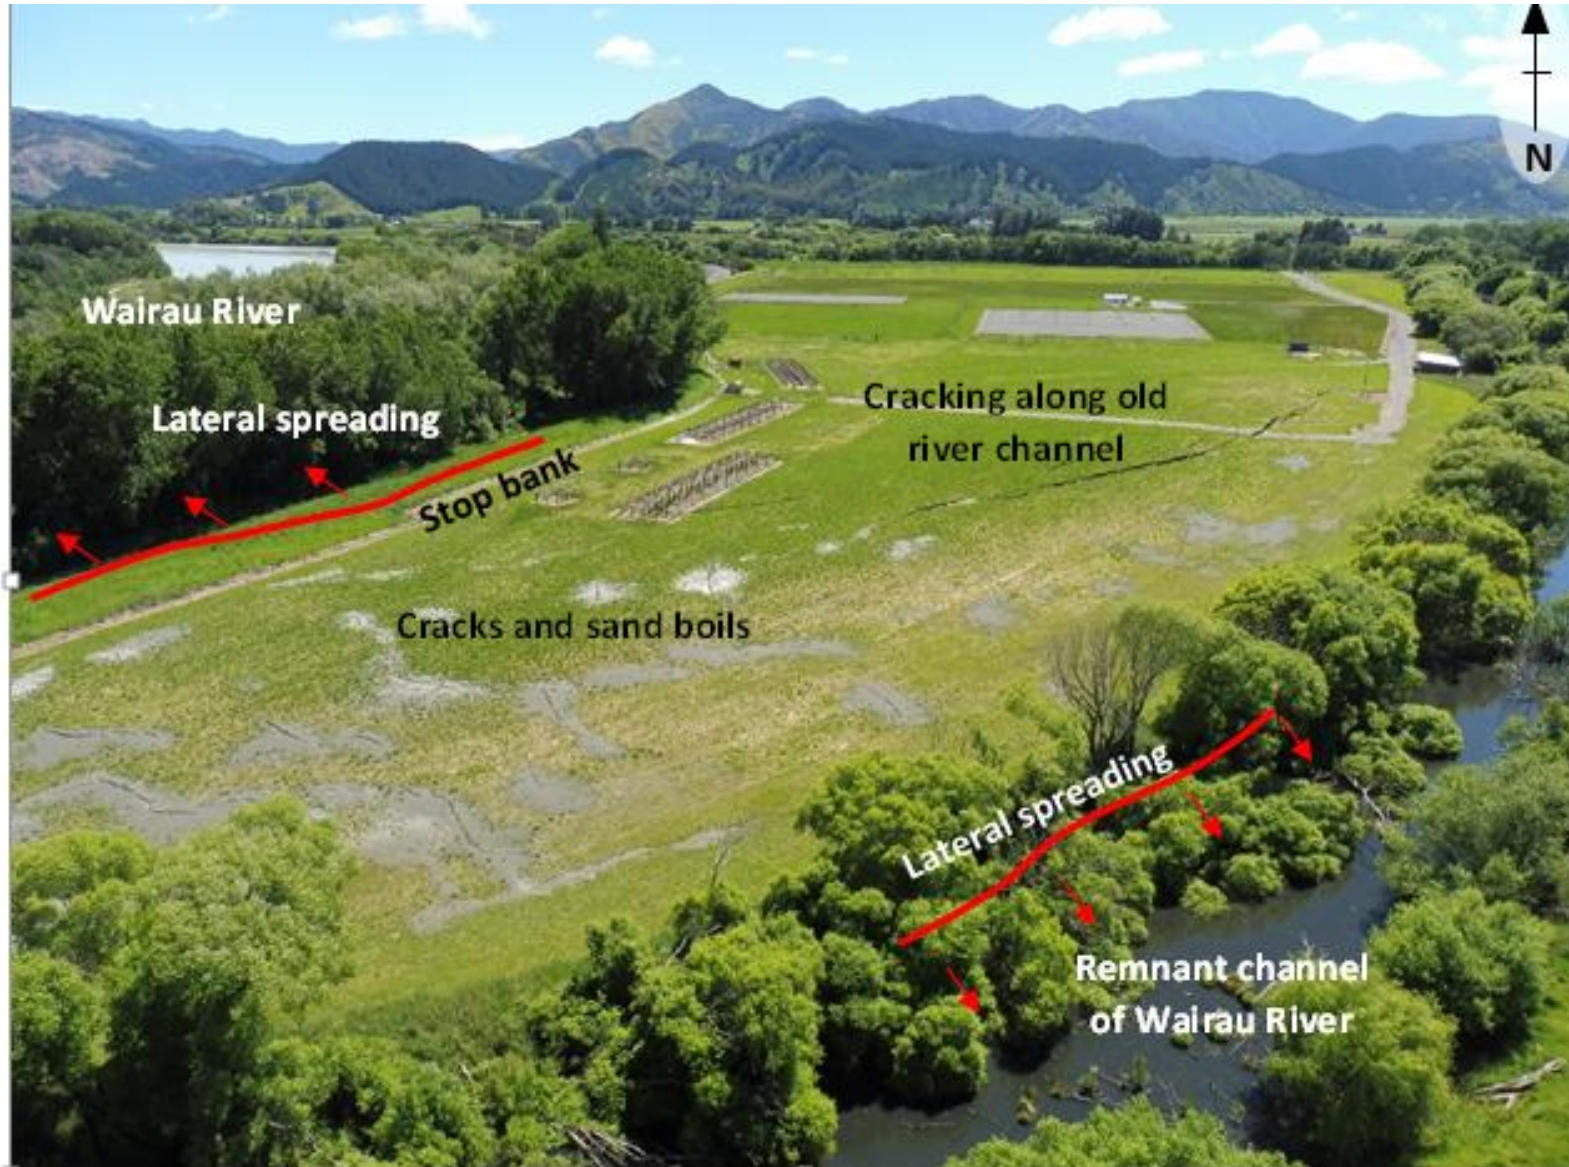
Equestrian Centre

Area encompassed by the Wairau River, Wairau Diversion, and a small channel associated with the Wairau River prior to diversion

Liquefaction observed within the paleo-channel associated with the former position of the Wairau River prior to diversion

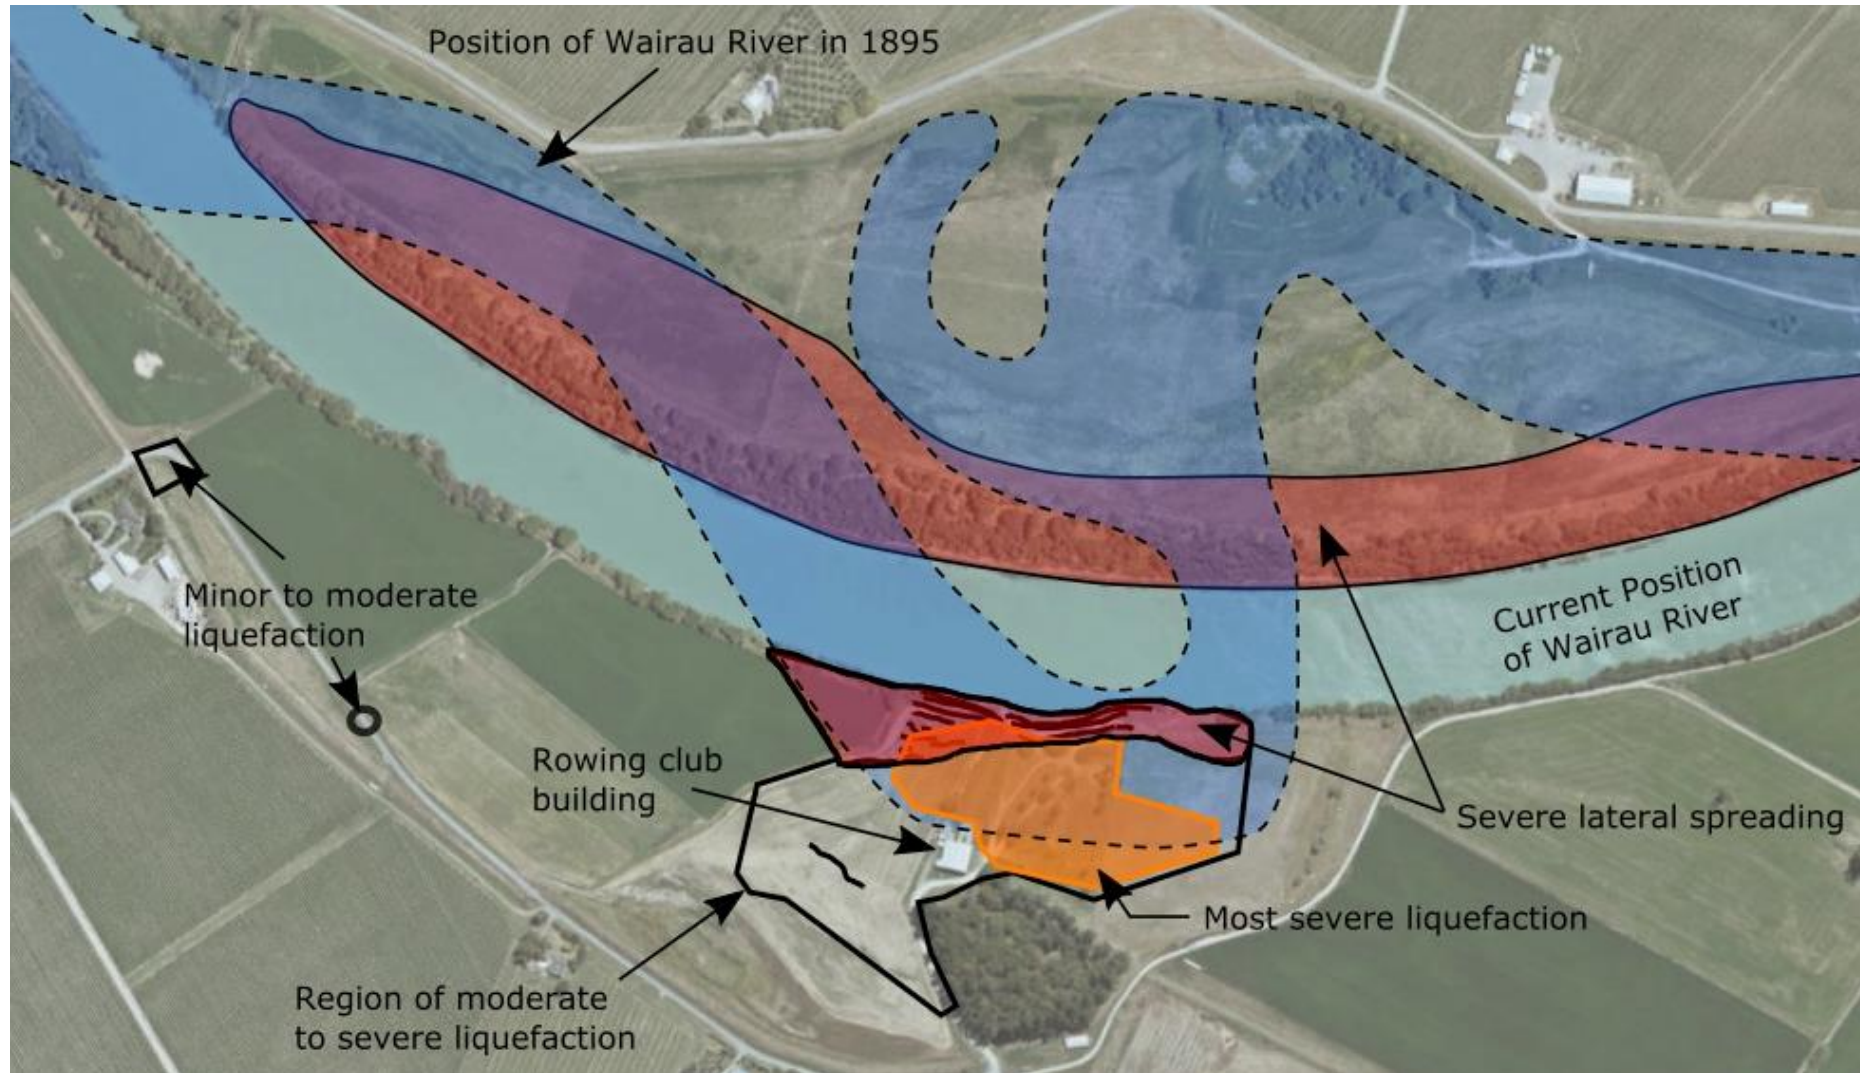
Blenheim Rowing Club

- Liquefaction occurred within the paleo-river channel from 1895

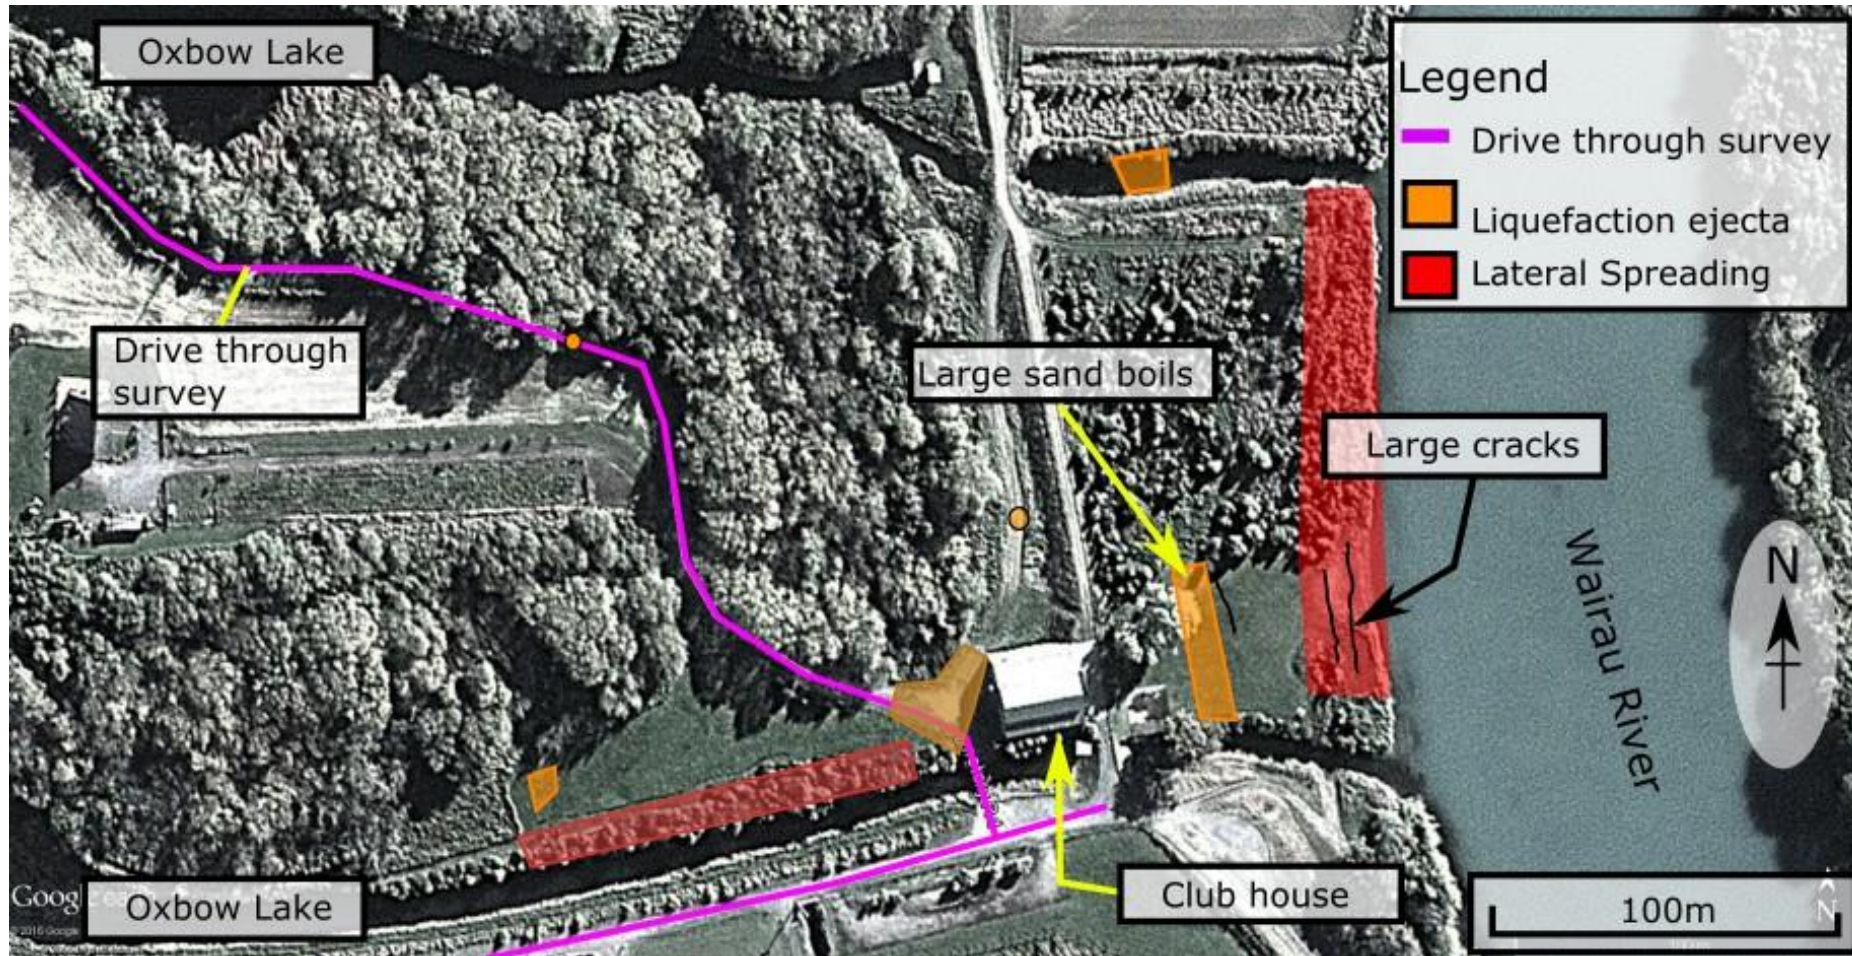
Wairau Rowing Club

- Encompassed by a meander-bend cut-off from the main channel – formed an ox-bow lake
- Liquefaction and lateral spreading occurred adjacent to the banks of the former and current river channel

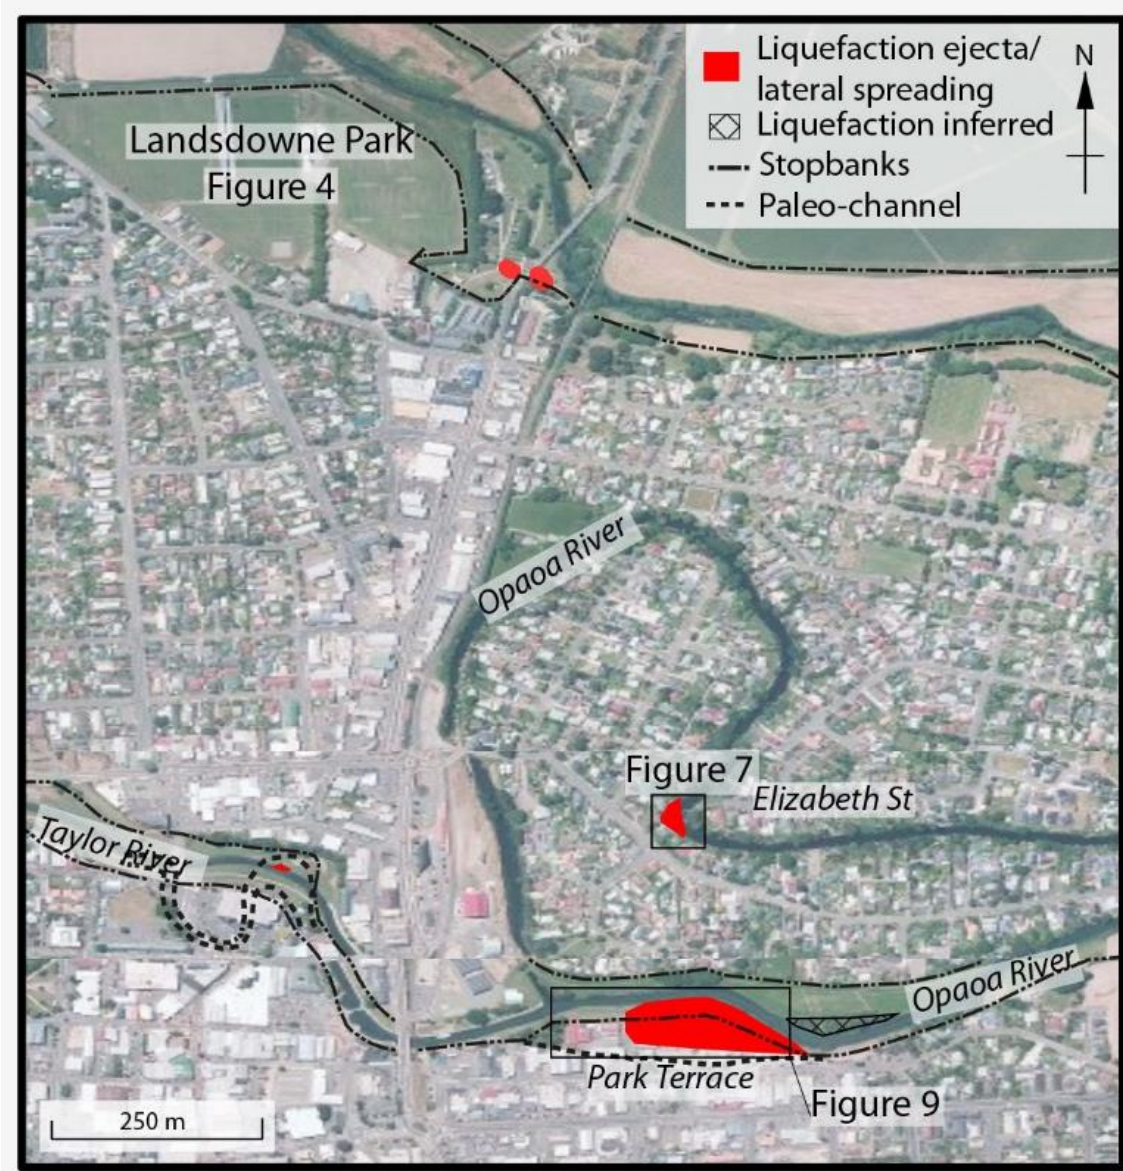
Overview of liquefaction damage in Central Blenheim

Localized liquefaction observed along the Opaoa and Taylor Rivers in Blenheim

Distributions observed within the inside banks of meander bends and within paleo-channels of the river

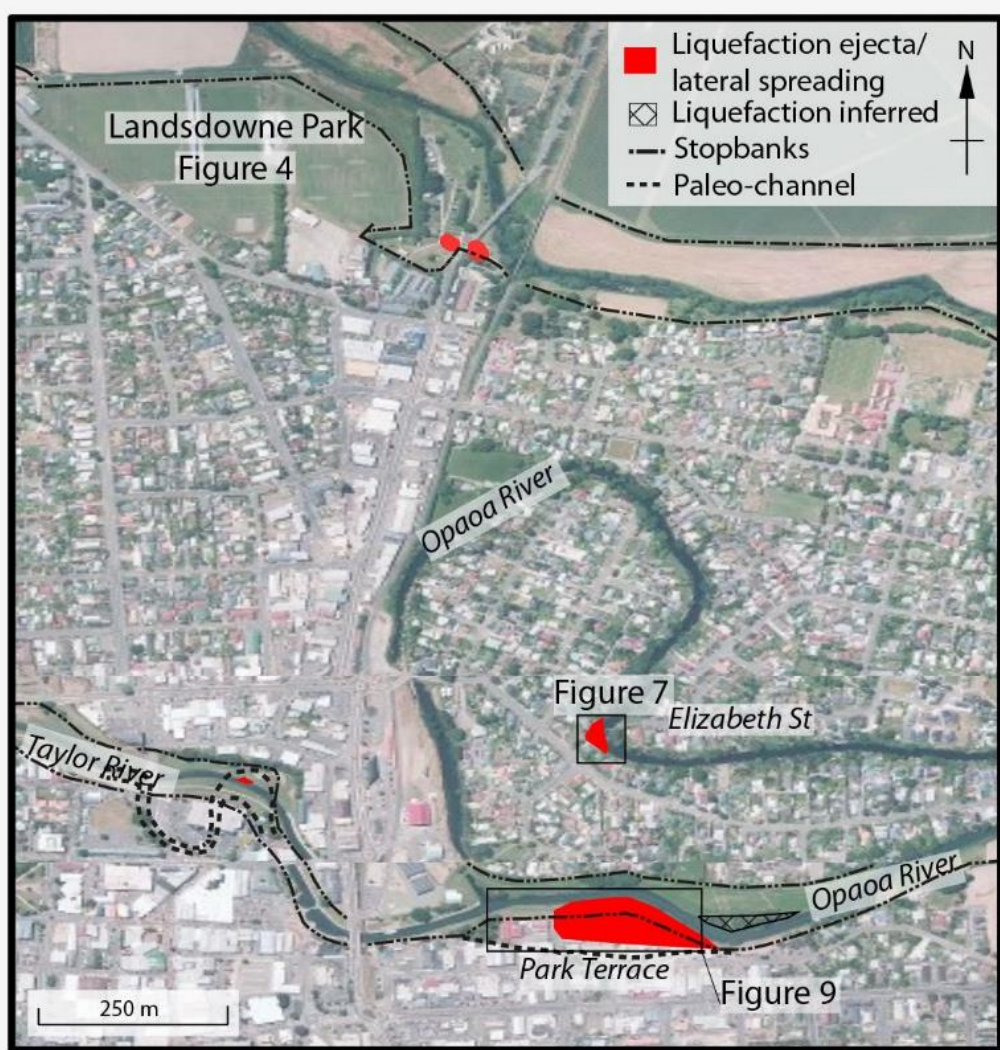
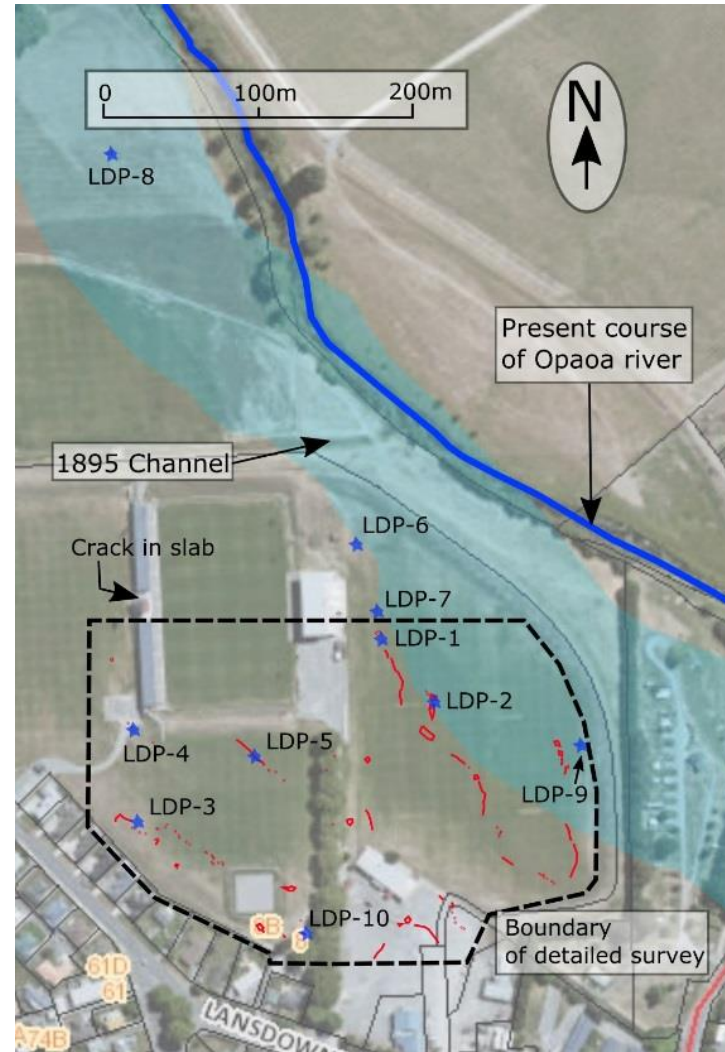
Landsdowne Park

Liquefaction and lateral spreading observed inside the 1895 paleo-channel of the Opaoa River, along with the surrounding over-bank flood plain deposits

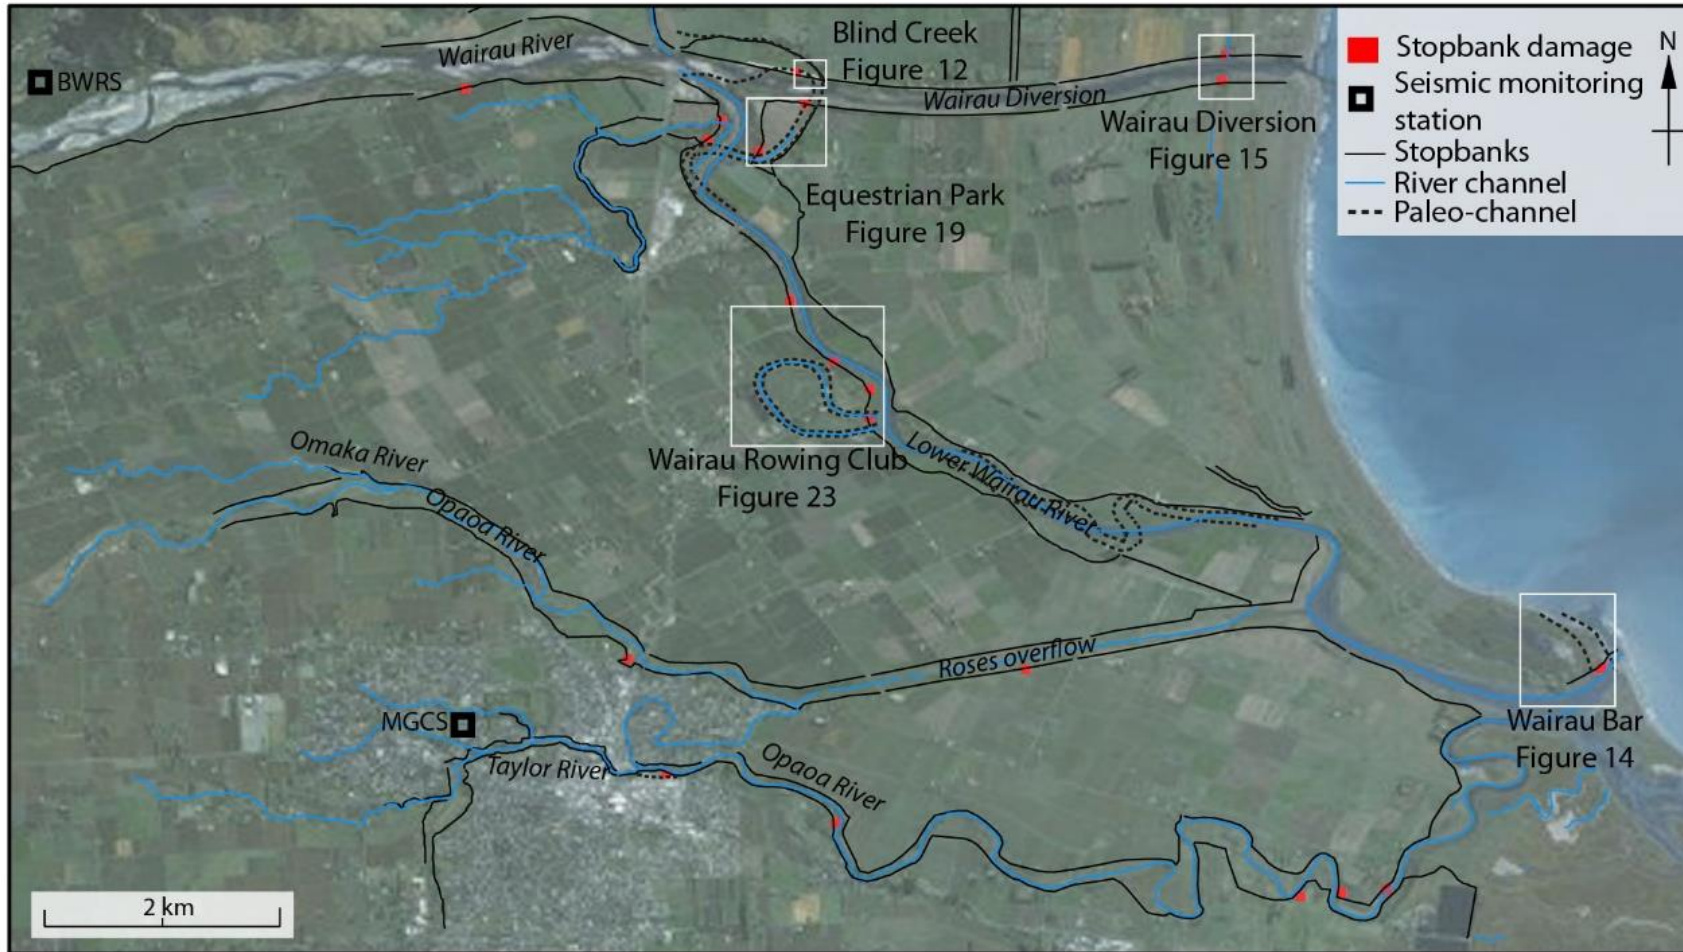
Stopbank damage around Blenheim

Liquefaction and lateral spreading induced damage to stopbanks corresponds with the location of paleo-channels and swamps along the Wairau River and Diversion, and with the inner banks of meander bends along the Opaoa River
