QuakeCoRE FP2 Meeting  
21 March 2017

## Damage in Wellington Waterfront Area following the 2016 Kaikoura Earthquake

University of Auckland Reconnaissance Team

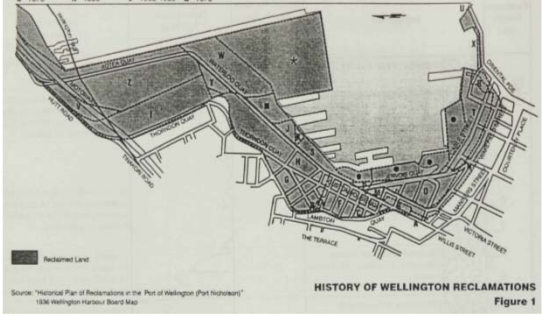
HISTORY OF WELLINGTON RECLAMATIONS  
Figure 1

- Based on the history of Wellington reclamation, ground damage in the form of cracks, ground settlement and fissures, appeared to be **concentrated in recently reclaimed areas, as late as in the 1970s**. Liquefaction-induced ground damage in Wellington was concentrated in the waterfront area north of the Queens Wharf Building.

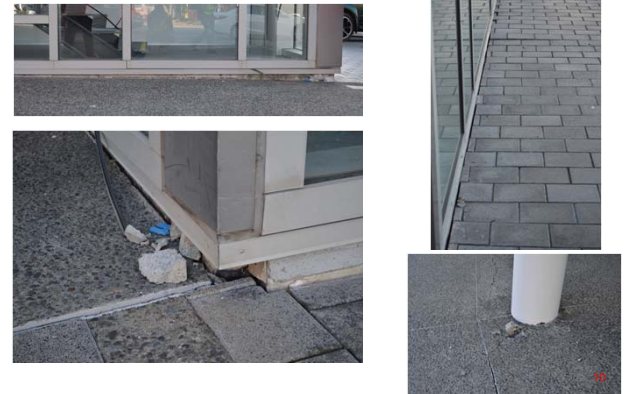
#### BNZ Bldg.

- Ground adjacent to buildings along the waterfront, such as near the BNZ building, Customhouse building, and Statistics NZ building, **showed evidence of moderate settlement**. Pavement buckling and cracking were also observed. These were mainly the result of ground oscillation and possible densification of the weak embankment fill, but liquefaction may have contributed in some instances.

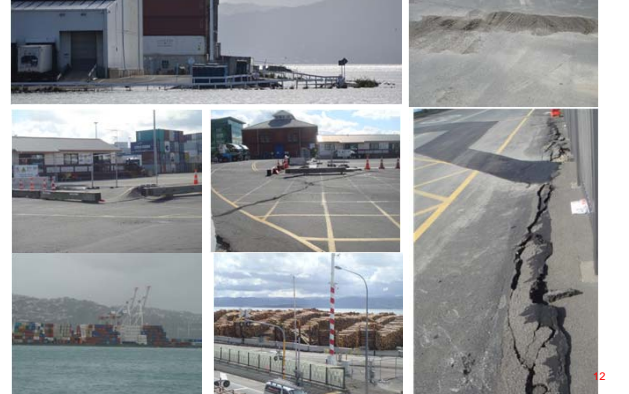
#### View from outside

- Although CentrePort was not accessible, **significant damage can be observed even from outside the port, possibly as a result of soil liquefaction**. Ground subsidence, cracks, differential settlements and other forms of ground movements have been observed within the port. Detailed investigation is recommended to examine the behaviour of the gravelly fill materials.
