Impacts of the Kaikoura Earthquake on Three Waters Systems in Wellington, Marlborough and Kaikoura

Preliminary Observations

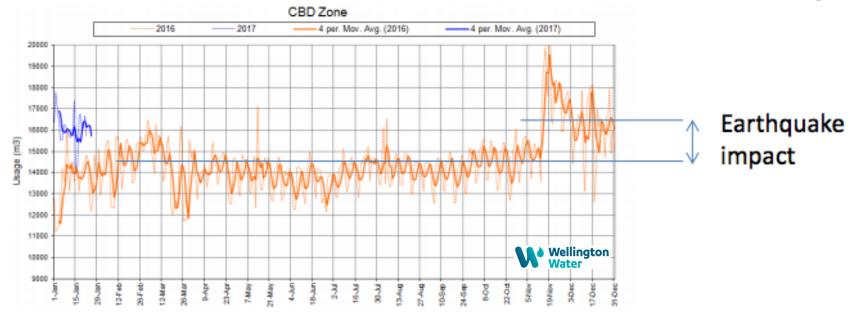
- Up to 15 breaks across the distribution network excluding the port area
- Major bursts and other minor pipe failures resulted in increased leakage.

With damage to pipes in the port area due to ground deformation ~14,000 m3 of water was lost within the first two days.

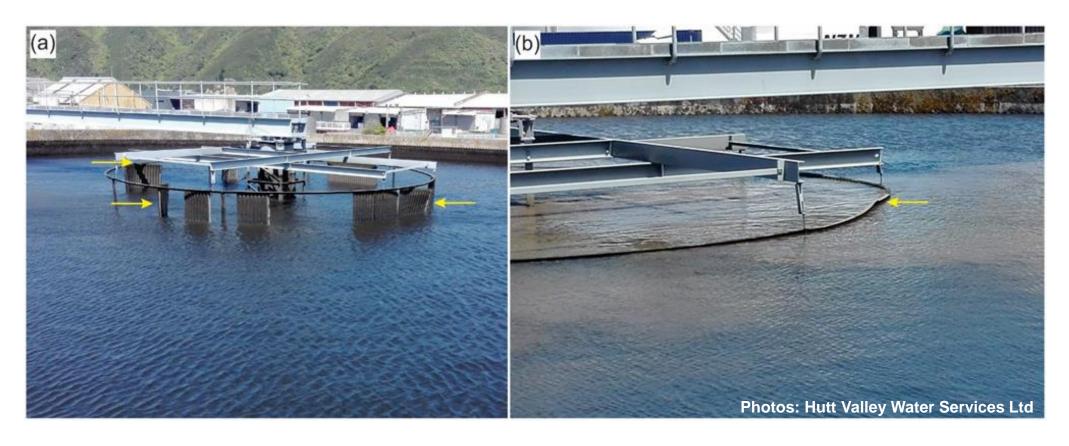
- No major structural damage to any of the four treatment plants
- In the Seaview and Porirua treatment plants, water sloshing in the secondary clarifier tanks damaged the stilling well curtains and their holding rings.

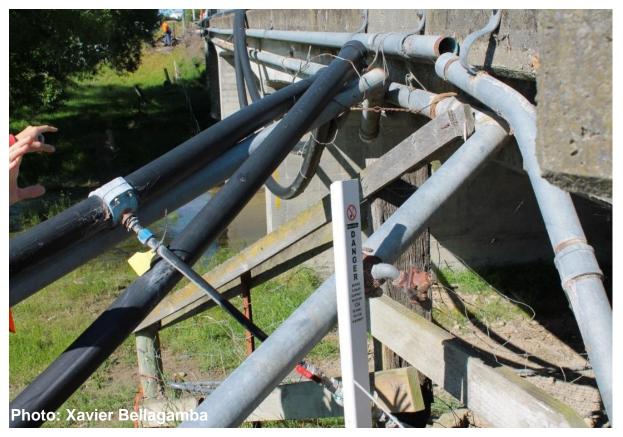
Needles Creek Bridge north of Ward on SH1

Damage occurred at several pipe service bridges across the region.

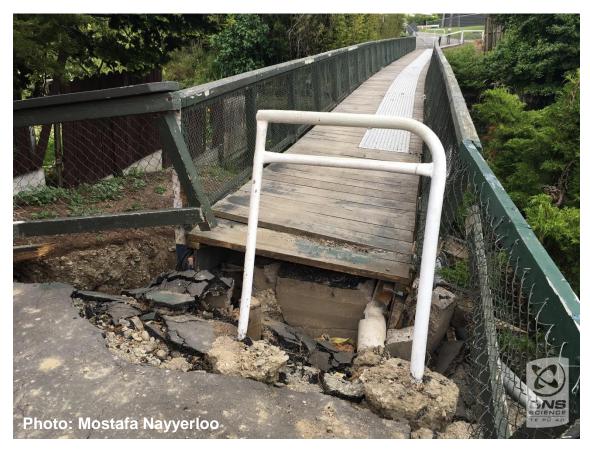
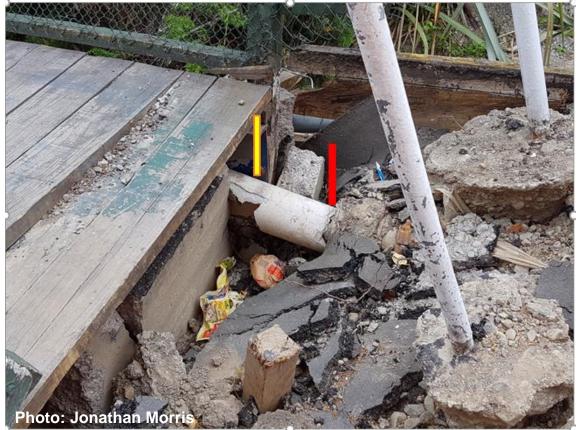
• At the Elizabeth Street footbridge in Blenheim, ground failure around the abutments resulted in complete failure of the AC pipeline suspended from the bridge.

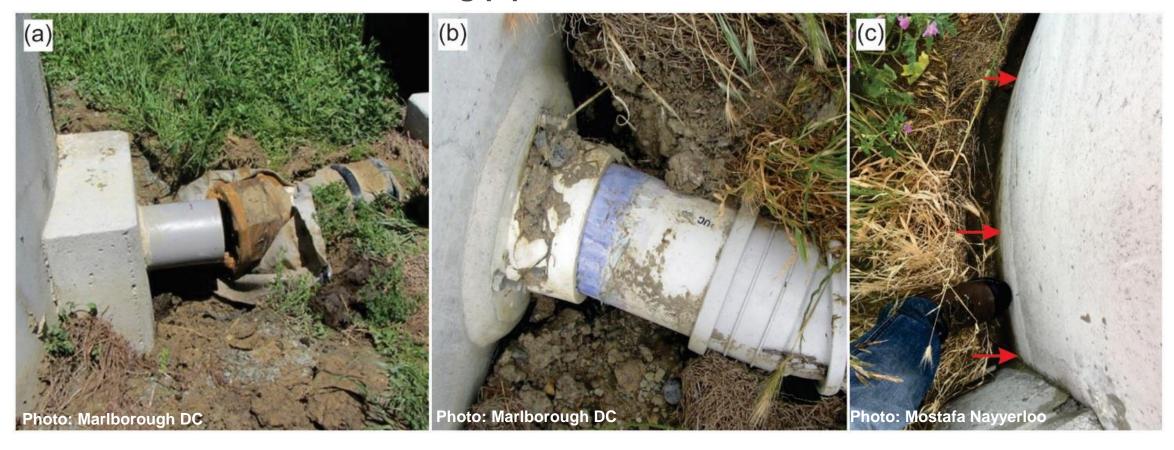
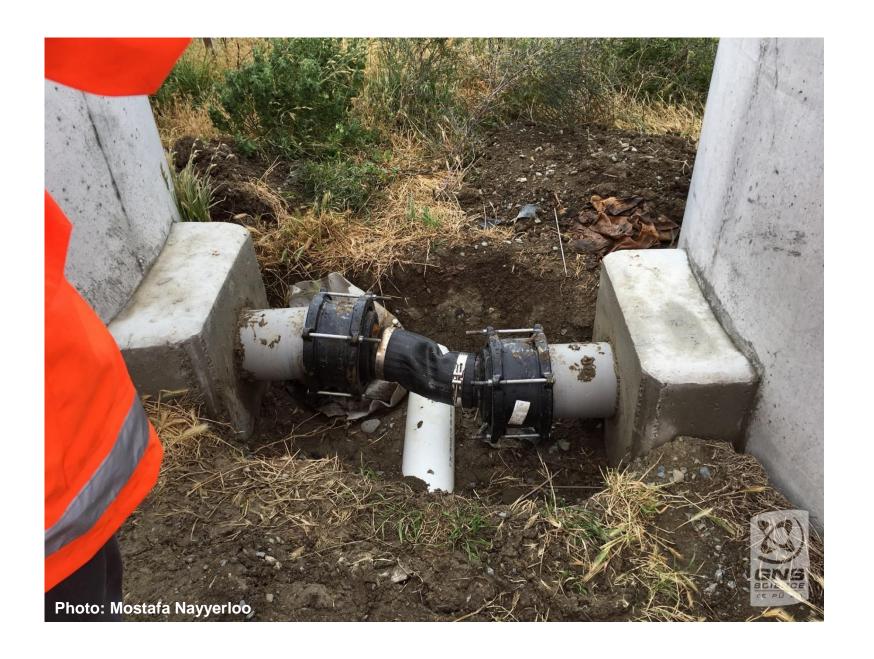
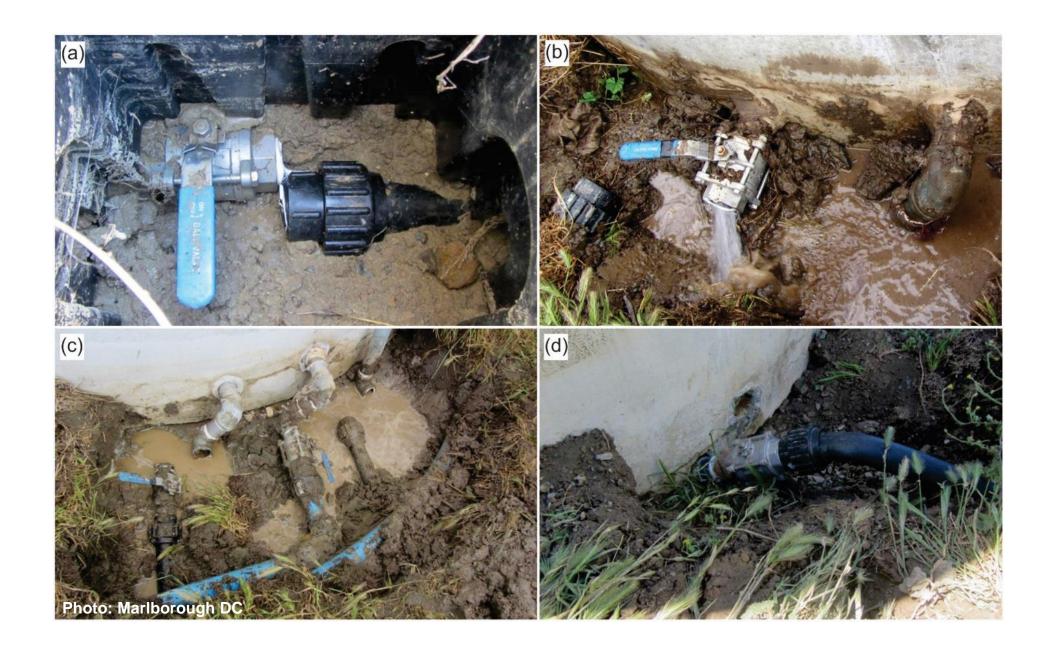
Newer concrete tanks appeared to have performed well with only some hairline cracks and connecting pipework failure due to excessive movement.

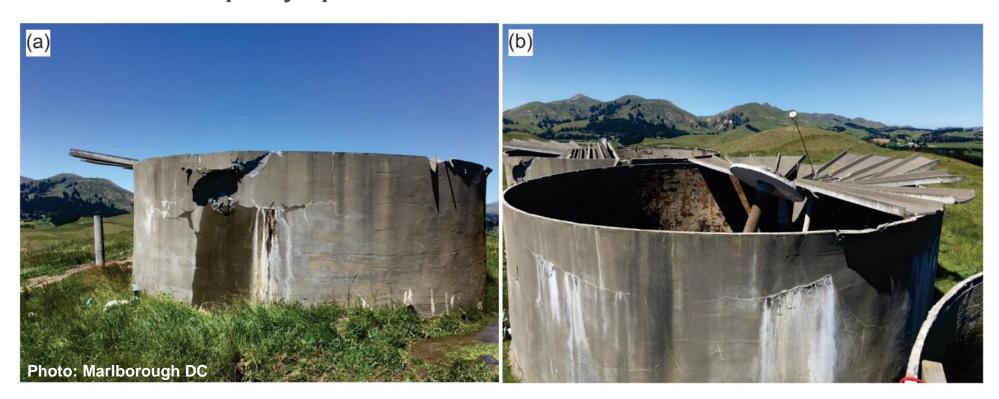
- Earthquake emergency shut-off valves were set to trigger at 0.2 g, but the maximum reported PGA at valves was 0.18 g, so they did not trigger.
- Older ferrocrete tanks in Ward had suffered structural damage although one of the tanks remained partly operational.

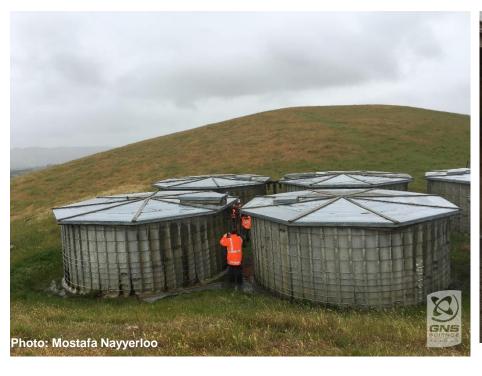
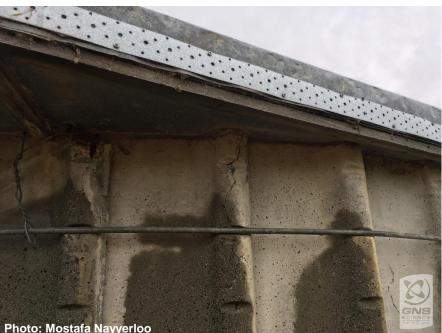
- As the hillside slopes were generally gentle and the tanks were set back from the hillside slopes, the tanks were not affected by slope instability.
- Concrete stave tanks suffered some damage but remained serviceable with some additional leakage through cracks, some of which were caused by the 2013 events and opened up a bit more during the Kaikoura earthquake.

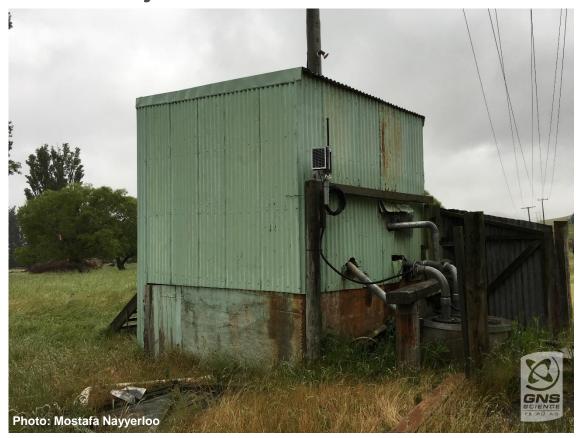
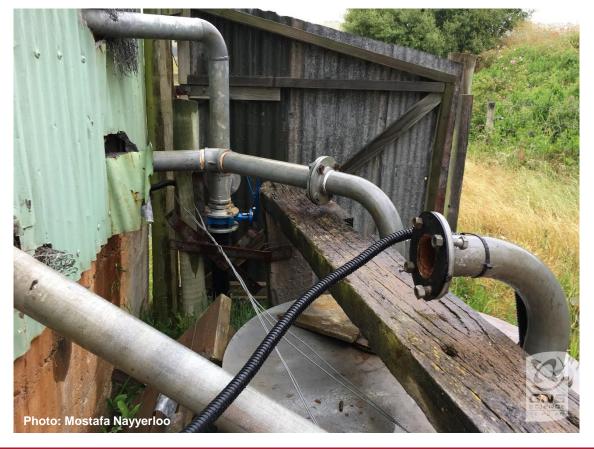
The Taimate bore pump in Ward failed when movement of the borehole relative to the nearby pump house resulted in the hold down bolts pulling out of the concrete base and displacement of the pump, despite the presence of a rubber bellow joints.
