Preliminary report on the investigation of the damage caused by the 2023 Turkey-Syria earthquake

JSCE Earthquake Damage Reconnaissance Team

03/05/2023 – 09/05/2023

Keisuke Ishikawa, Tokyo Denki University

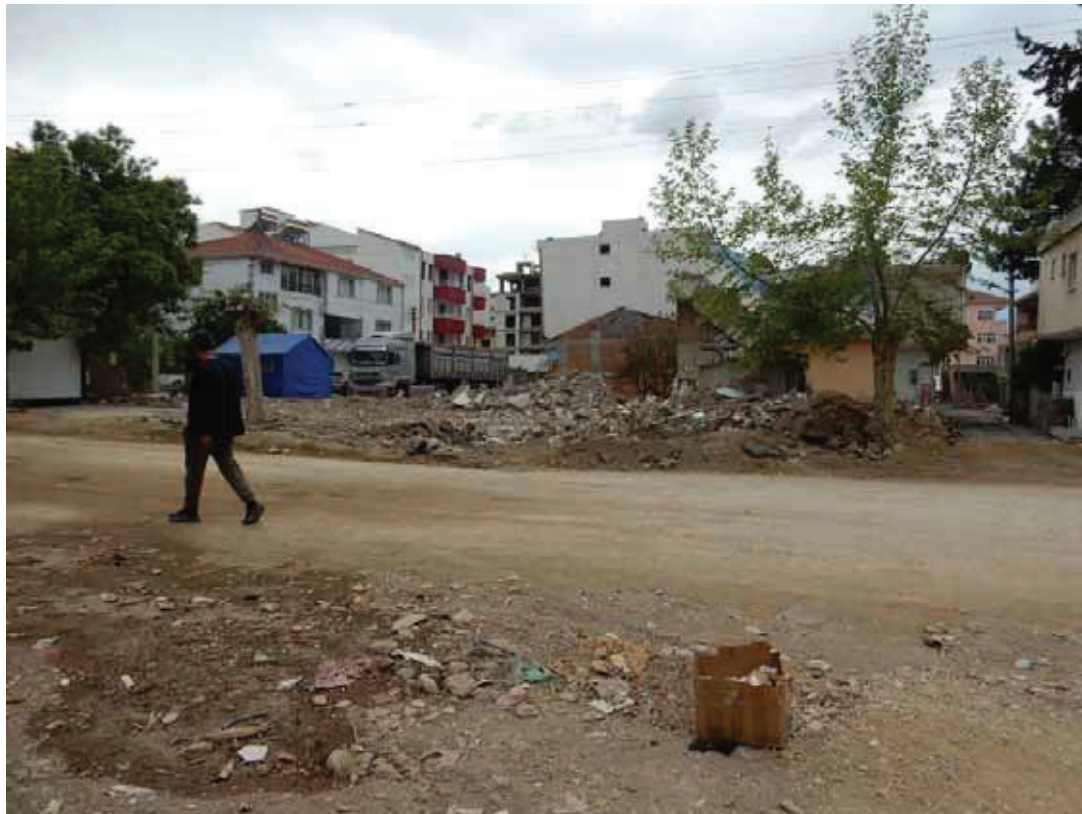
Building damage due to surface rupture or severe seismic motion: N37.78359597,E37.63840377

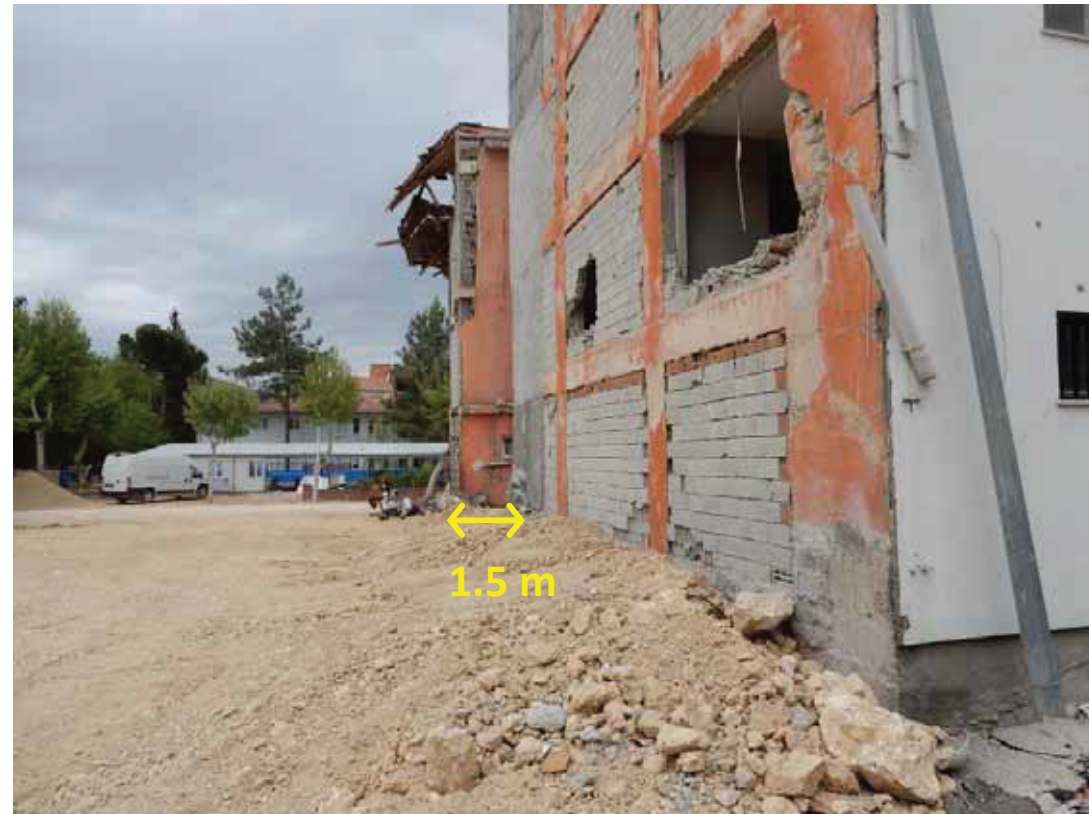
**Building movement due to surface rupture:
N37.78370000,E37.63863000
These buildings were lined up in the same position
before the earthquake. This building is rotating.**

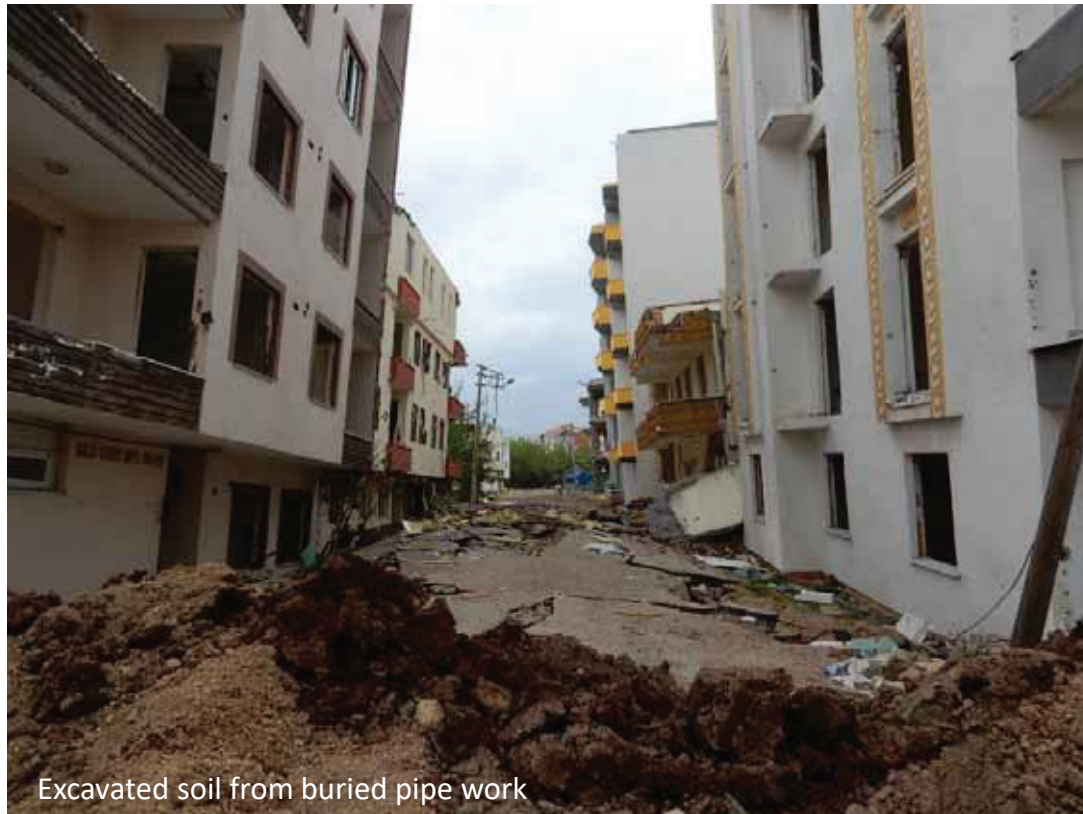
Excavated soil from buried pipe work

Road uplift caused by building settlement and tilting due to liquefaction: N37.78771333,E37.64247833

No damage to exterior walls or windows.

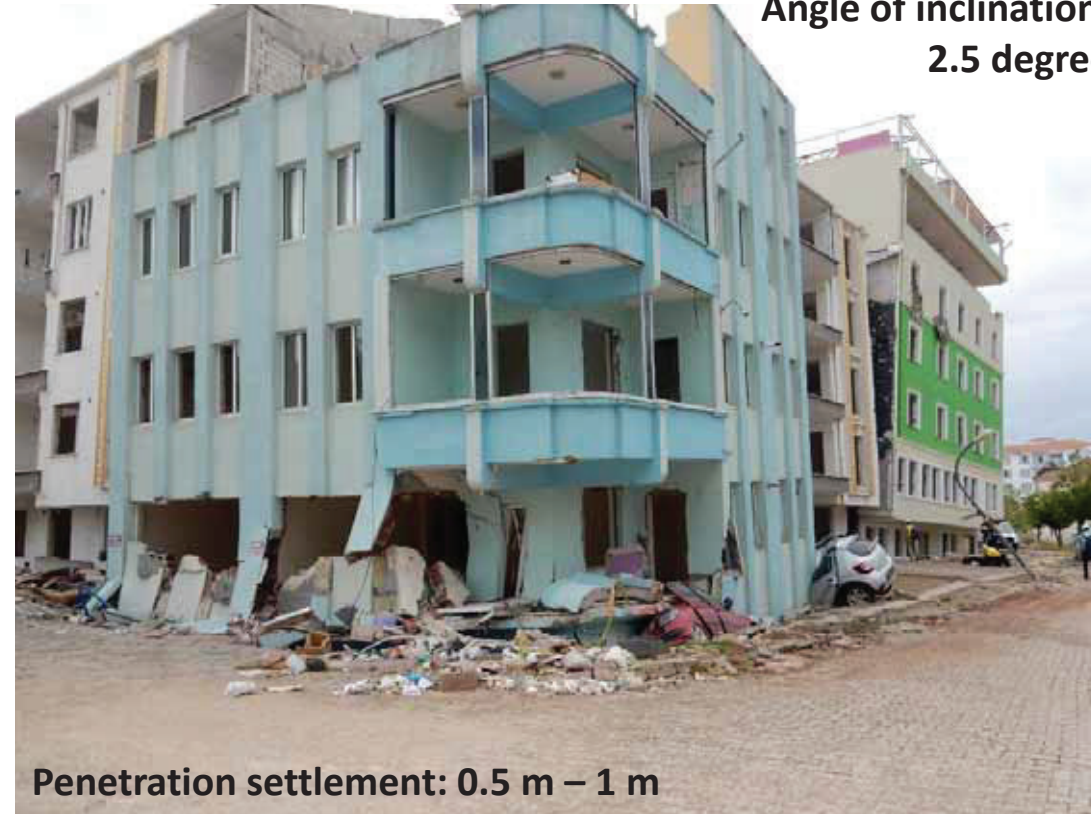
Angle of inclination:
2.5 degree

Penetration settlement: 0.5 m – 1 m

Building settlement and tilting due to liquefaction:
N37.78788500,E37.64269167

The soil deposited on the building was **plastic sandy silt**.

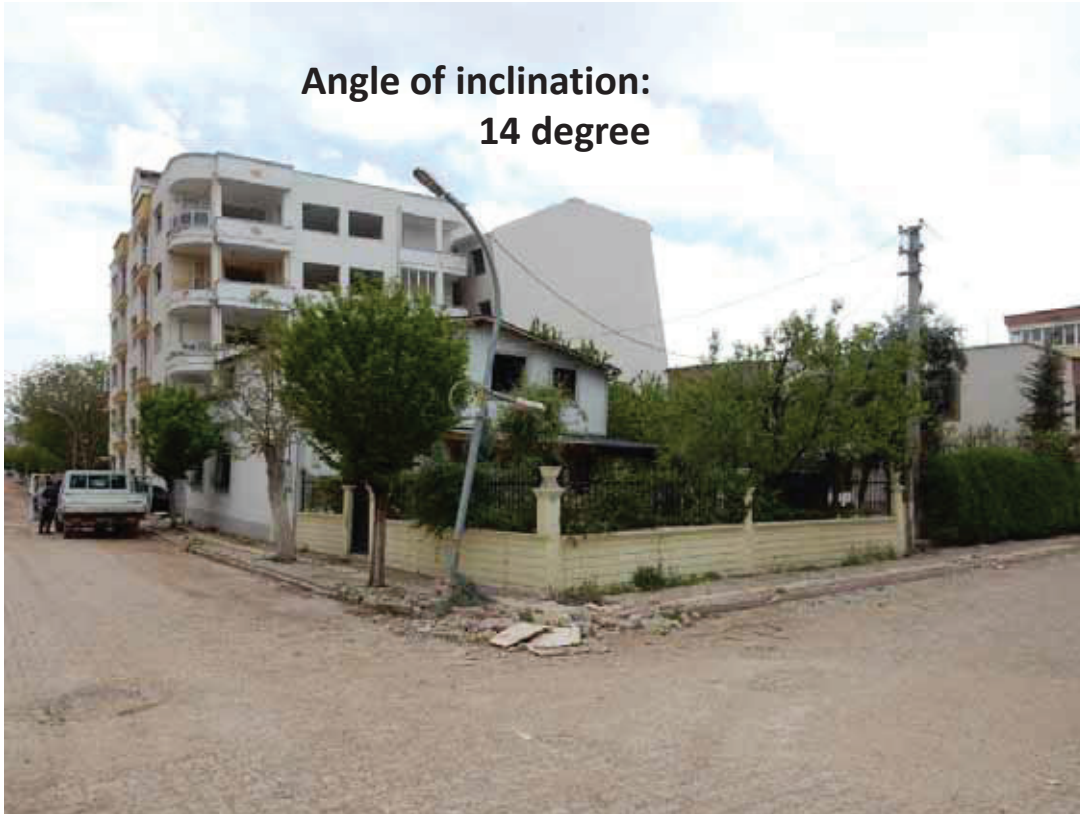
Angle of inclination:
14 degree

Inclined building due to liquefaction?:

N37.78749333,E37.64292167

Possible loss of bearing capacity of soft ground?

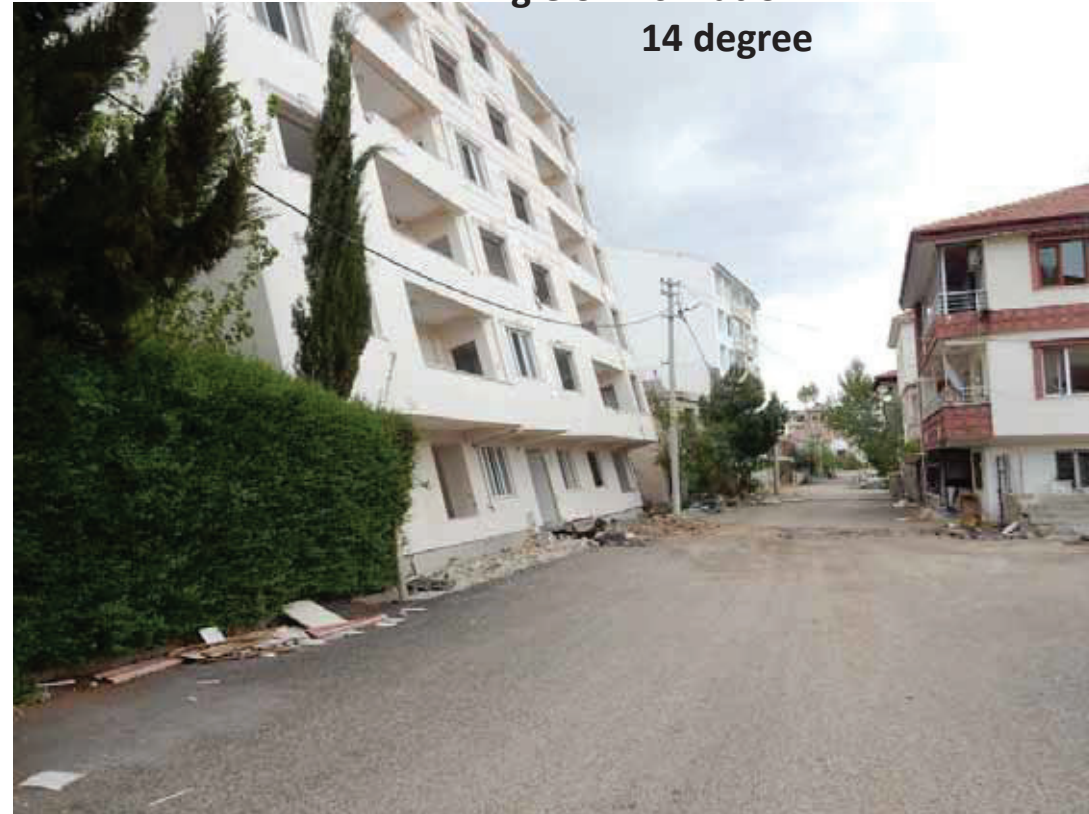
Angle of inclination:
14 degree

Inclined building due to liquefaction? :

N37.78750000,E37.64312500

Settlement and tilting of small buildings is minor.

Why have no road surface deformations occurred?

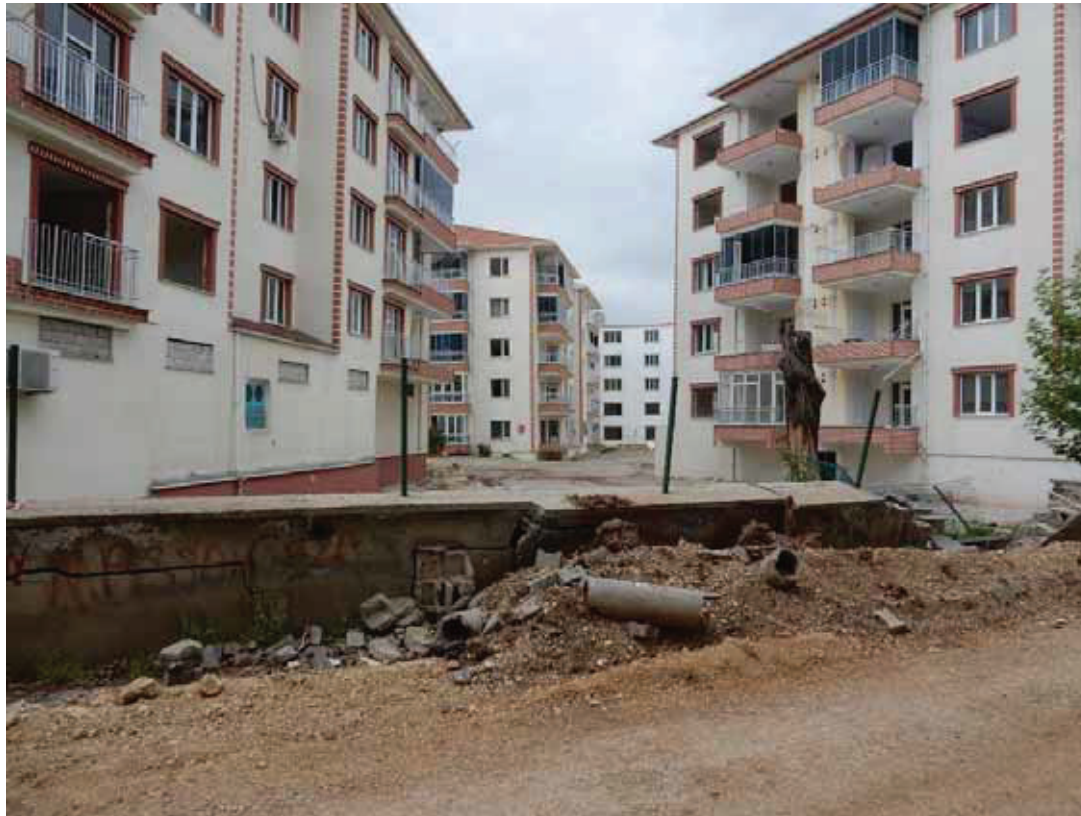
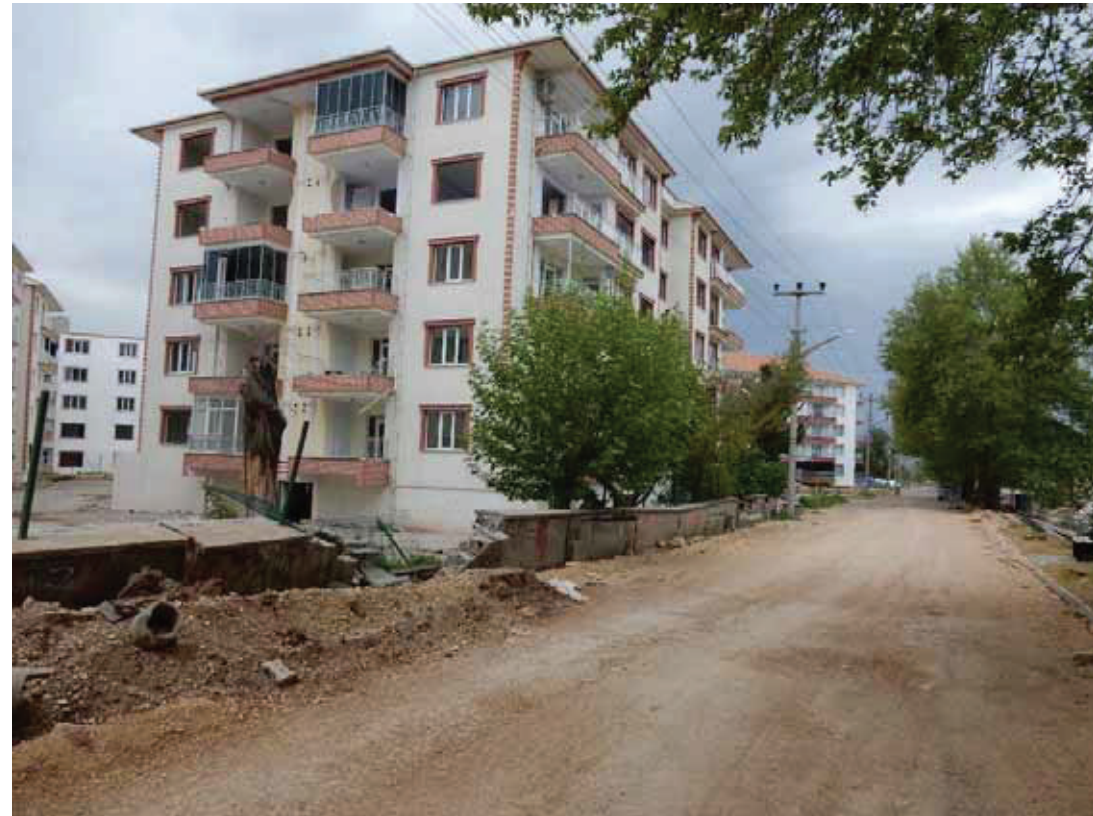
Apartment complex is settlement and tilting: N37.78797963,E37.64211058

What factors have contributed to the reduced settlement and tilting of the buildings?

- ✓ Is it primarily because the buildings are not adjacent to each other?
- ✓ Or is it related to alterations in the surface properties of the ground?

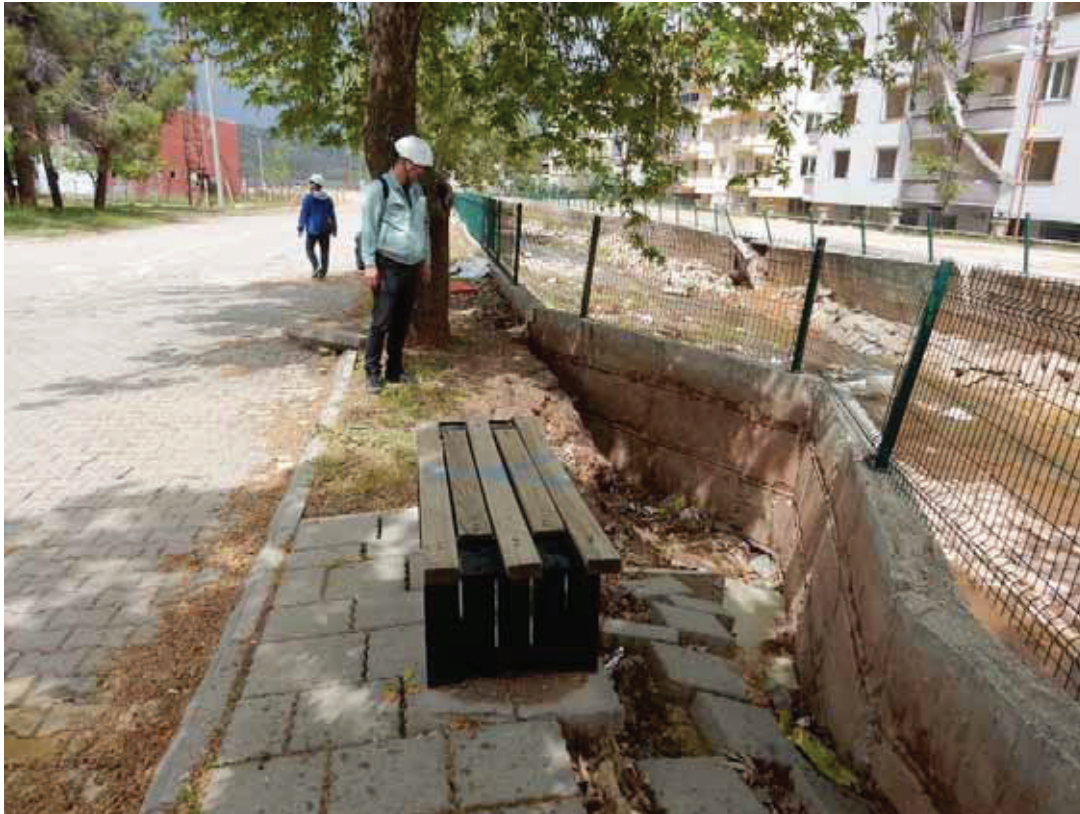
Deformation of creek revetment due to compressive displacement of ground: N37.78966333,E37.64352500
There is a 15 cm crack in the road surface, indicating that the ground has moved in the direction of the lake.

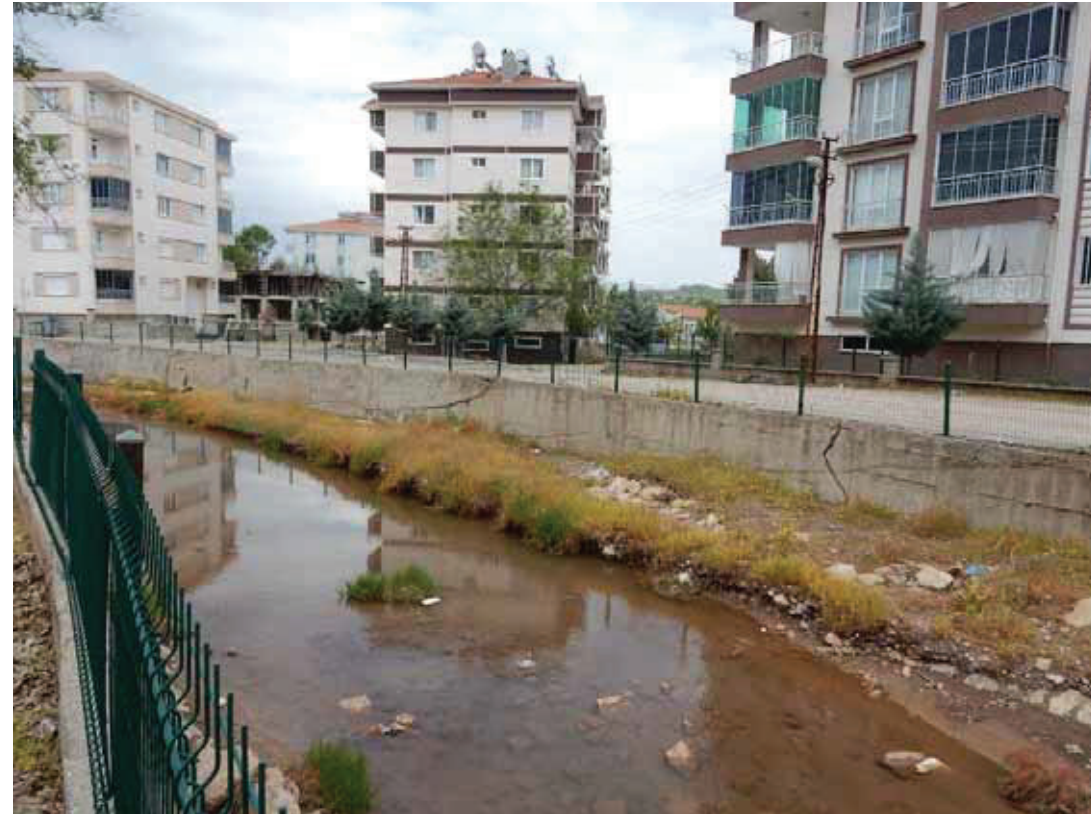
**Open cracks in creek revetment:
N37.78972167,E37.64348500**

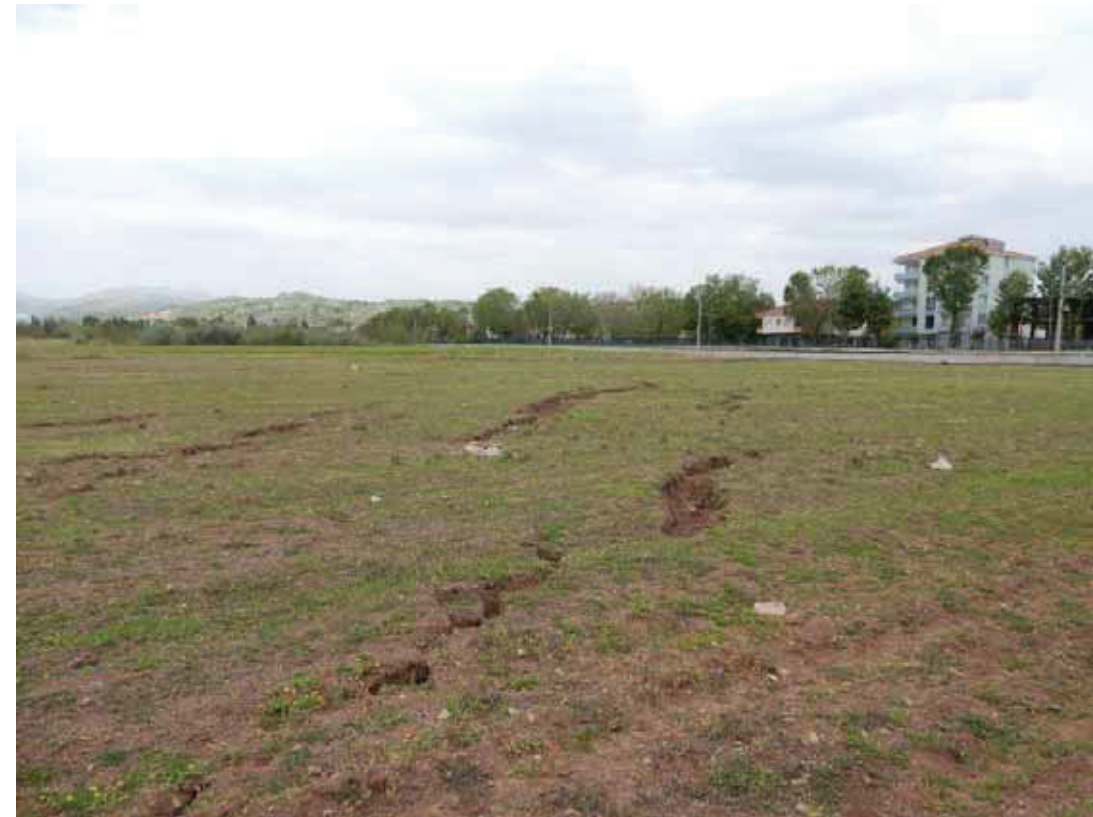
Open cracks in agricultural land near Lake Gölbaşı:

N37.79147833,E37.64386500

The open cracks are about 1 m in length and are distributed in a geese pattern.

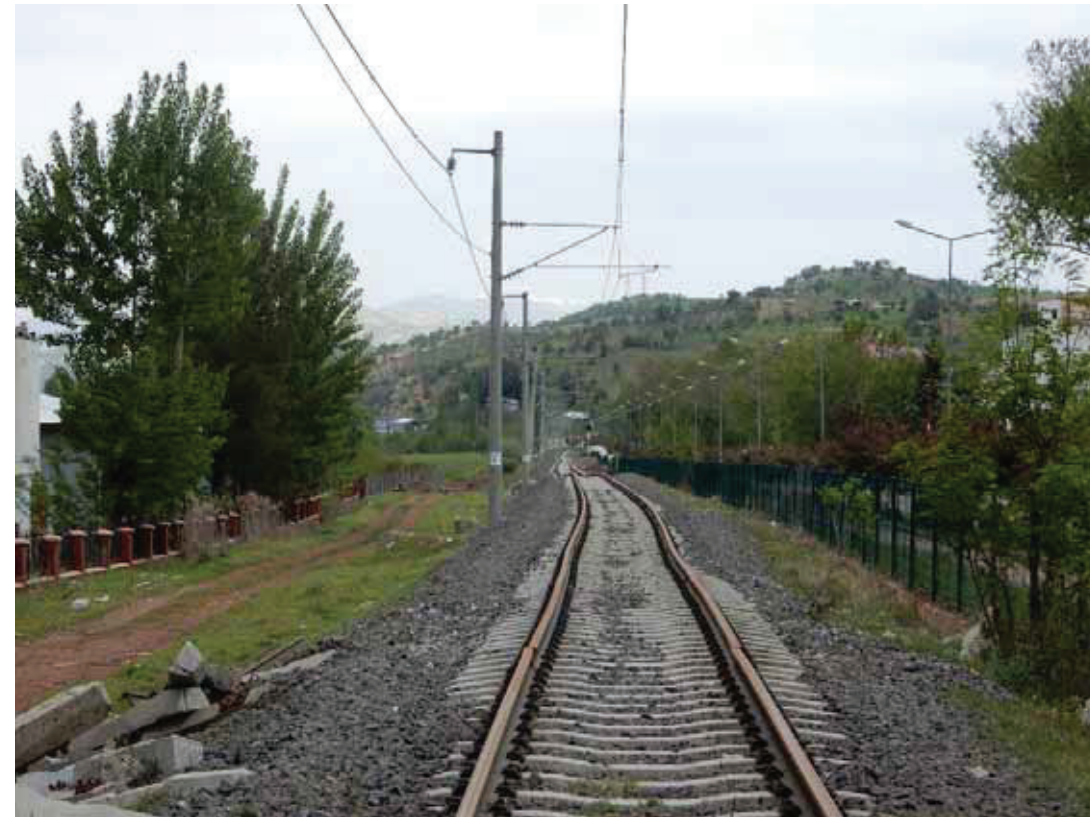
Deformation of the railway line along Lake Gölbaşı:

N37.79269833,E37.64961500

Lateral spread of the ground toward Lake Gölbaşı caused the deformation of the railway line and embankment.

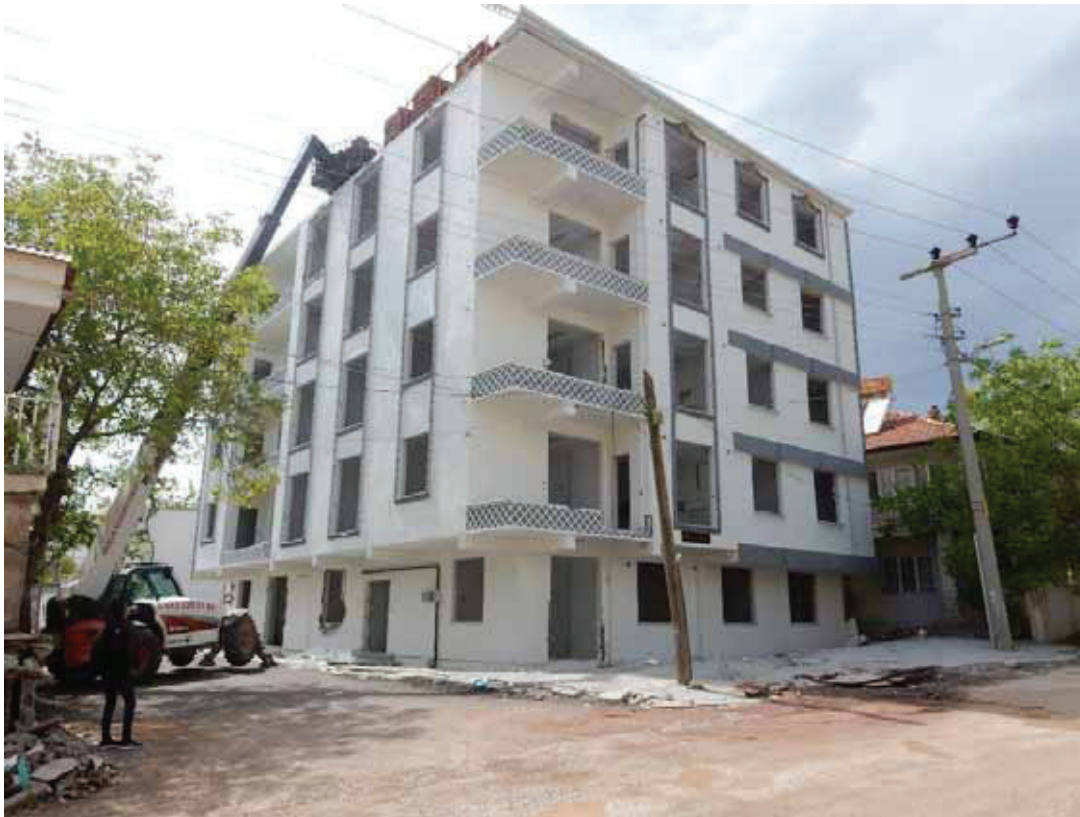
Settlement and tilting of a 5-story building:

N37.78915000,E37.64116000

No liquefaction layer? Thin layer of soft clay soil?

In addition, open cracks in the road surface occurred at regular intervals in this area from Lake Gölbaşı.

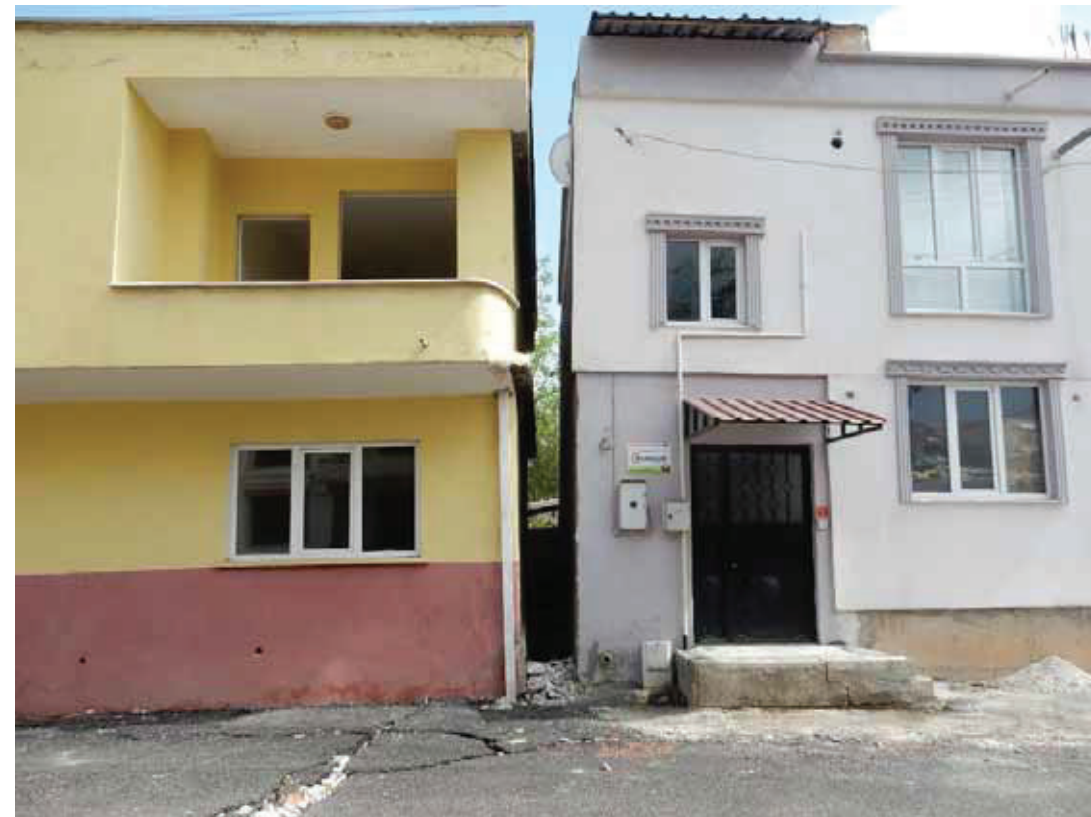
Tilt due to nonuniform settlement of older small buildings: N37.78846833,E37.64055167

No damage to exterior walls or windows.

Settlement and tilting damage due to decrease or loss of bearing capacity of soft clay soils?

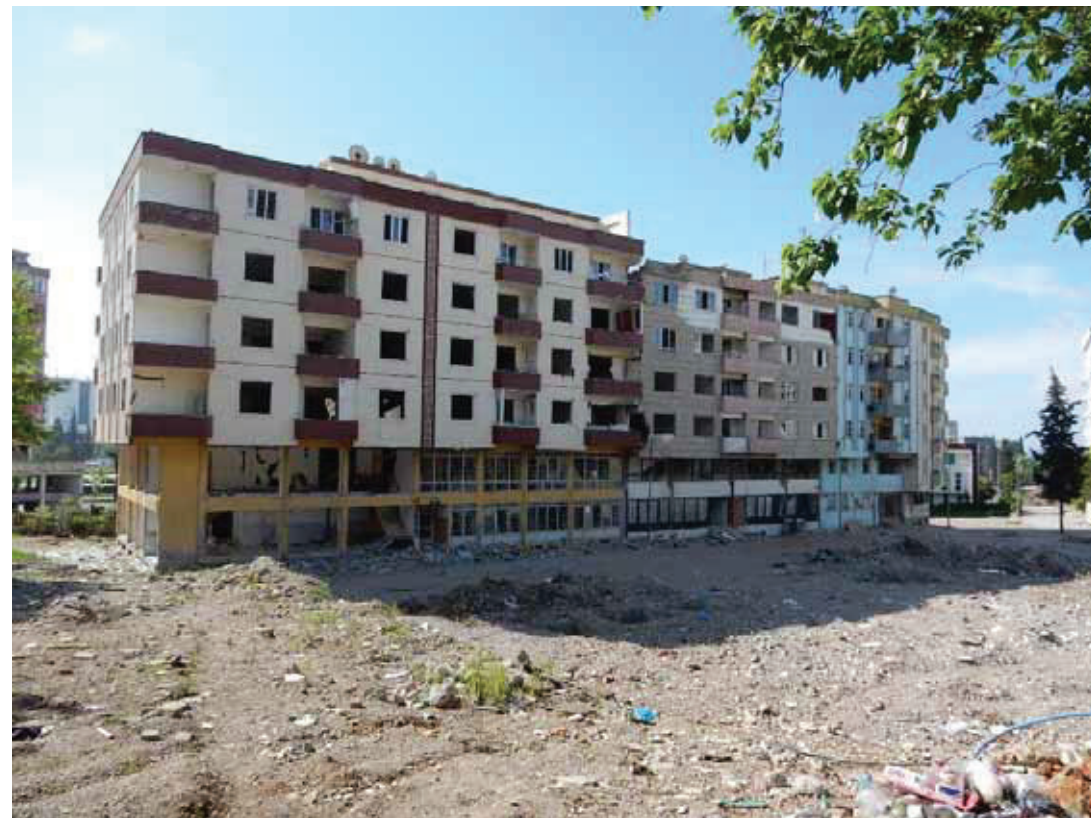
Many buildings damaged near the boundary with the hillside: N37.57974500,E36.92288833

Were seismic motions and displacements amplified near the topographic boundary?

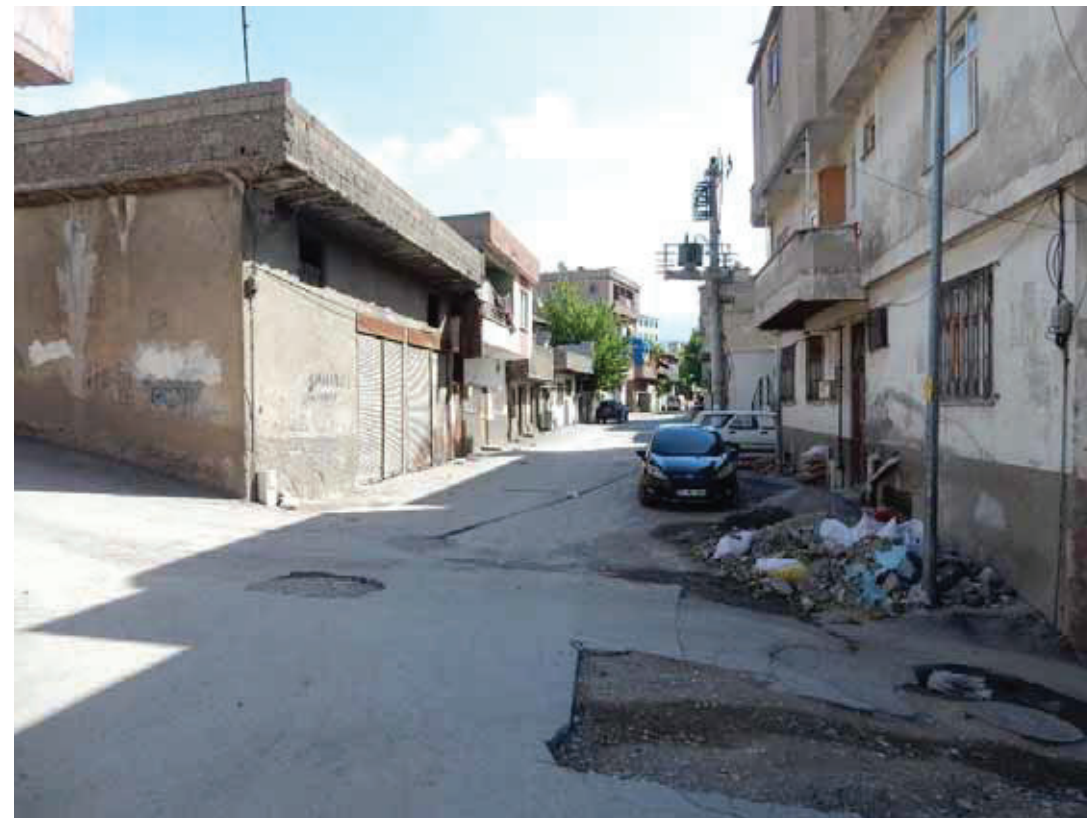
Old city on hilly terrain: N37.58003500,E36.92053833
Building is old but not collapsed. There is damage from shaking, such as collapsing outside walls.

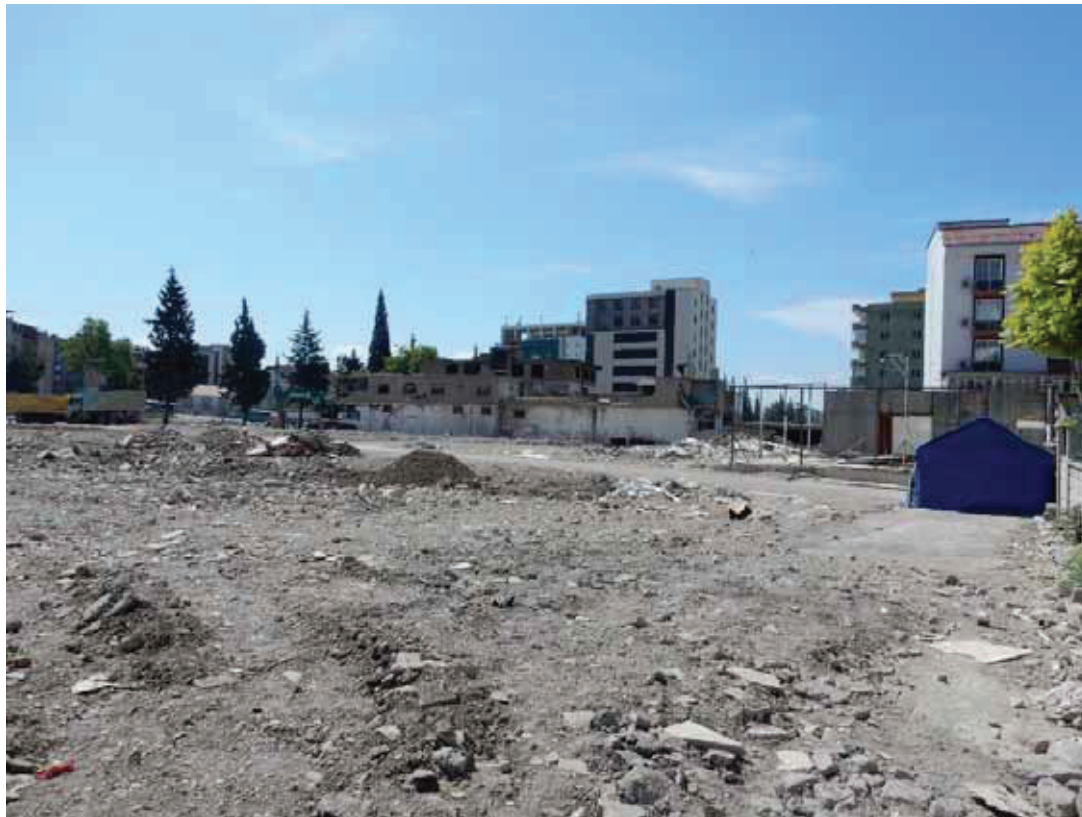
Devastation of New Town on the valley floor:

N37.57912500,E36.92572333

The damaged buildings had been removed and were in a state of disrepair.

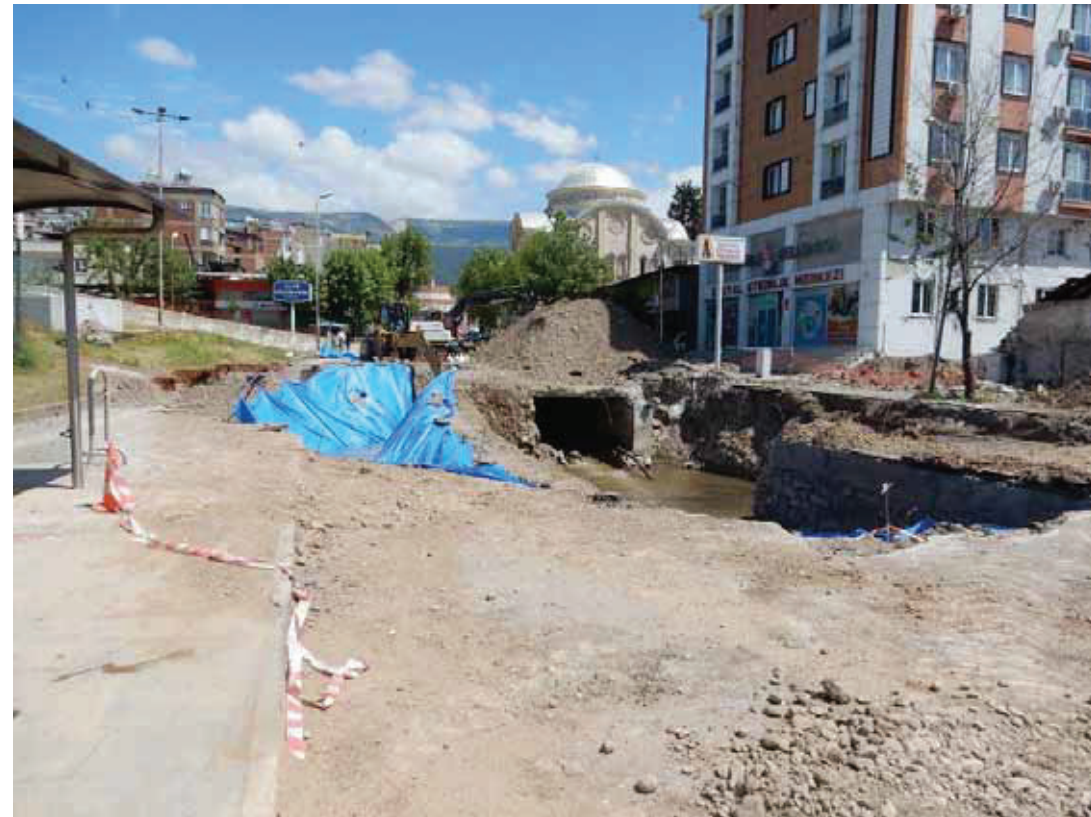
Underground river systems have been established in the valley floor plain: N37.57803833, E36.92531833

- ✓ **The underground river had a lot of water.**
- ✓ **Groundwater easily collects from the surrounding hills.**

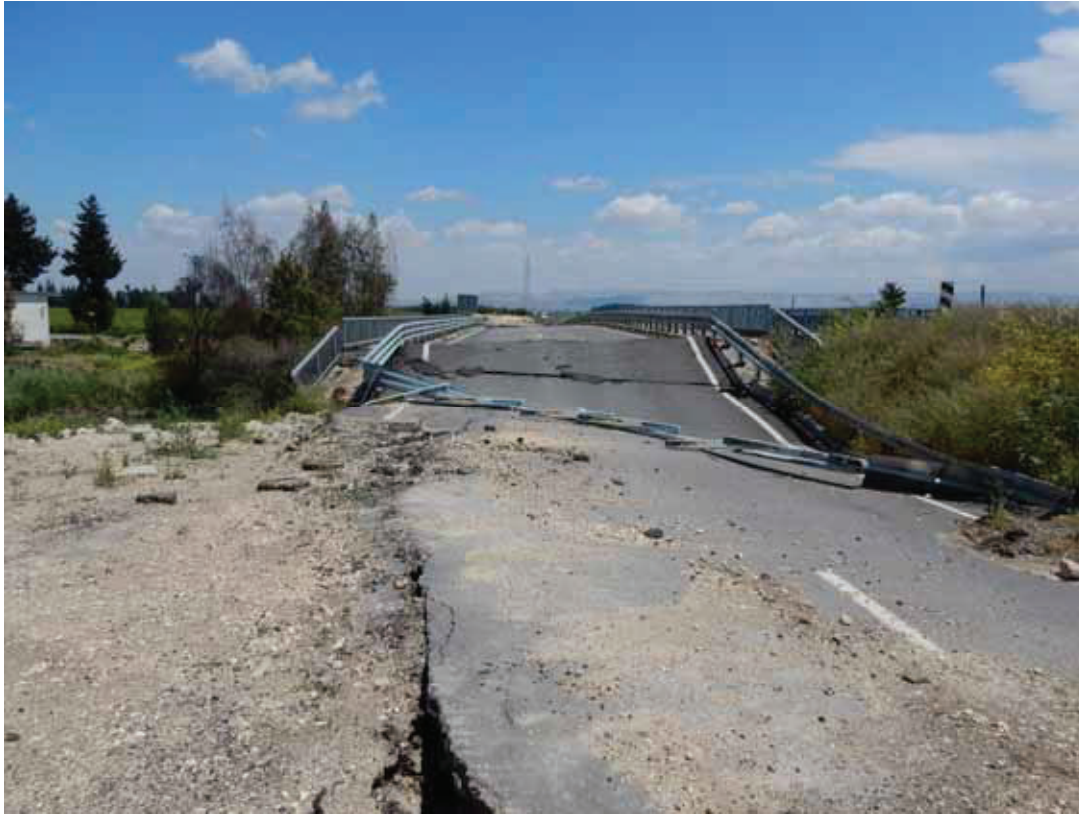
Bridge abutment on west side of D-480

Deformation of the embankment attached to the abutment: N36.24596500,E36.35660667

The embankment behind the abutment was deformed and stepped.

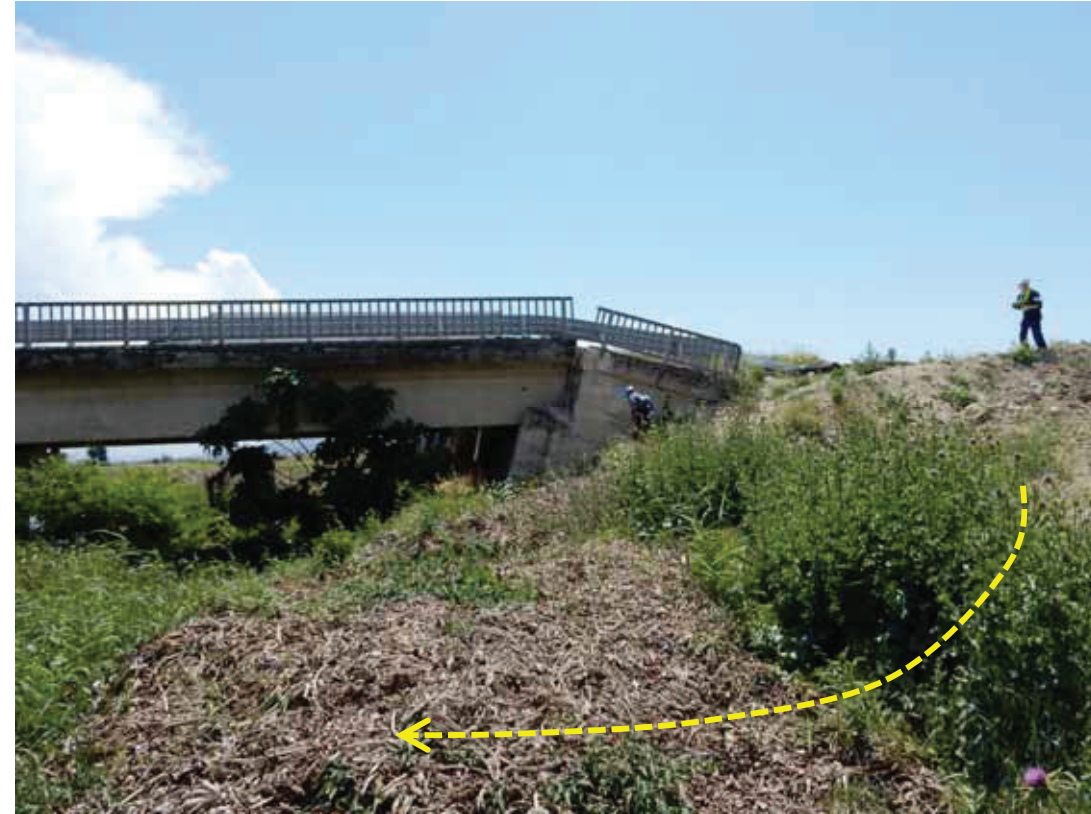
Deformation of bridge abutments: N36.24612167, E36.35683333

The abutment foundation moved into the river area in response to the liquefaction-induced deformation, which caused the abutment to rotate.

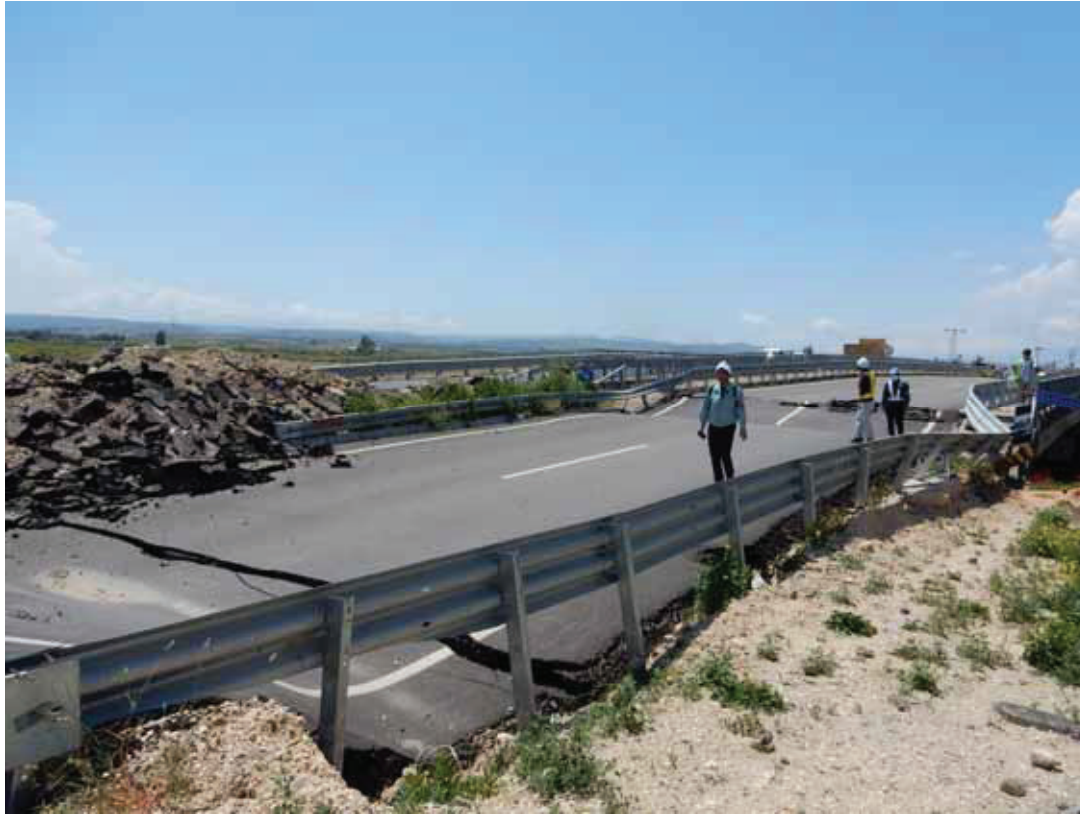
Bridge abutment on east side of D-480

Deformation of the embankment attached to the abutment: N36.24590833,E36.35762333
East side has the same deformation as the west side.

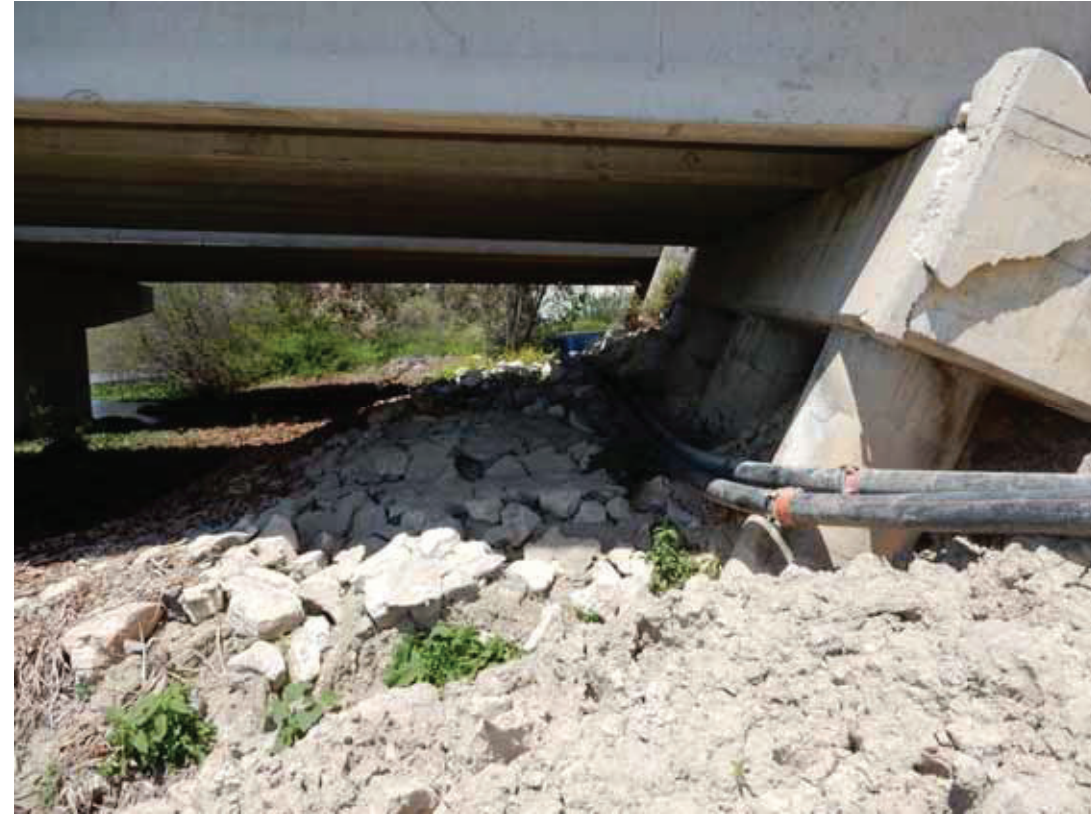
Deformation of bridge abutments: N36.24612167,
E36.35683333

Why are the RC piles placed on the abutment in a single row?

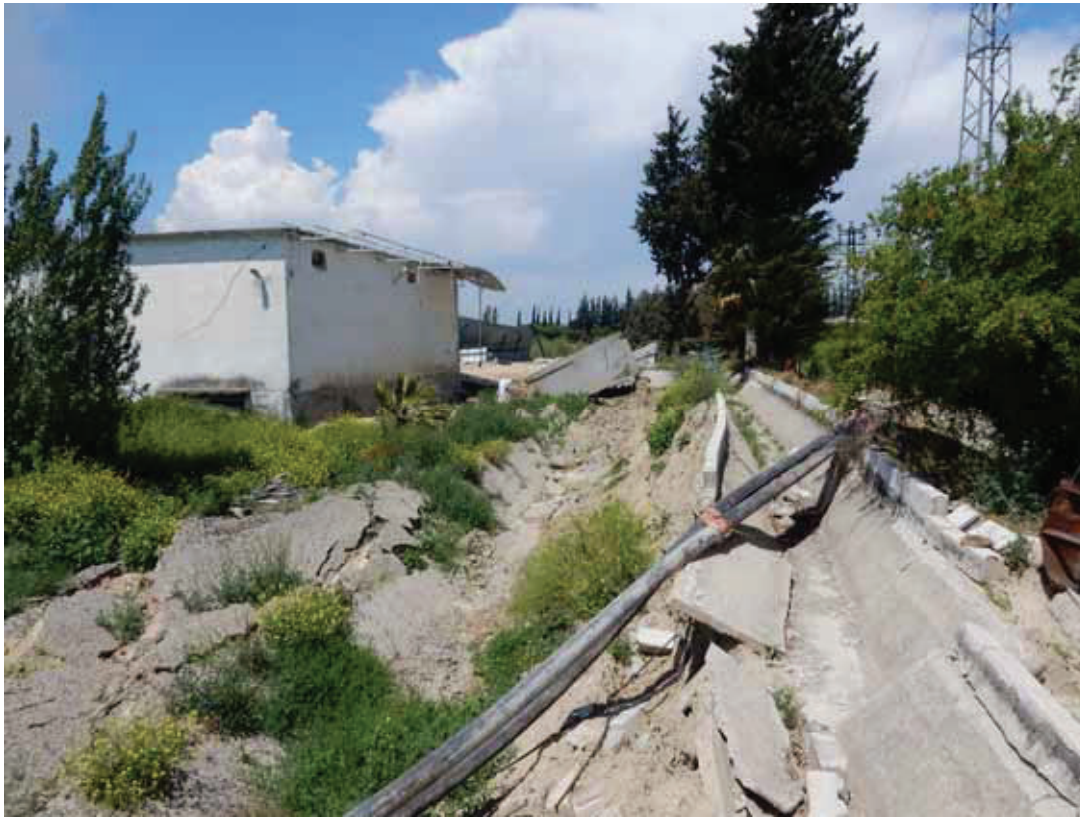
**Movement of agricultural facilities due to liquefied induced deformation: N36.24596047,E36.35770262
The Facility probably moved 5–10m to the river side.**

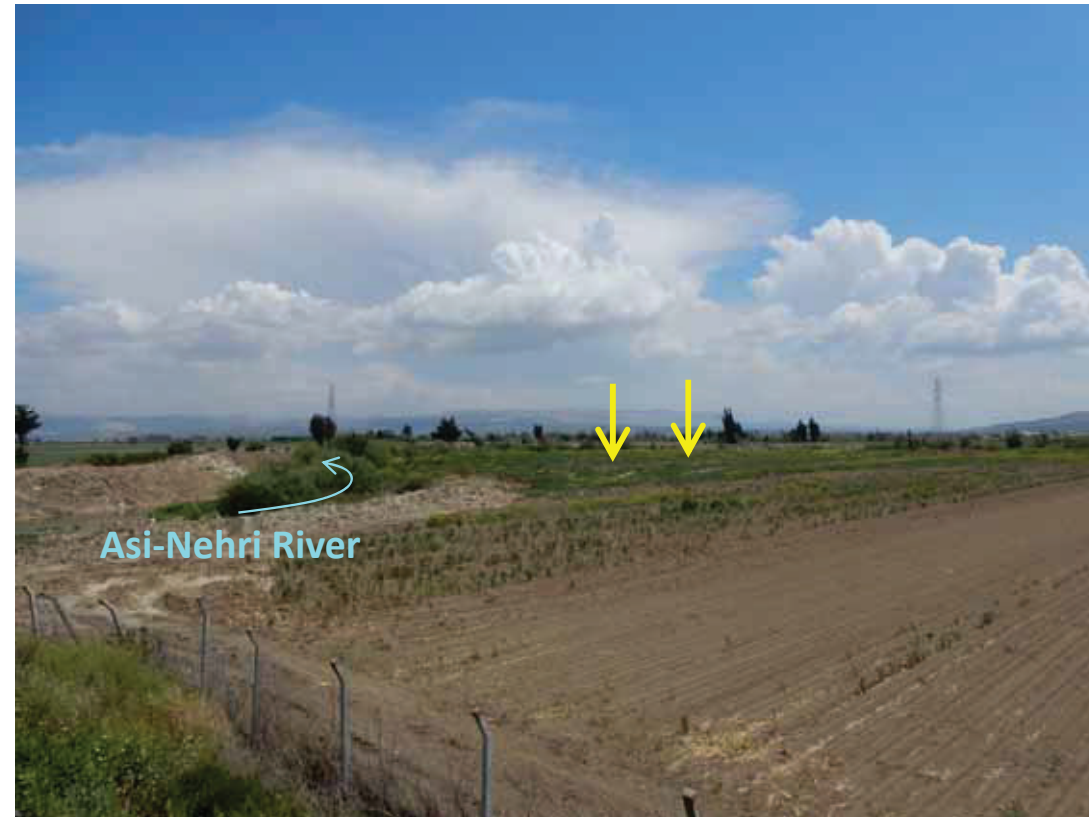
**Lateral spread due to liquefaction: N36.24575333,
E36.35633167
Surface deformation is also observed on the agricultural land along the Asi-Nehri River.**
