Preliminary report on the investigation of the damage caused by the 2023 Turkey-Syria earthquake

JSCE Earthquake Damage Reconnaissance Team

03/05/2023 – 09/05/2023

Keisuke Ishikawa, Tokyo Denki University

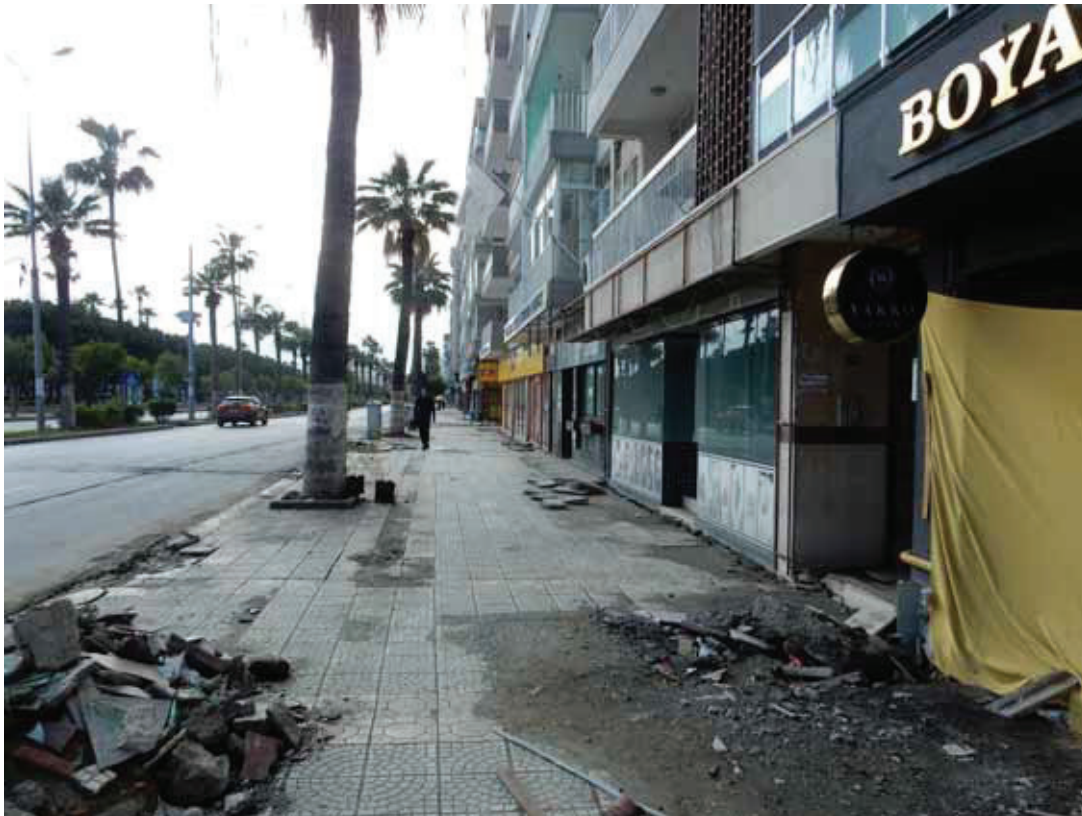
Buildings along the coastline:
N36.59319167,E36.16618333
The building is slightly settled but not tilted.
Sidewalks and driveways are cracked.

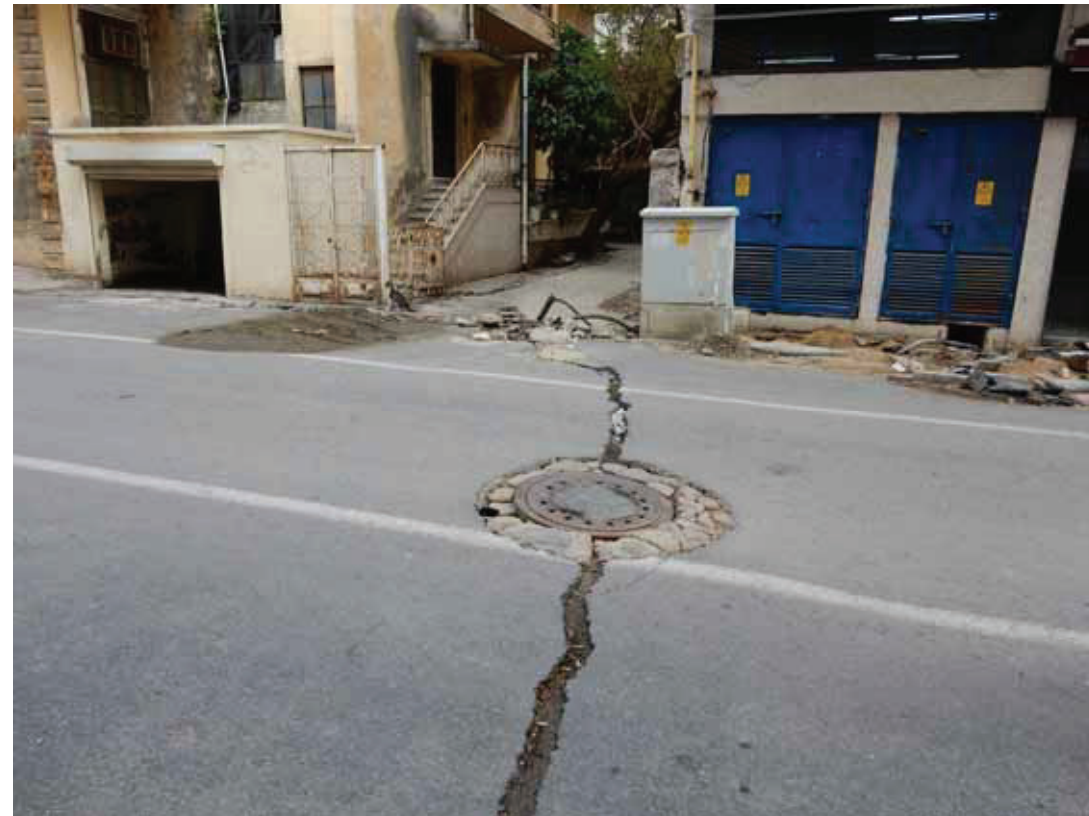
Open cracks in the roadway:
N36.59276000, E36.16663667
Near the boundary between 0m and 1m elevation at
20m DEM

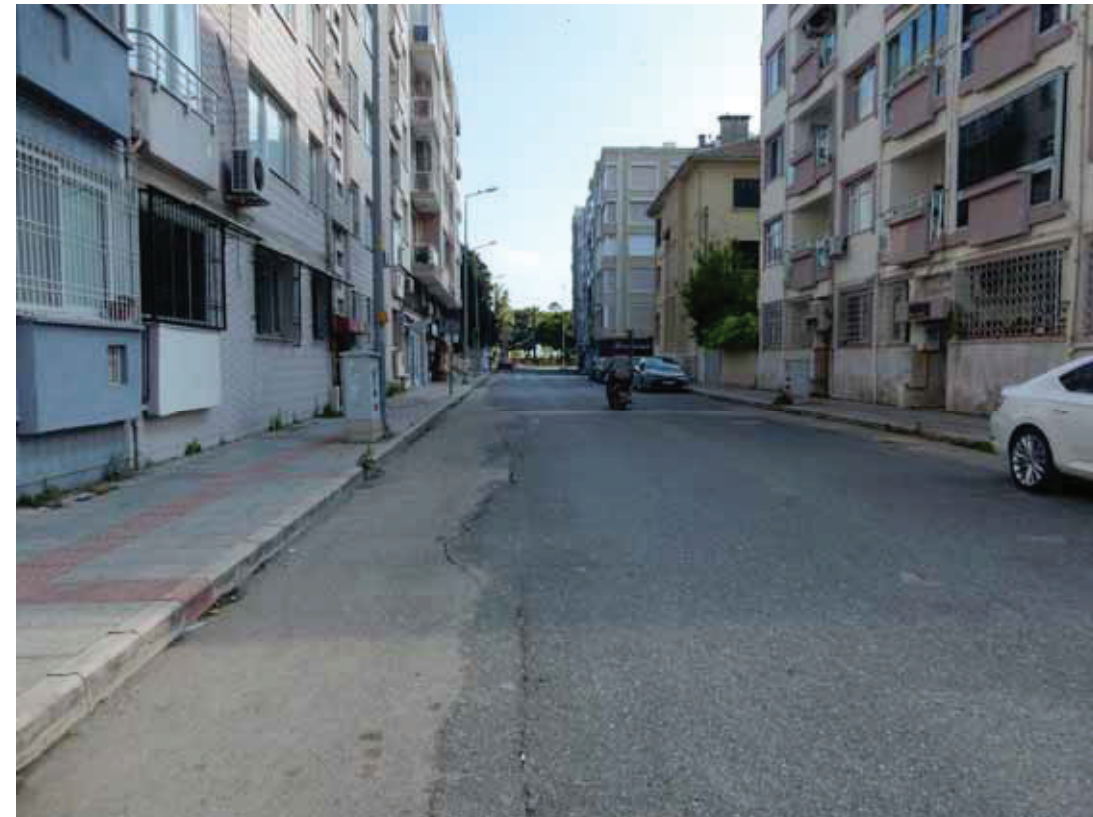
Buildings along the coastline:

N36.59244667,E36.16491333

No ground deformation can be observed in this area.

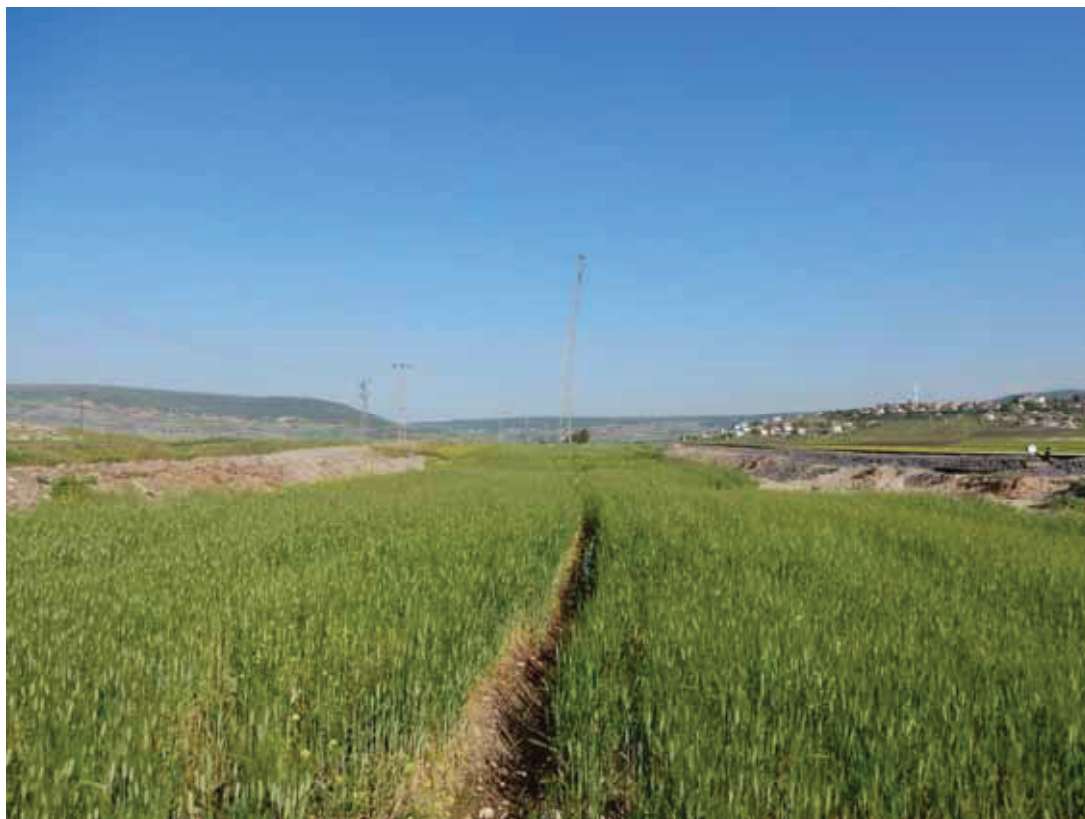
Deformation of power tower due to fault displacement

: N37.40201167,E37.15233833

Graben in front of power tower due to fault displacement

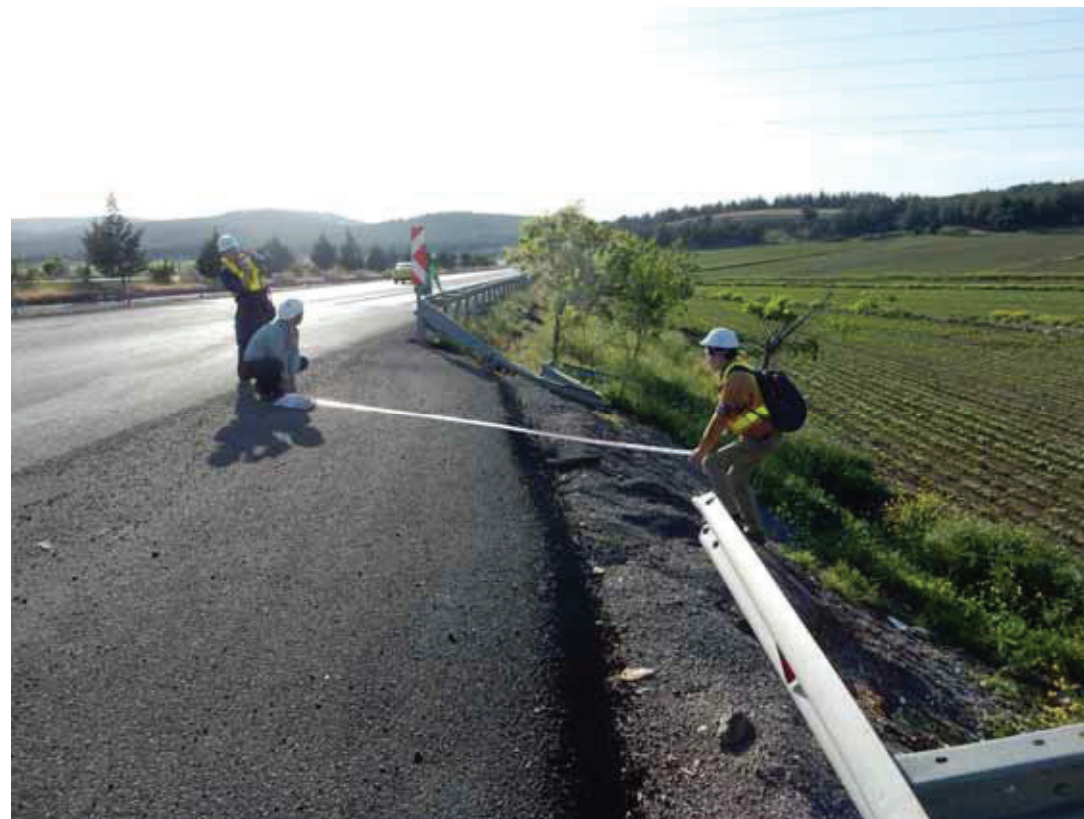
Deformation of motorway due to fault displacement:

N37.48005500,E37.04264167

The fault displacement moved one lane.

There is no problem for driving a car because of the lateral displacement fault.

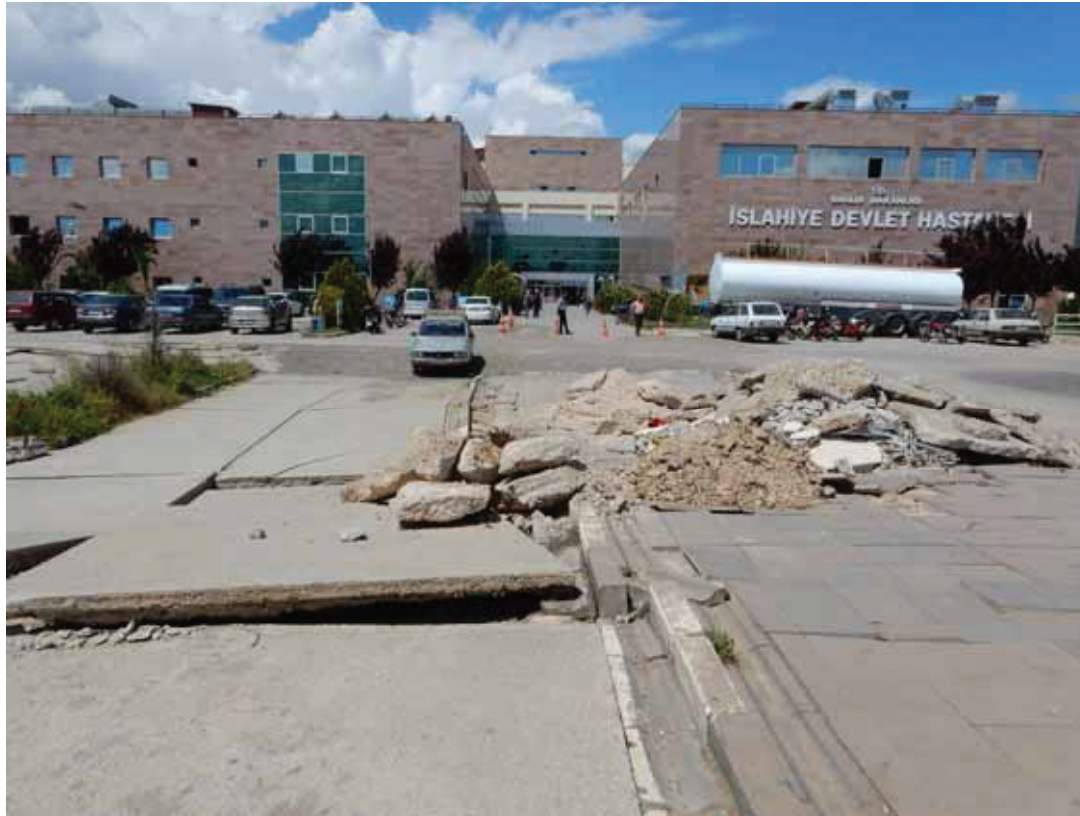
Ground deformation due to fault displacement:

N37.04485000,E36.62950667

İslahiye State Hospital's foundation is isolated and undamaged
