Hawkes Bay flood protection infrastructure: **Preliminary observations on embankment performance following Cyclone Gabrielle**

Dr Kaley Crawford-Flett

Stopbanks and related infrastructure: *A short overview*

Dams and related infrastructure:

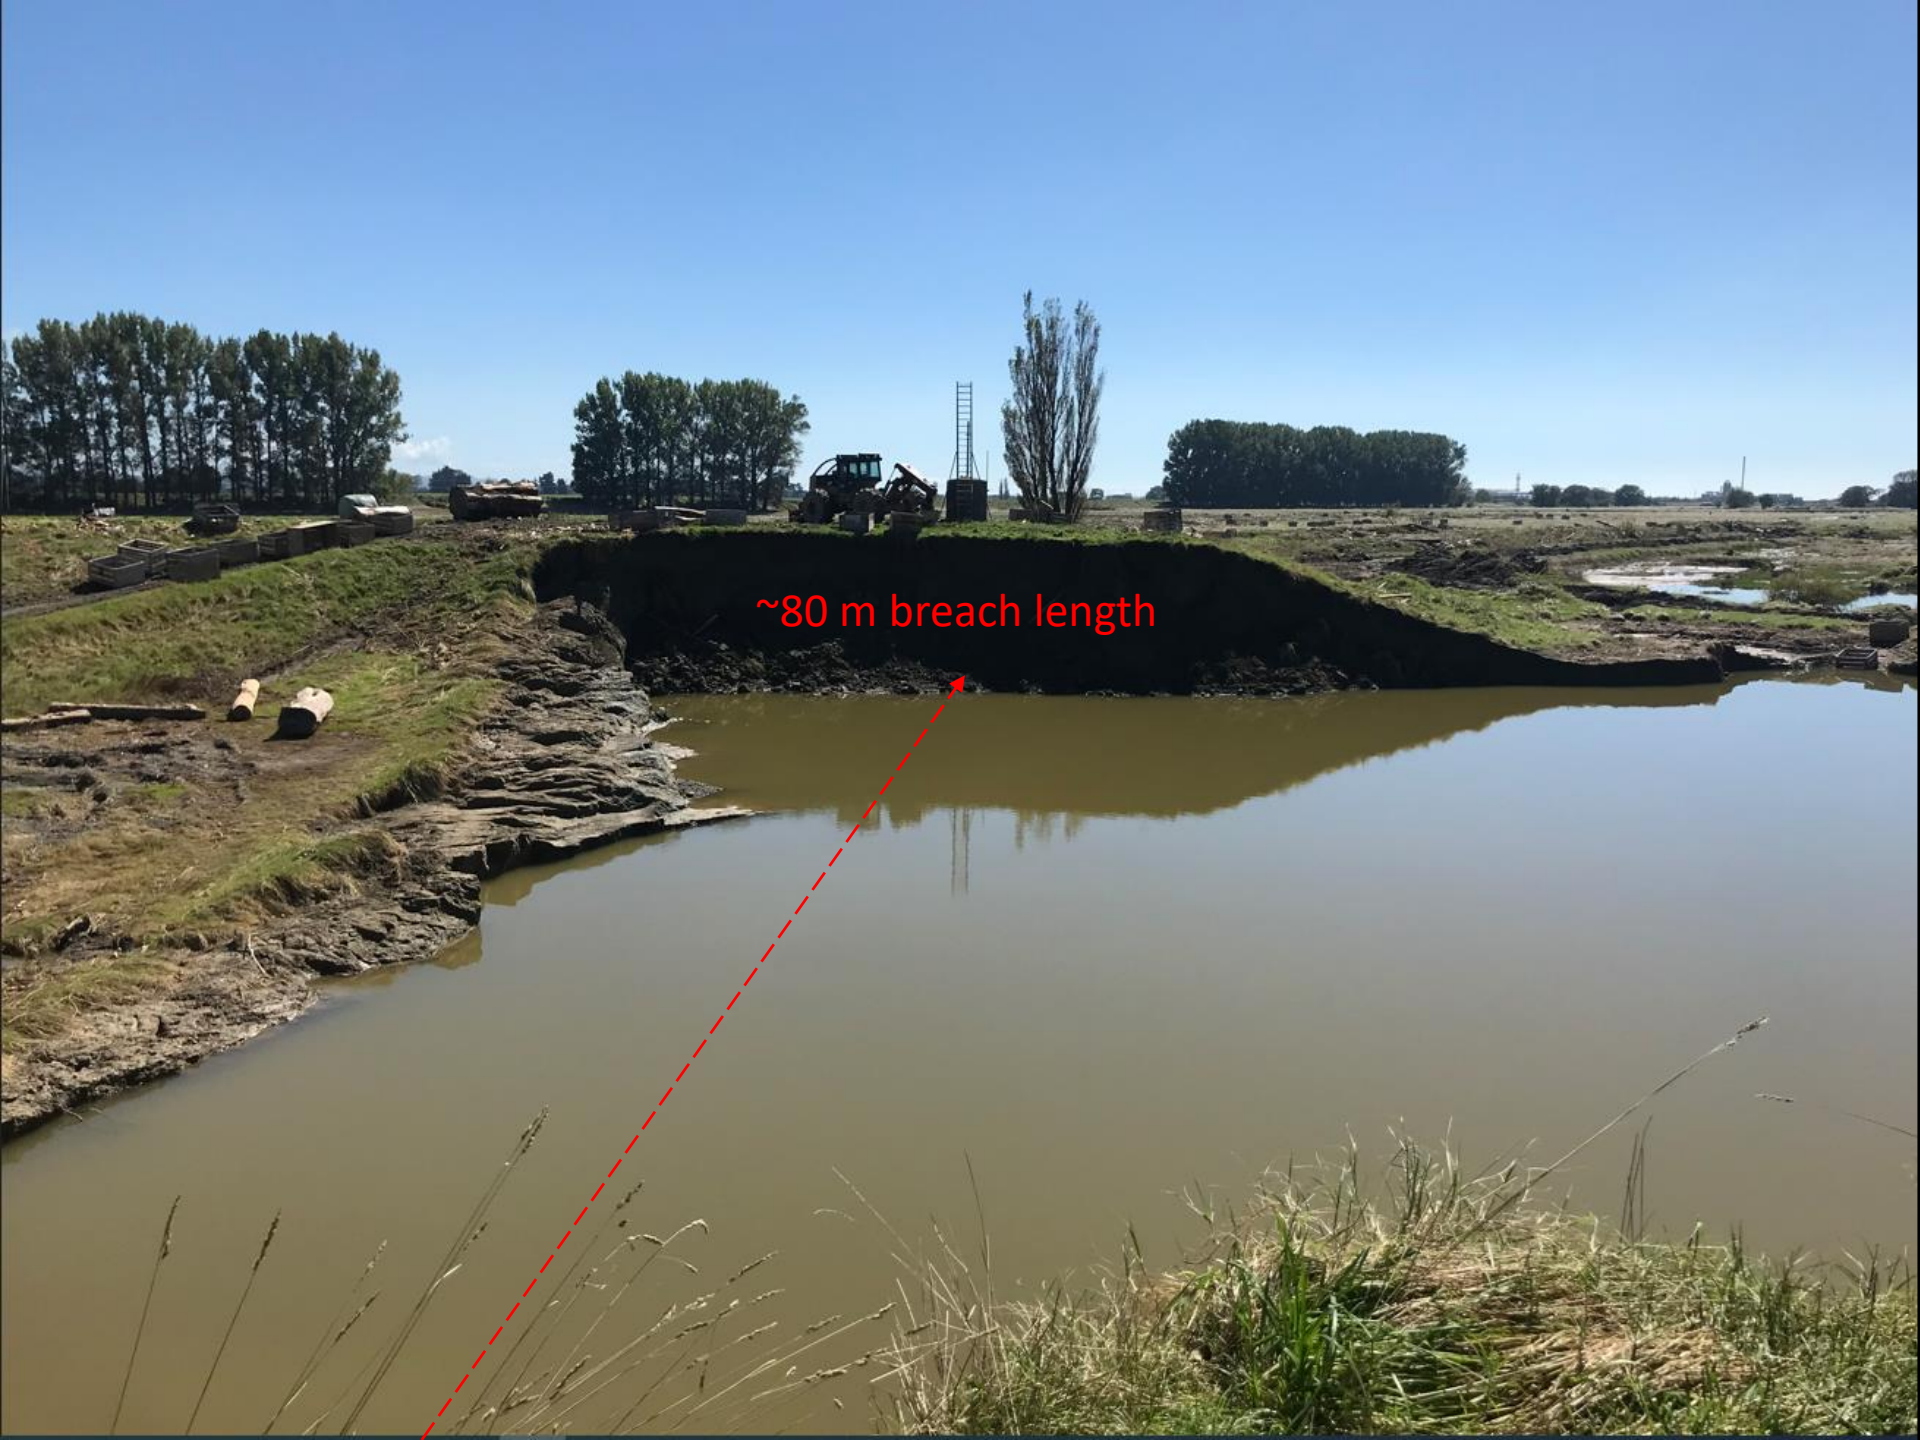
~80 m breach length

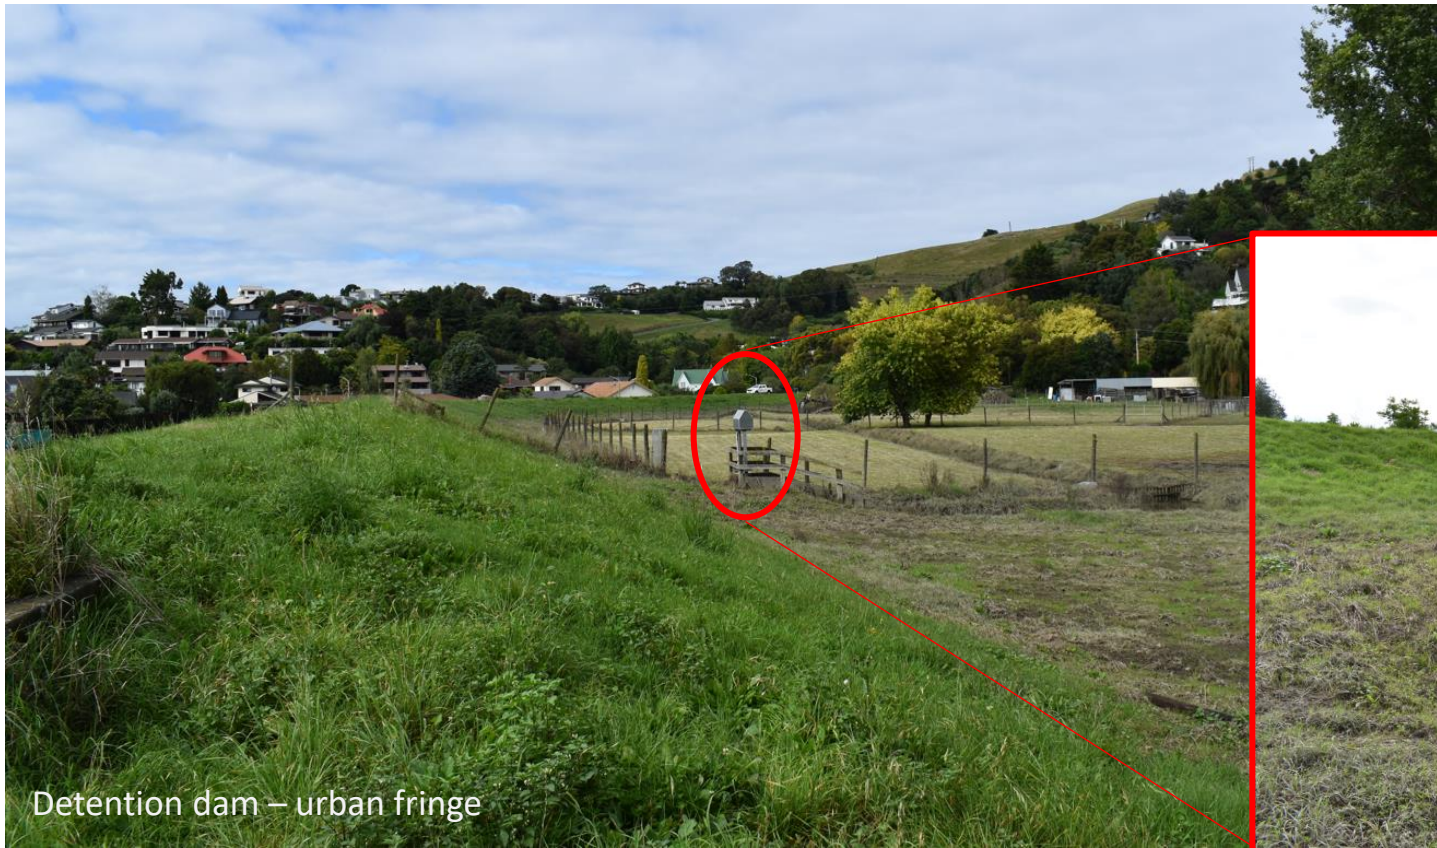
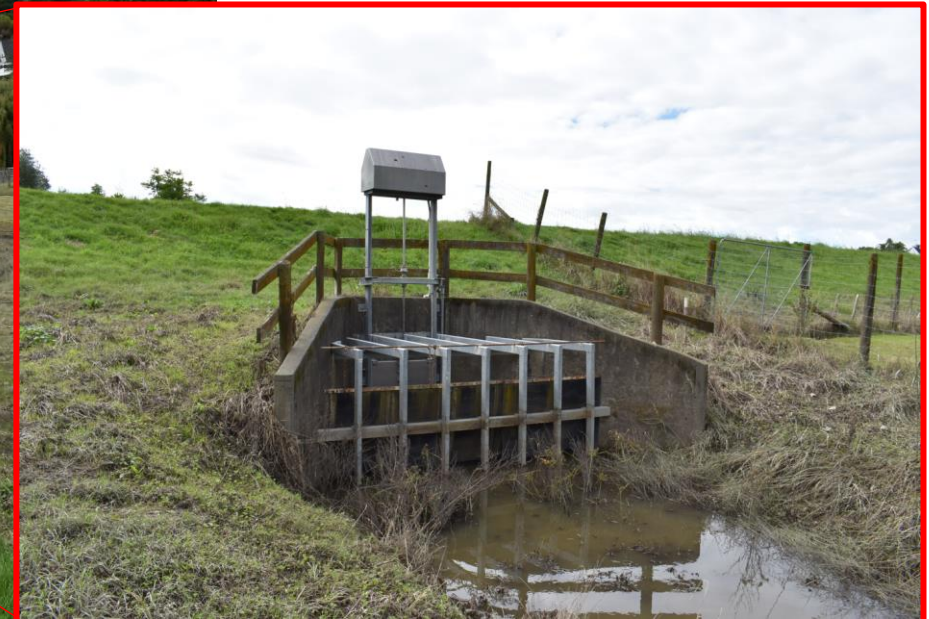
- Many challenges associated with ‘dry’ (flood detention) dams
- Outlet blockages (part 1)
 - Gate control when equipment sits below reservoir level
 - Knife gates present many challenges (again)
 - Not the design intent... embankment and spillway loading?
 - Emergency planning?

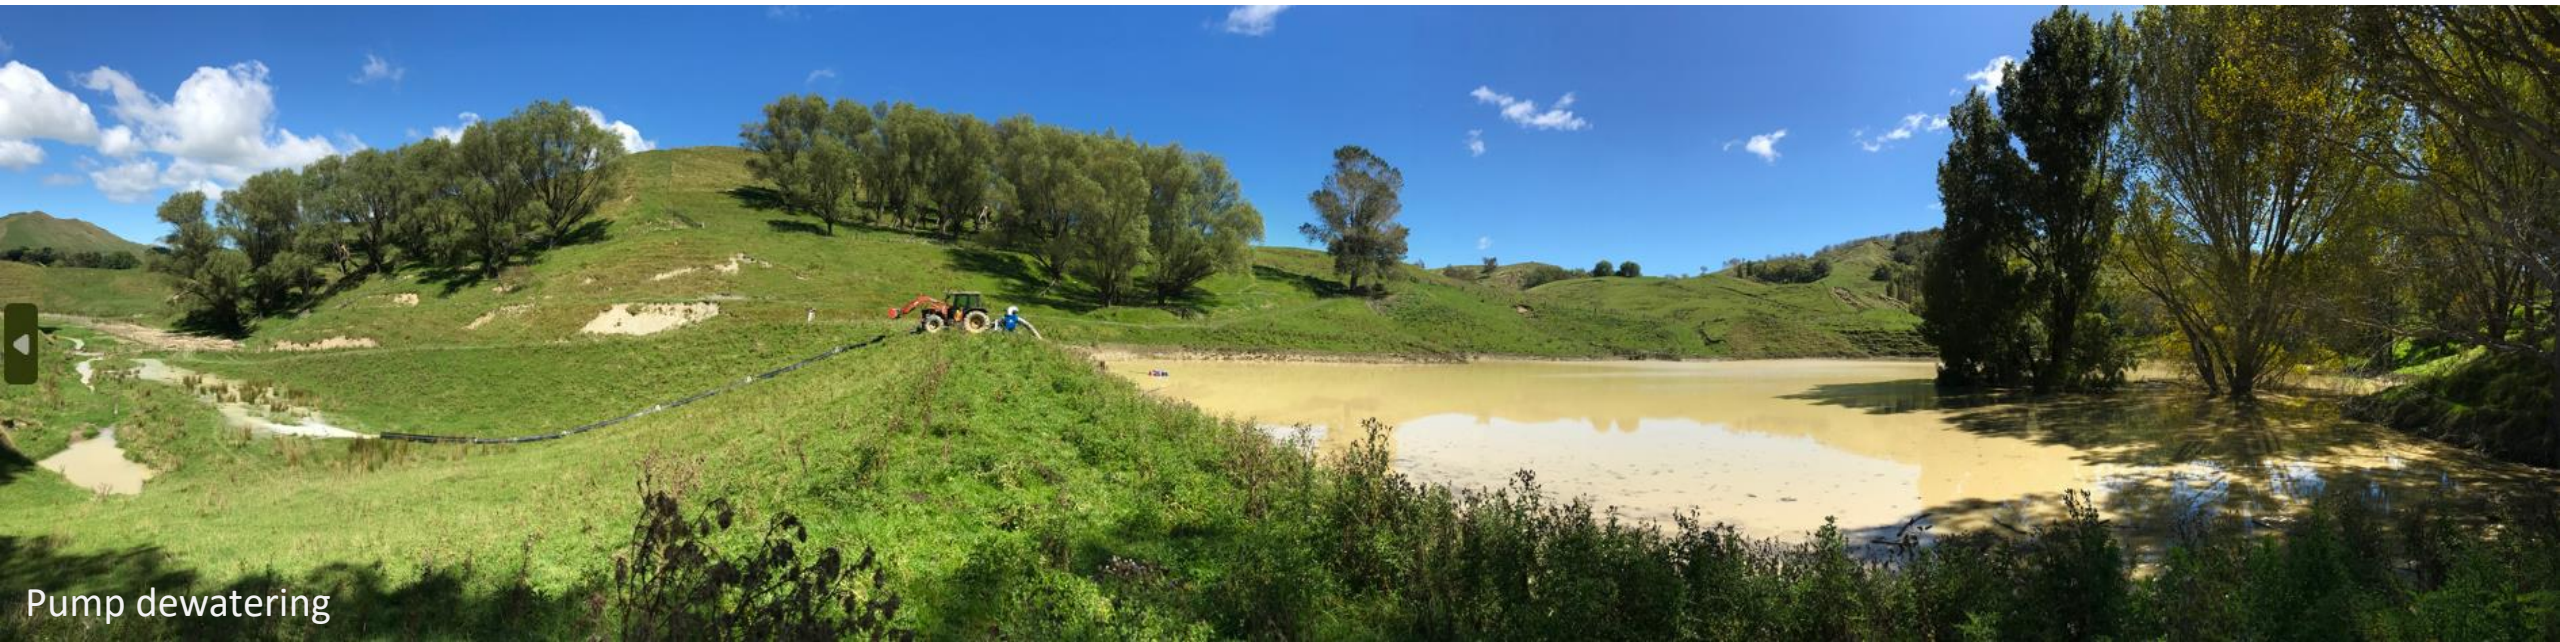
Pump dewatering

- Outlet blockages (part 2)
 - Gate outlet control when equipment sits below reservoir level
 - Rural dams unable to drain, full and spilling for weeks
 - Performing outside of design intent
 - Emergency planning?
- Emergency or auxiliary spillway operations
 - First opportunity (in 40 + years) to observe performance in extreme events
 - Erosion in grass-lined channels - some significant (performed, survived, but compromised)
 - Ongoing performance philosophy?
