# IMPACTS OF THE 14<sup>TH</sup> NOVEMBER 2016 KAIKŌURA EARTHQUAKE ON THREE WATERS SYSTEMS IN WELLINGTON, MARLBOROUGH AND KAIKŌURA, NEW ZEALAND: PRELIMINARY OBSERVATIONS

**Matthew W. Hughes<sup>1</sup>, Mostafa Nayyerloo<sup>2</sup>, Xavier Bellagamba<sup>3</sup>, Jonathan Morris<sup>4</sup>, Pathmanathan Brabhaharan<sup>4</sup>, Stephen Rooney<sup>5</sup>, Erica Hobbs<sup>5</sup>, Keith Wooley<sup>6</sup> and Steve Hutchison<sup>6</sup>**

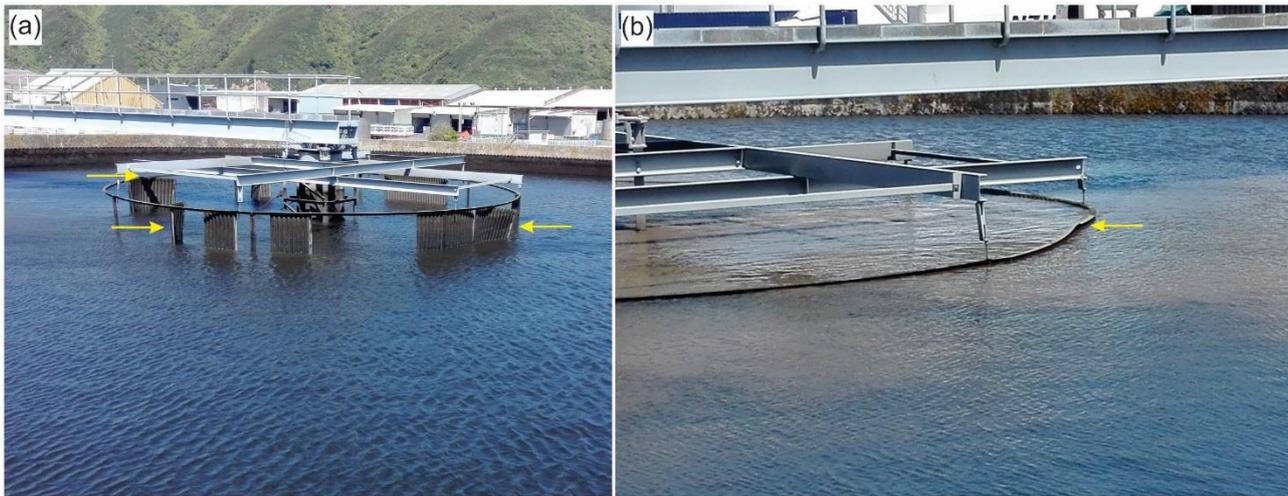
The four wastewater treatment plants in Wellington region are. Moa Point (Wellington), Seaview (Upper Hutt and Lower Hutt; see Figure 1a for location), Porirua and Western (Karori). In the Seaview and Porirua treatment plants, water seiching in the secondary clarifier tanks damaged the stilling well curtains and their holding rings that baffle mixed liquor influent to aid settling (Figure 2).

**Figure 2. Damage at the Seaview Waste Treatment Plant. See Figure 1a for location. (a) Displaced curtain panels in the stilling well in one of the Seaview treatment plant clarifiers. (b) Damaged ring that holds the curtains of the stilling well in one of the Seaview treatment plant clarifiers (Photos: Hutt Valley Water Services Ltd).**

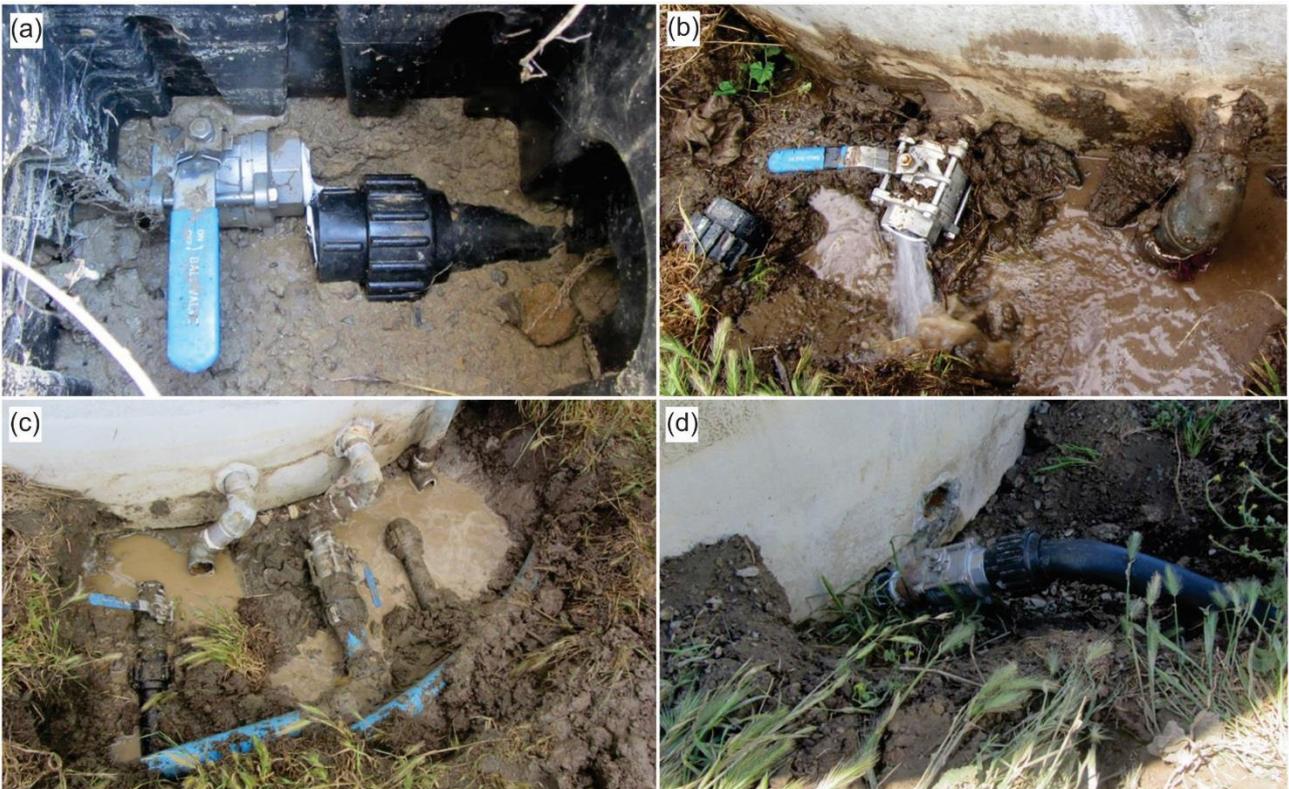
**Figure 5.** (a) Blind River Tanks. Failure failed threaded fitting due to horizontal displacement. (b) Flaxbourne, failed threaded fitting (Photo: Marlborough District Council). (c) Flaxbourne, failed threaded fitting and rotated galvanized pipe. The pipes rotated due to lateral ground movement. The seal around the pipes into the tanks has been compromised by the movement (Photo: Marlborough District Council). (d) Wheelers Hill. Pipe pulled out of tank wall due to relative displacement (Photo: Marlborough District Council). See Figure 1 for locations.

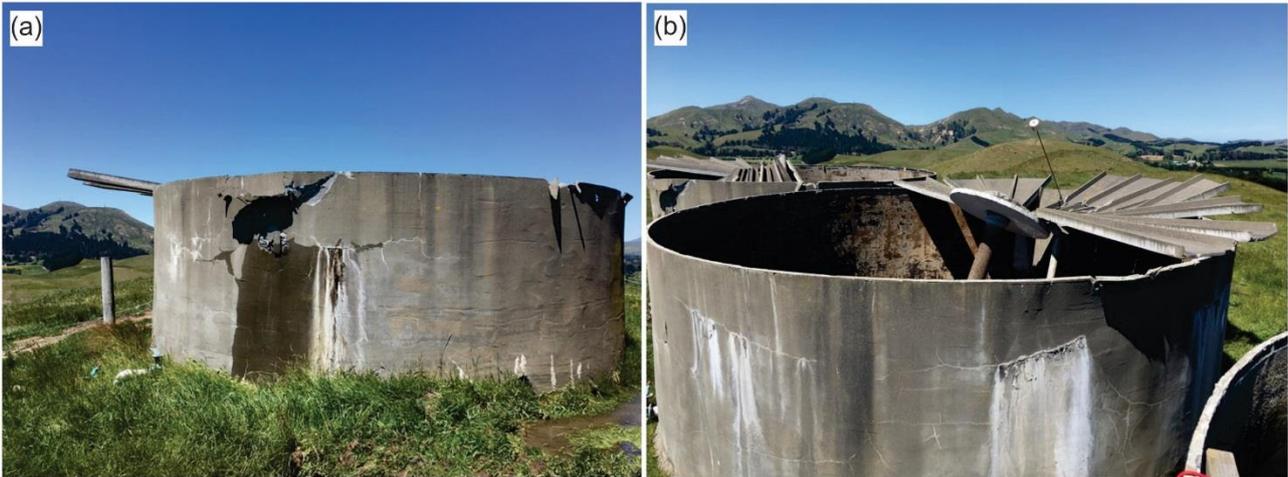
Storage tanks in the rural water supply systems in the Ward and Seddon areas experienced some damage (Figures 1, 4-6). Older ferrocrete concrete tanks in Ward installed in the 1950s suffered structural damage although one of the tanks remained partly operational. Newer tanks (both concrete and Polyethylene (PE)) appeared to have performed well. Where new concrete tanks had cracked this was minor and is expected to seal through autogenous healing. Concrete stave tanks had been damaged but remained serviceable, although with some additional leakage through cracks, some of which are likely to heal over time. If structural integrity has not been compromised, patch repair of damaged concrete may extend the useful life and defer the need for replacement. The tanks were generally located on hill tops, and hence were on good ground, and were not affected by liquefaction. As the hillside slopes were generally gentle, and the tanks were set back from the hillside slopes, the tanks were not affected by slope instability. Some cracks in the ground inferred to be due to slope displacements were observed

**Figure 6. Ferrocement tanks at Ward, installed in the 1950s. (a) The thin ferrocement walls have failed and the segmented roof has collapsed (Photo: Marlborough District Council). (b) The segmented roof and the central pillar have collapsed (Photo: Marlborough District Council).**

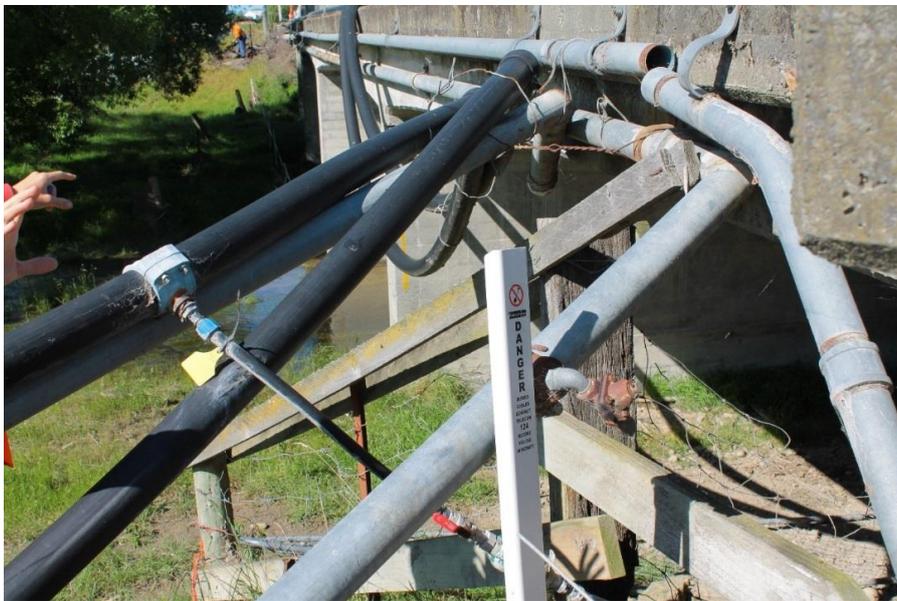
In addition to the Elizabeth Street footbridge in Blenheim, damage occurred at several other pipe service bridges across the region. For example, pipelines between relatively rigid bridge abutments and the ground were damaged as observed at

the Needles Creek bridge site along State Highway 1, north of Ward (Figure 7). Observed damage where pipes connect to bridges and other structures suggest more flexibility of the pipeline system would be important. A water supply well pump in Ward failed when movement of the water supply well relative to the nearby pump house resulted in the hold down bolts pulling out of the concrete base and displacement of the pump despite the presence of a rubber bellows joint. While this had caused an outage, it was believed that this had prevented failure of the pump itself (Figure 8).

**Figure 7. East side of the Needles Creek Bridge north of Ward on the SH1, viewed from the north. Original freshwater pipelines have failed and been replaced temporarily with ductile pipes (in black) (Photo: X. Bellagamba).**

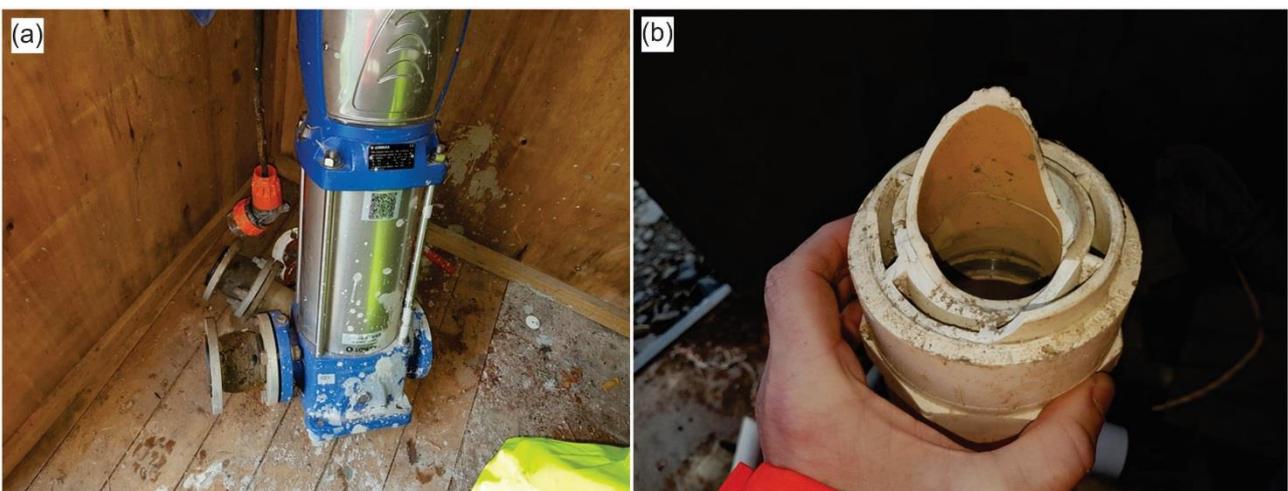
**Figure 8. (a) Grundfos pump in pump house at Ward. When the water supply well was displaced, the galvanized steel pipework pulled on the pump. The bolts holding the pump to the concrete slab then failed, causing the pump to topple. (b) Failed PVC pipework from the Taimate water supply well near Ward. The pump house building slid on its base, causing the water supply well pipework to fail.**

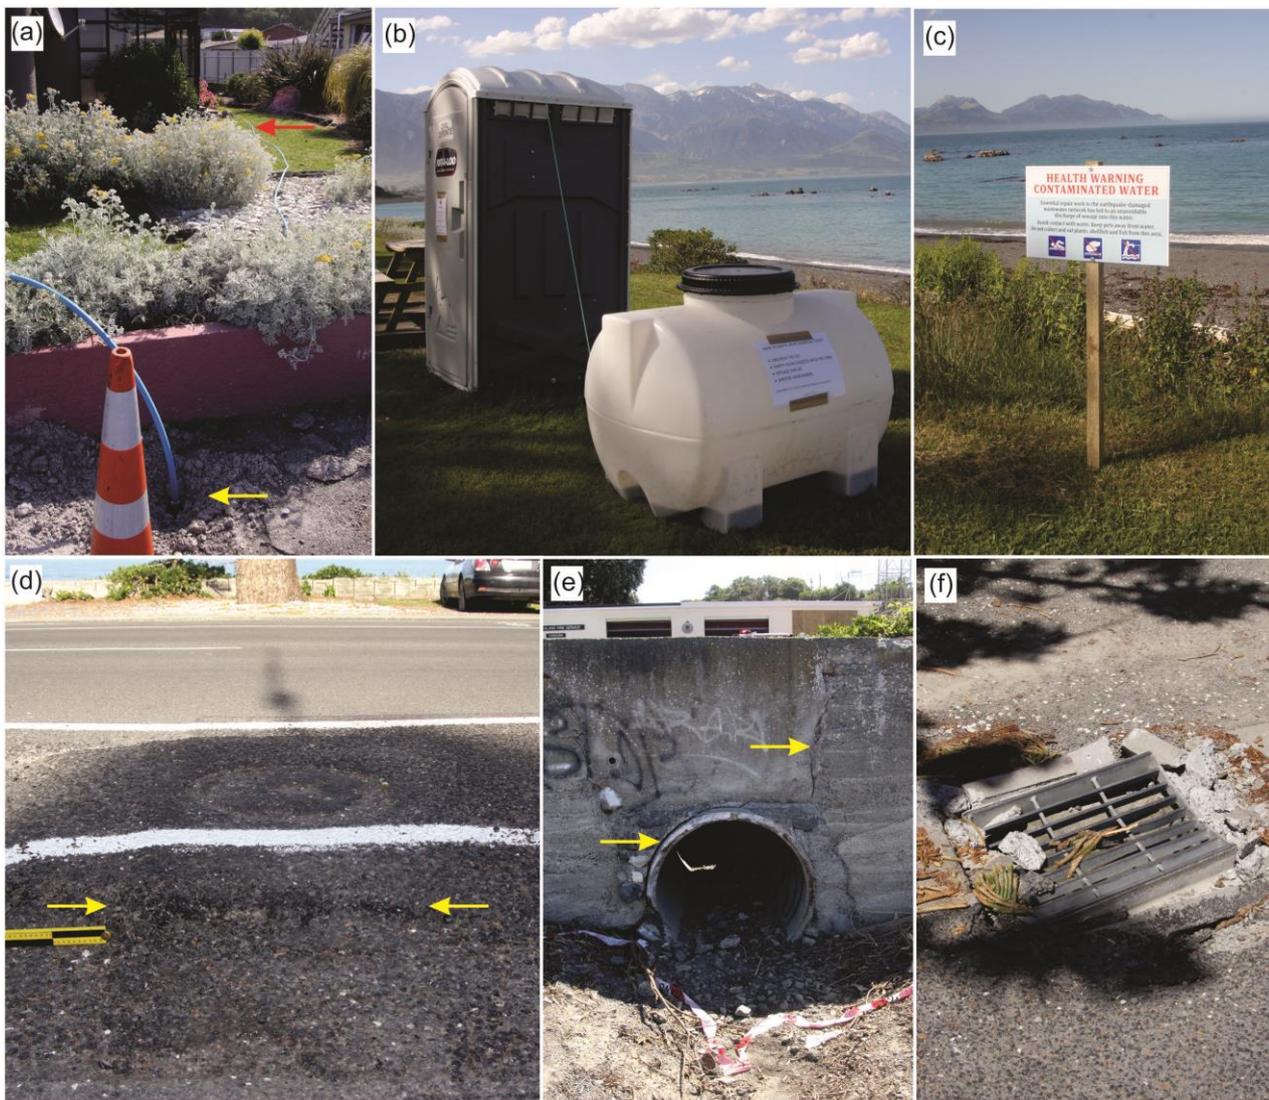
The Kaikōura supply system is a combination of water supply wells and hilltop reservoirs, which feed a reticulated supply to Kaikōura township and surrounding suburbs. The 14<sup>th</sup> November 2016 event shut down all power to the system, and in combination with severe damage to buried services the reticulated supply reduced to zero. At the time of the event one reservoir was full, but would have lasted only one day at normal demand (I. Walker, pers. comm.). Kaikōura District Council (KDC) initiated a rapid programme of assessment and repairs, and by 15<sup>th</sup> November was able to inform residents which streets had supply. Residents without supply were encouraged to approach others on streets that had supply to access water. By 19<sup>th</sup> November, water stations had been set up at various locations around the township by the New Zealand Defence Force, as well as a mobile public shower unit. Due to system supply shortages, residents were instructed to not use showers in their homes, and to minimise all other water use. By 25<sup>th</sup> November supply had been sufficiently restored in the township to enable use of flush toilets and showers, although the community was asked to shower only every second day, and to not use washing machines or dishwashers. This reflected the fragility of the restored supply, as well as the inability of the waste water system to receive residential grey water (see below). Residents were also instructed to not water their gardens. By the beginning of December supply had been restored to the Kincaid area north of Kaikōura township, but ongoing system leaks did require restrictions to be reinstated until repairs could be completed; water was distributed in tankers to these residents, and by 4<sup>th</sup> December reticulated supply had been reinstated. Full supply was restored to the Kincaid and Fernleigh water schemes by 9<sup>th</sup> December. Throughout the period 14<sup>th</sup> November to 22<sup>nd</sup> December a boil water notice was placed on all reticulated supply, and public water conservation messages were broadcast. These restrictions were lifted for most of Kaikōura township, suburbs and outlying supply schemes on 23<sup>rd</sup> December, due to system repairs and use of chlorination, although some individual households were required to continue boiling water before use. People returning to houses unoccupied since 14<sup>th</sup> November were urged to run water for 10 minutes and flush toilets, and conduct inspections of pipes and tanks on their properties. For damaged pipes on residential properties, owners were required to attend to these issues on their own initiative, sometime using temporary overlanding of supply (Figure 9a).

Wastewater pipes experienced significant damage, compromising most of the system that is reticulated to the treatment plant north of Kaikōura township. As a result residents were advised to use available portaloos already present in Kaikōura, or to use buckets or holes dug in gardens to dispose of human waste. On November 18<sup>th</sup> chemical toilets were delivered by the New Zealand Defence Force to be distributed to all households in Kaikōura, although the necessary supply of chemical solution for them was delayed by 2-3 days. Residents were informed of chemical toilet dump station locations (Figure 9b). Portaloos were also distributed

**Figure 9. Three waters impacts along The Esplanade, Kaikōura. (a) Temporary overlanding of domestic water supply from the street connection (yellow arrow) to the house's kitchen area (red arrow). (b) Portaloos (left) and chemical toilet dump station (right). (c) Contaminated water warning, discouraging swimming, fishing and shellfish collection. (d) Differential manhole movement of ~3 cm (arrows). (e) Cracking in retaining wall (arrows) surrounding stormwater culvert. (f) Damaged concrete gutter due to impact by steel stormwater grate. (Photos: M.W. Hughes).**

There was little physical manifestation of system damage along roadways, although at least one manhole was noted to have experienced slight differential movement through the 14<sup>th</sup> November event (Figure 9d). Pipe condition assessments via CCTV were occurring from the days after the event, supported by experience and expertise gained from condition assessments conducted in Christchurch through the 2010-2011 CES [21].
