# IMPACT OF THE KAIKŌURA EARTHQUAKE ON THE ELECTRICAL POWER SYSTEM INFRASTRUCTURE

## ABSTRACT

This paper summarizes the impact the 2016 Kaikōura earthquakes have had on electrical transmission and distribution infrastructure performance. It also provides background context to the distribution network operator, MainPower's, prior earthquake preparedness following the 2010 earthquakes in the region.

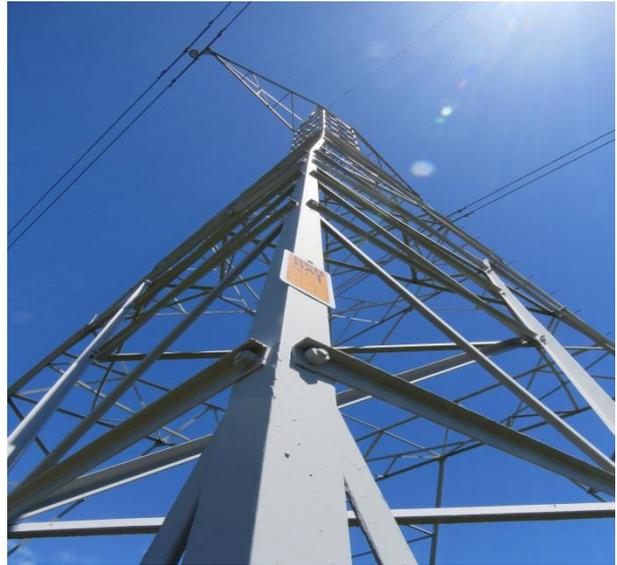
Transpower identified a tower on the HVDC line in Marlborough region north of Kaikōura that had earthquake damaged and needed replacement following the Kaikōura earthquake. One of the damaged legs of the HVDC line tower is shown in Figure 5. Figure 6 illustrate the face damage

*Figure 5: Leg damage of the HVDC Tower.*

Considering the location and the impact on the HVDC link, Transpower decided to use temporary tower poles and currently has plans for the construction of a new tower. Despite the need for replacement, the HVDC tower was not at immediate risk during normal conditions and it was decided that the tower should be kept under regular observation until replacement works were completed. As a consequence of this earthquake damage, the tower is more prone to further damage from larger aftershocks or extreme storms/winds. To accommodate this risk, Transpower changed the risk

The tower repair was completed on 21 January 2017 and the requirement to change the risk reclassification of the HVDC when unusually high winds are forecast was cancelled.

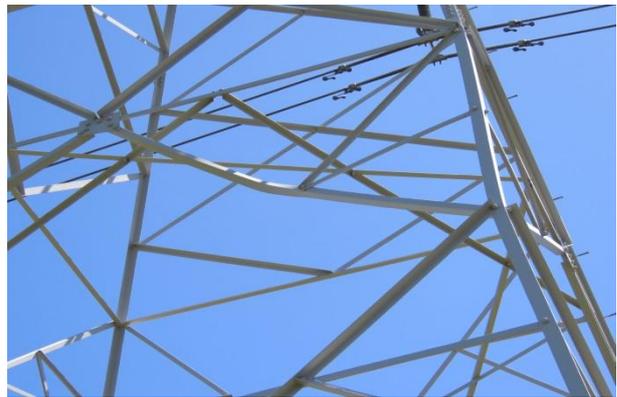
between two legs and Figure 7 shows multiple ground cracks between the HVDC tower legs.

*Figure 6: Damaged face of the HVDC Tower.*

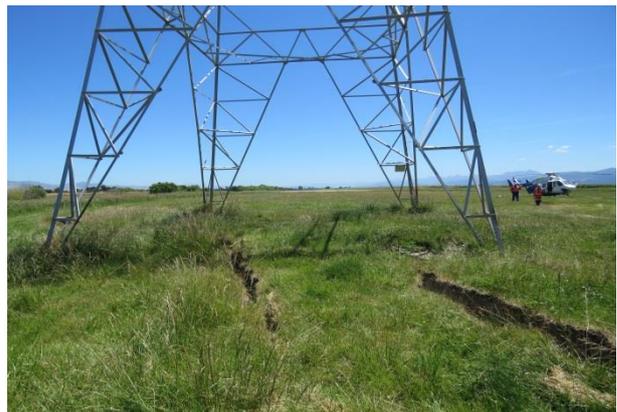
*Figure 7: Ground crack between legs of the HVDC tower.*

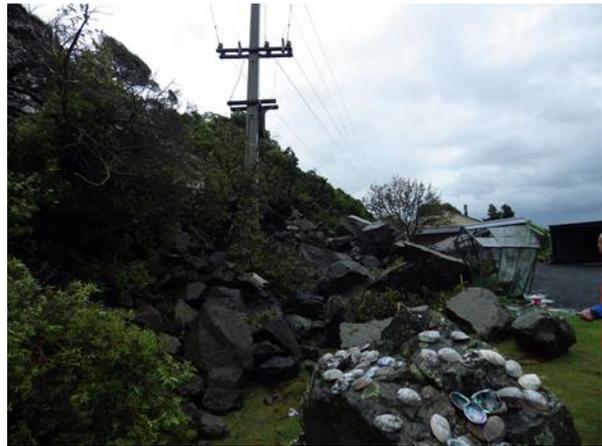
The earthquake damage to the lines south of the Waiau River was minor and most customers there had power restored by late afternoon of the 14<sup>th</sup> November. On the contrary, there was extensive damage to HV and LV lines in the vicinity of the Waiau town and Inland Rd to Kaikōura. As a result, 400 Waiau area customers were without power at the end of first day. Figure 8 shows a damaged 33kV pole in Oaro.

*Figure 8: Oaro 33kV pole damage.*

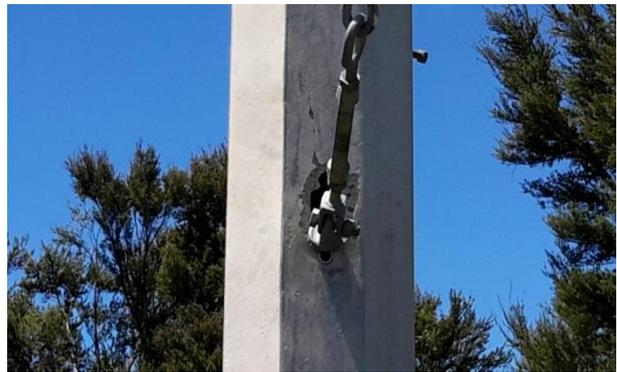
*Figure 9: Cracked 66 kV pole.*

As a consequence of losing 66kV supply at Ludstone Rd substation (Kaikōura) from Transpower GXP and extensive distribution system damage, approximately 2700 customers were affected. Figure 9 shows a cracked 66kV pole. The 33kV coastal link was patrolled by helicopter and power restored to the substation via 33kV from Waipara by 1 pm on the 14<sup>th</sup> November. The Inland Rd 66kV line was also patrolled with many poles with a substantial lean found.
