# Infrastructure Impacts of the 2019 Rangitata Flood

Liam Wotherspoon

# 2019 Flood Event

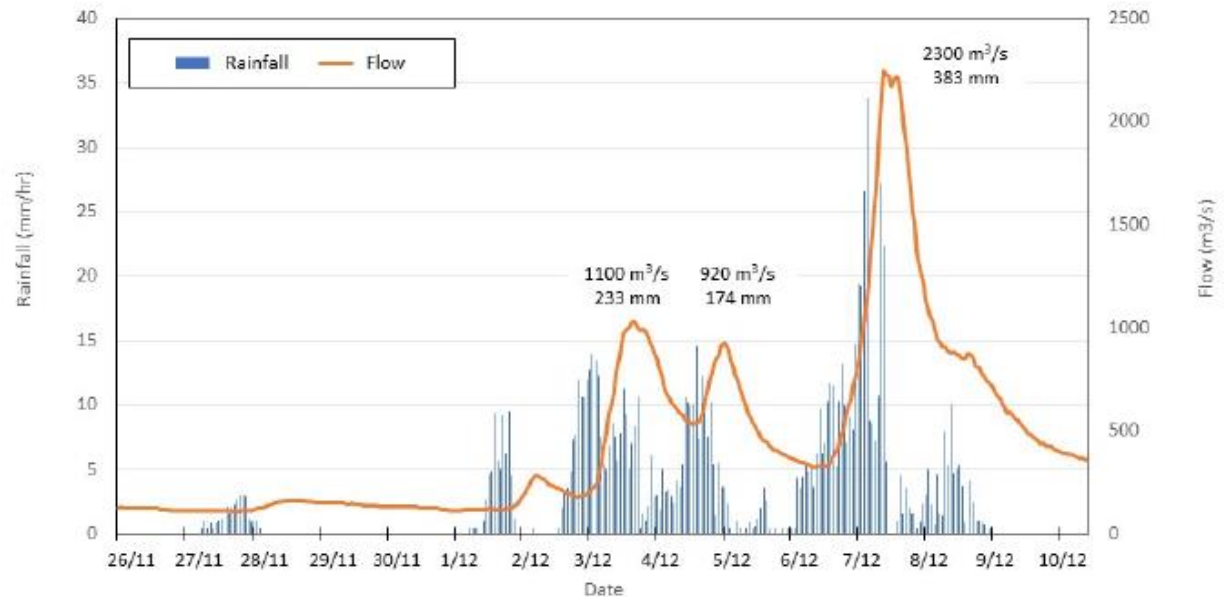
- Rainfall
  - 875 mm over 7 days at headwaters
- Flow
  - Peak of 2,300 cumecs
  - Over 2,000 cumecs for 10 hours – 7<sup>th</sup> December 2019
  - Largest volume event on record

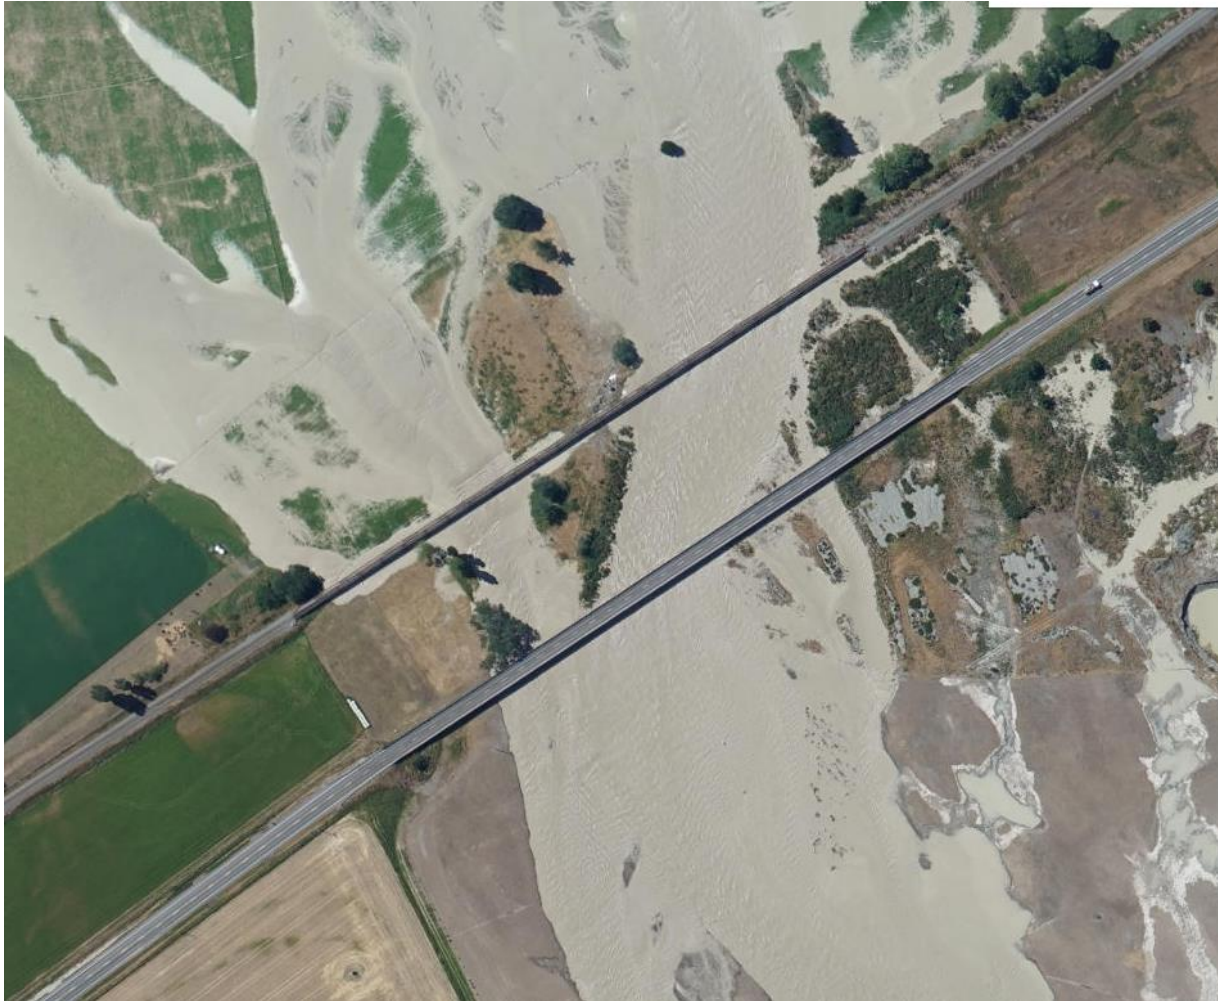
- Bridges over South Branch

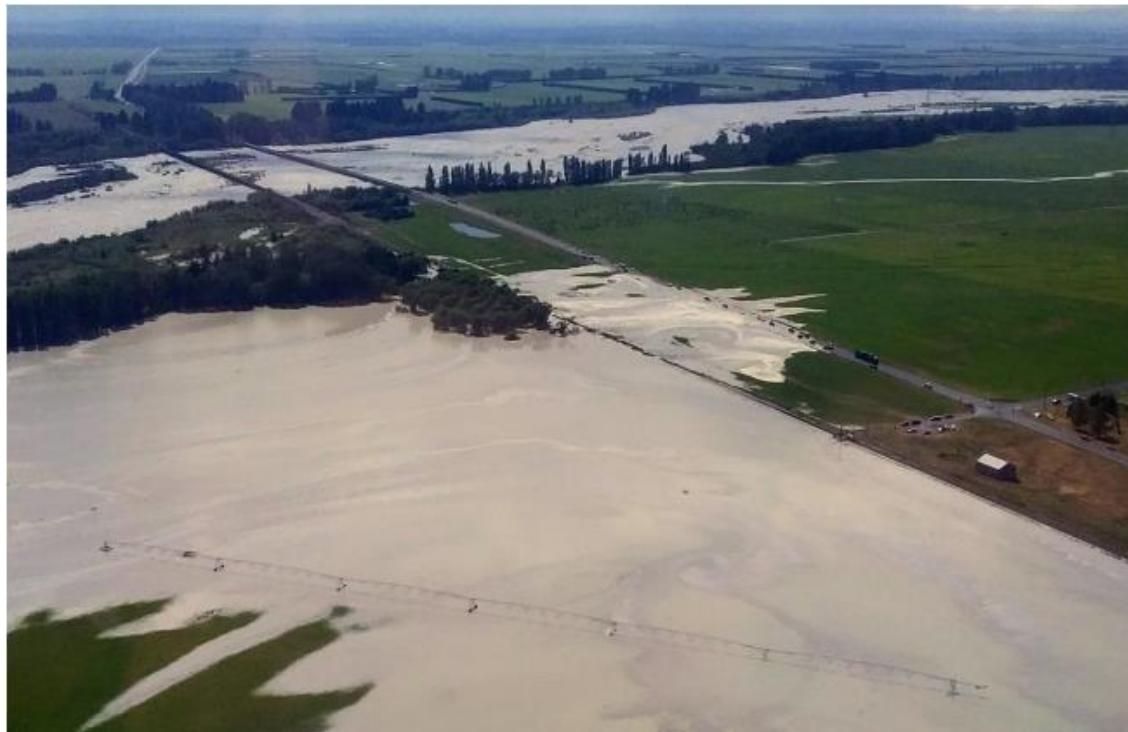
- Main South Line washout
  - 330 m of significant damage
  - Two other locations with less severe damage

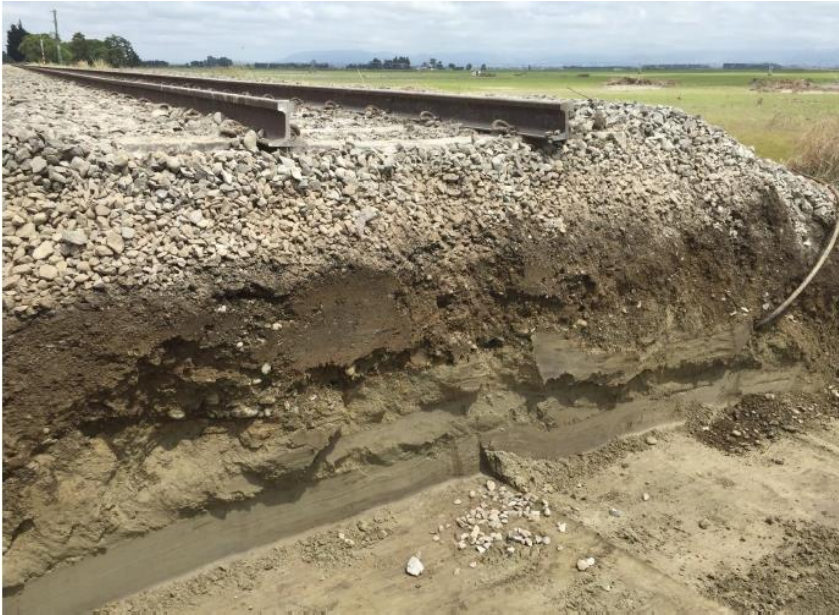
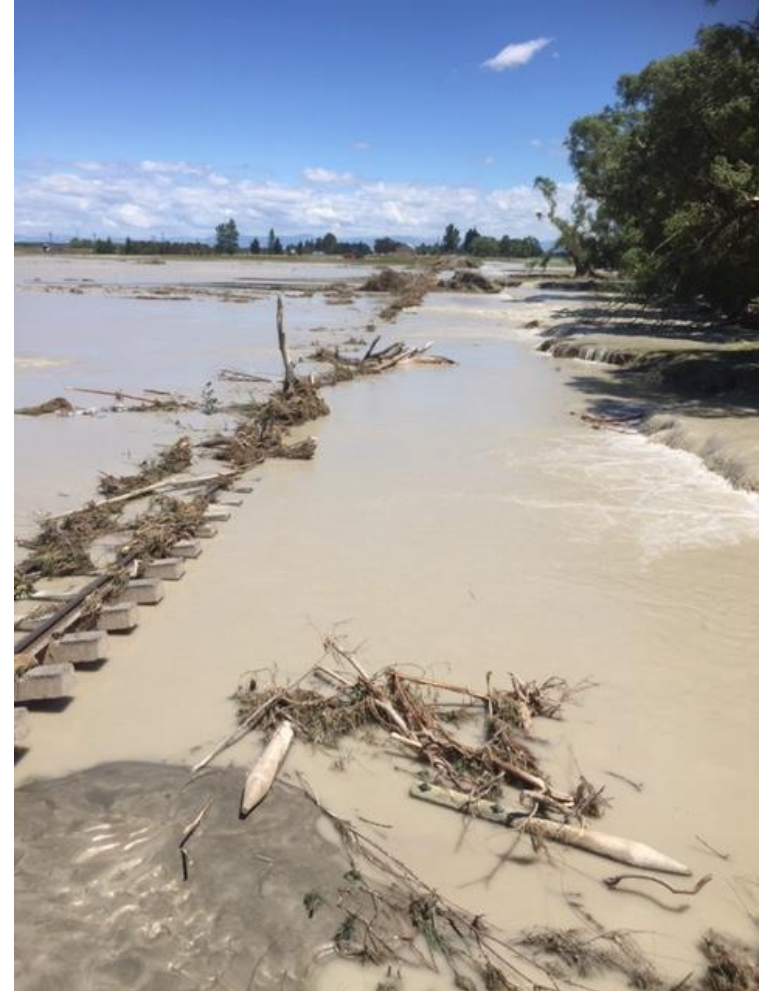
- Reopened 20<sup>th</sup> December
  - 13 days after event

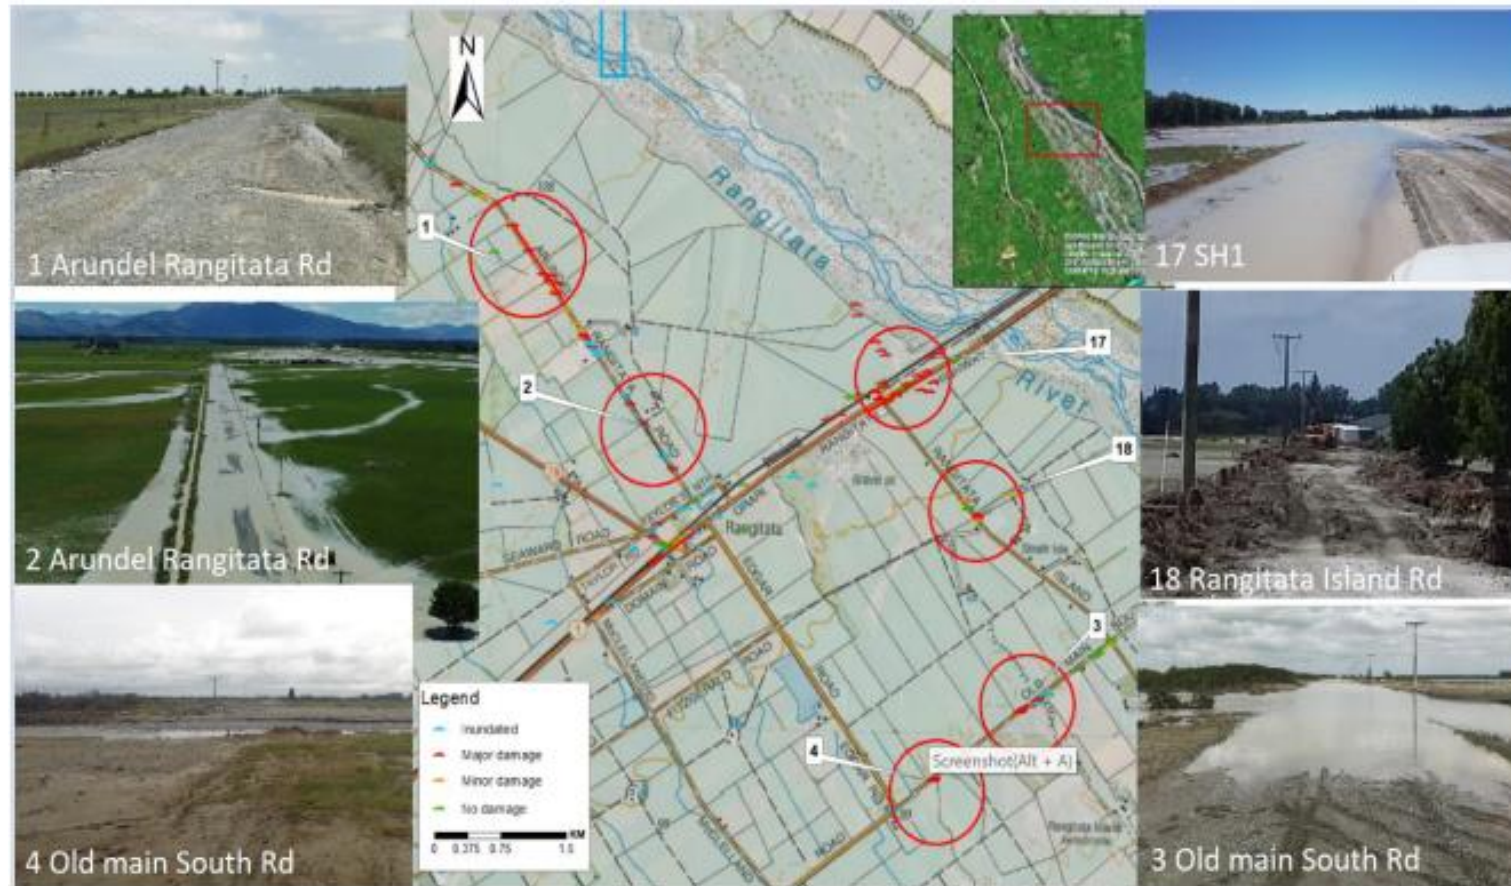
- Road and bridge abutment scour
- Scouring of up to 3 m in some areas

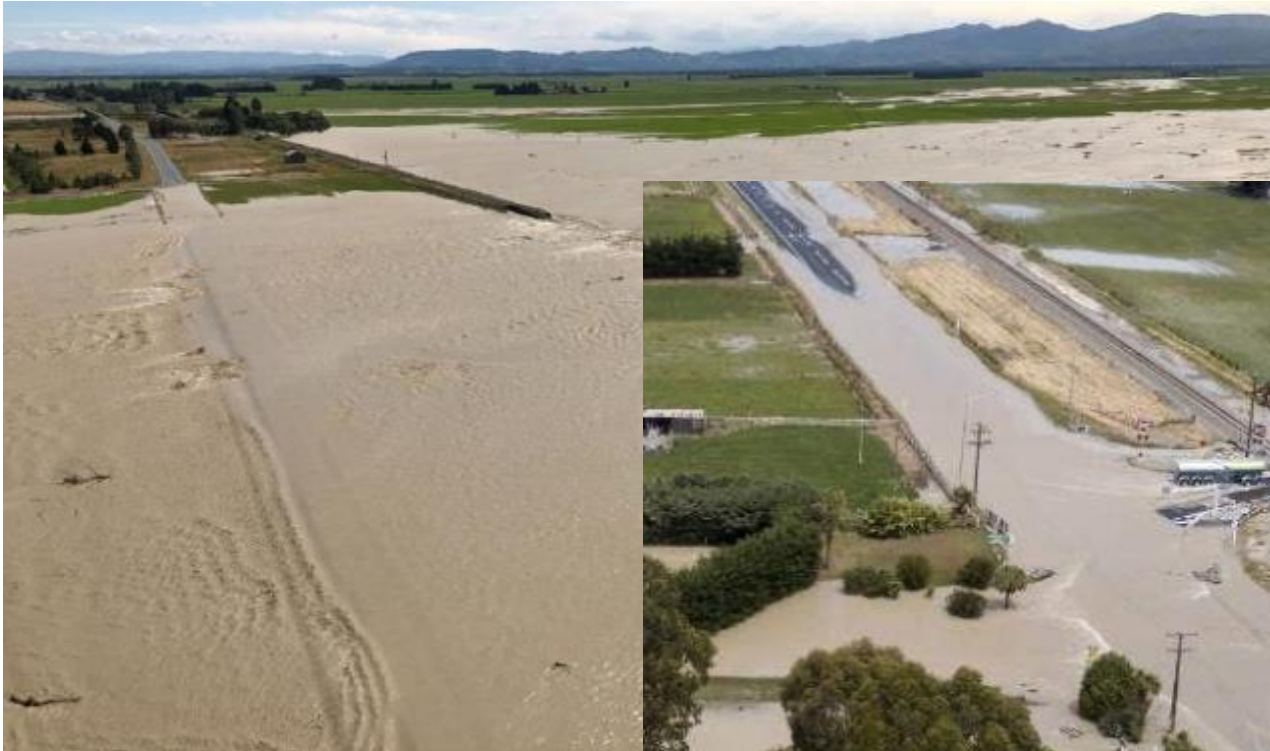
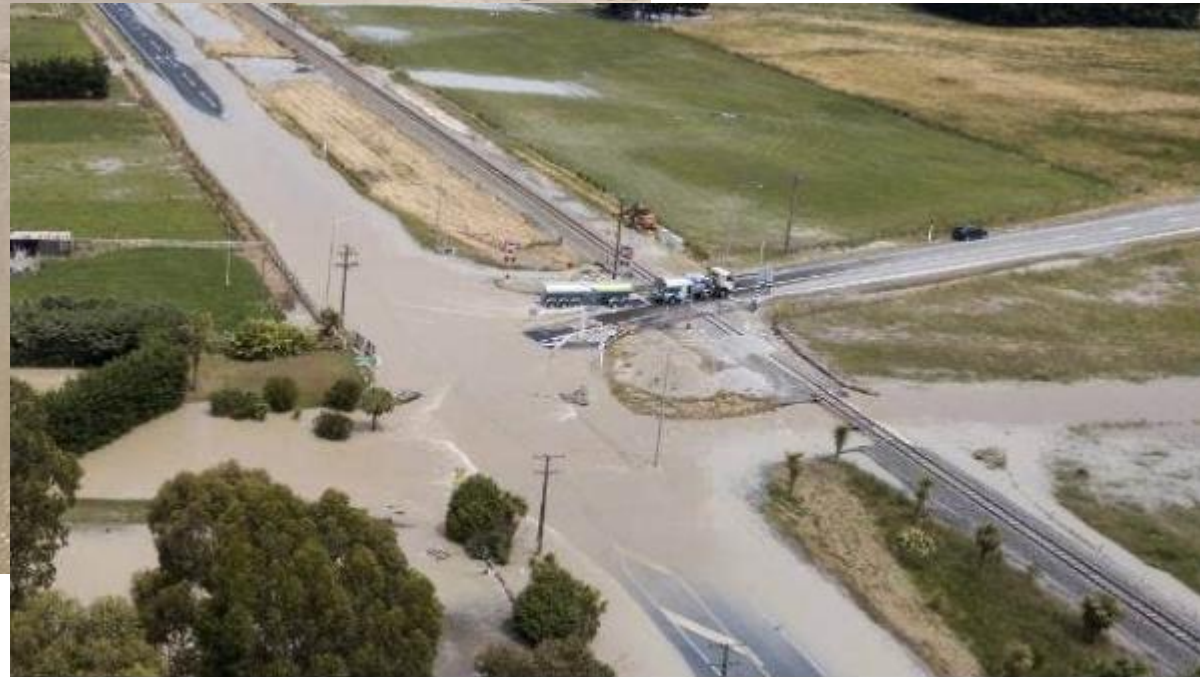
- SH1 & SH72
  - SH1 closed Dec 7 -11
  - SH79 short closure

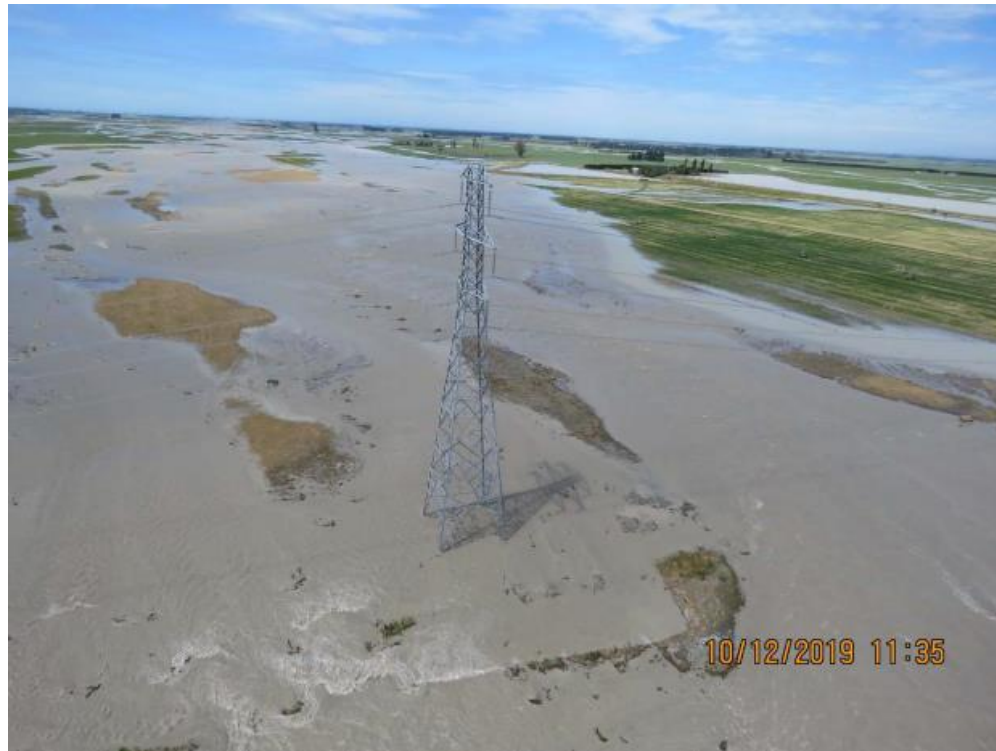
- Damage to 7 transmission structures on ROX-ISL
- Loss of one circuit
- No loss of power through transmission network

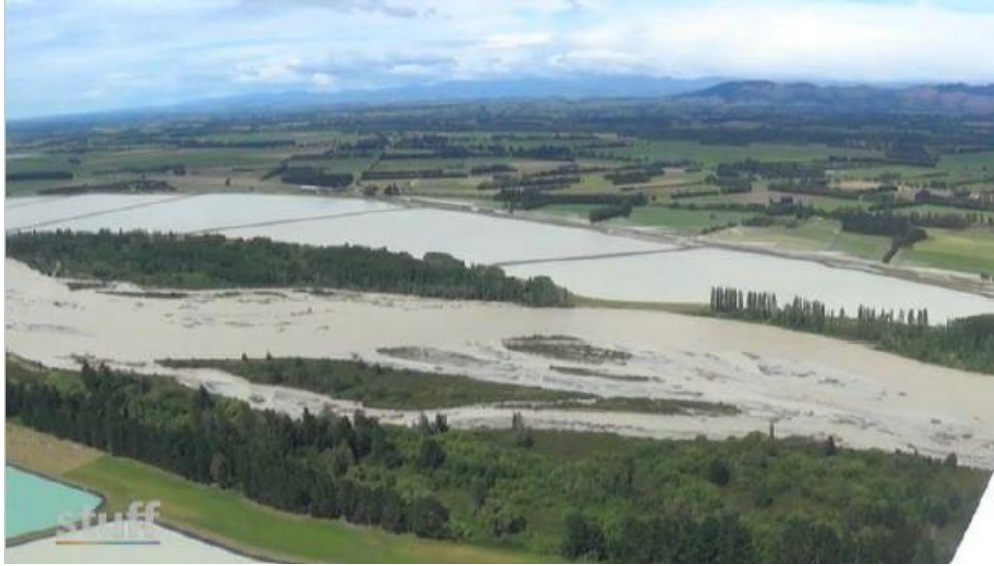
Discharge through pond weir
