Understanding Risk in Levee Systems

Student: Thomas Wallace

Supervisors: Tom Logan , Kaley Crawford-Flett, Matthew Wilson

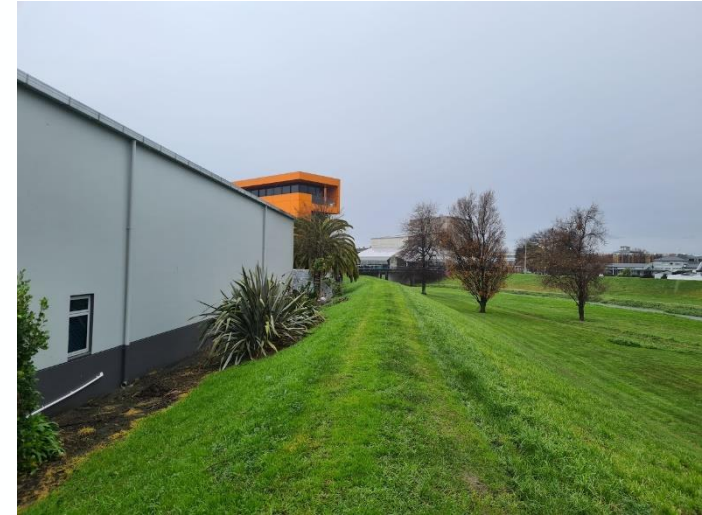
Example of Blenheim Levee

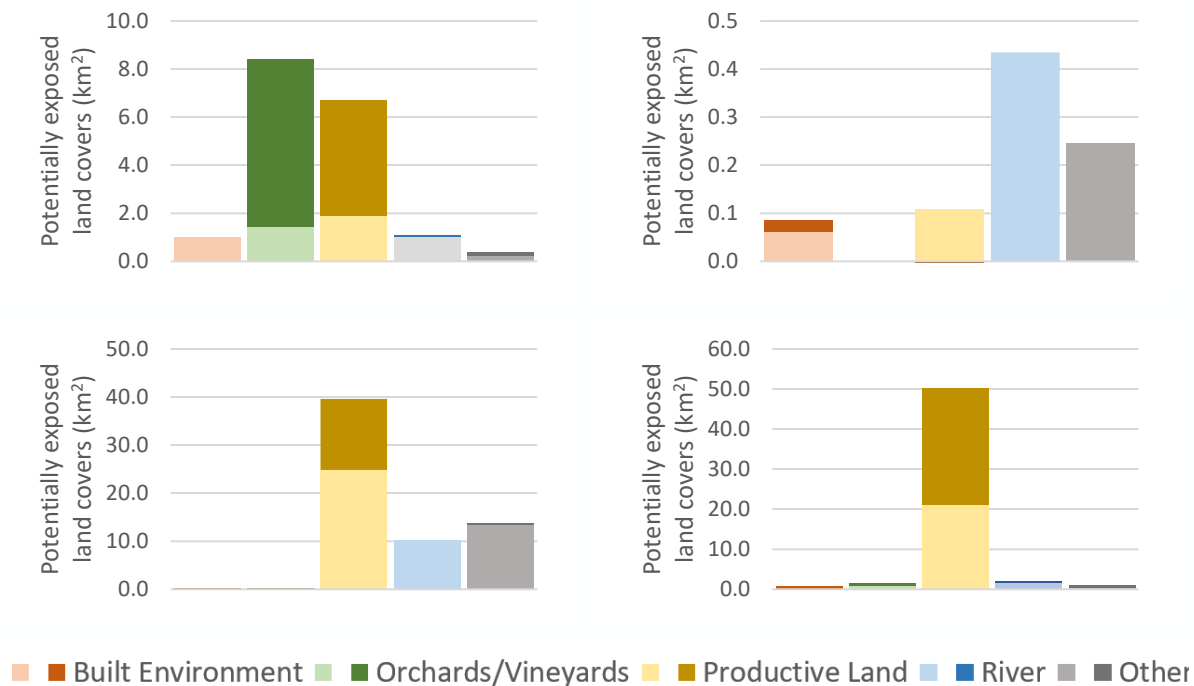
Potentially exposed land covers (historically exposed in lighter, additionally exposed in darker)
 (a) Taylor catchment, (b) Maitai catchment, (c) Opuha catchment, and (d) Rangitaiki catchment

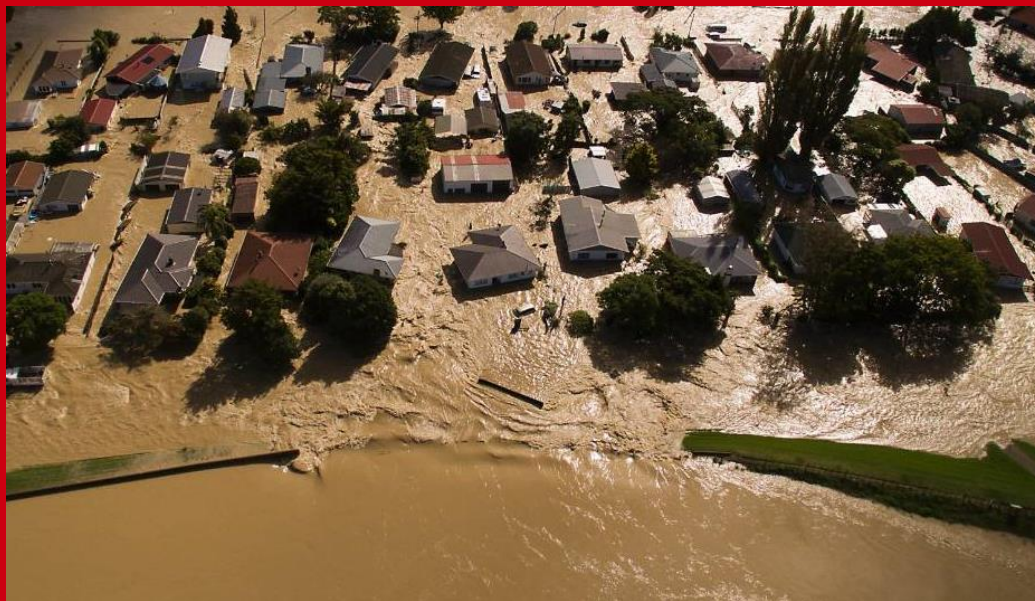
*Breached Floodwall in Edgecumbe
(Chris McKeen, Fairfax New Zealand, 2017)*
