Vulnerability and Resilience Assessment of the New Zealand Telecommunication Infrastructure The case of the 2011 Christchurch Event

Silvia Bertelli
silvia.bertelli@ucl.ac.uk
Supervisors:
Dr Sonia Giovinazzi
Rob Ruiters
Dr Susana Lopez-Querol
Dr Liam Wotherspoon
Prof Tiziana Rossetto
University College London
Department of Civil, Environmental & Geomatic Engineering

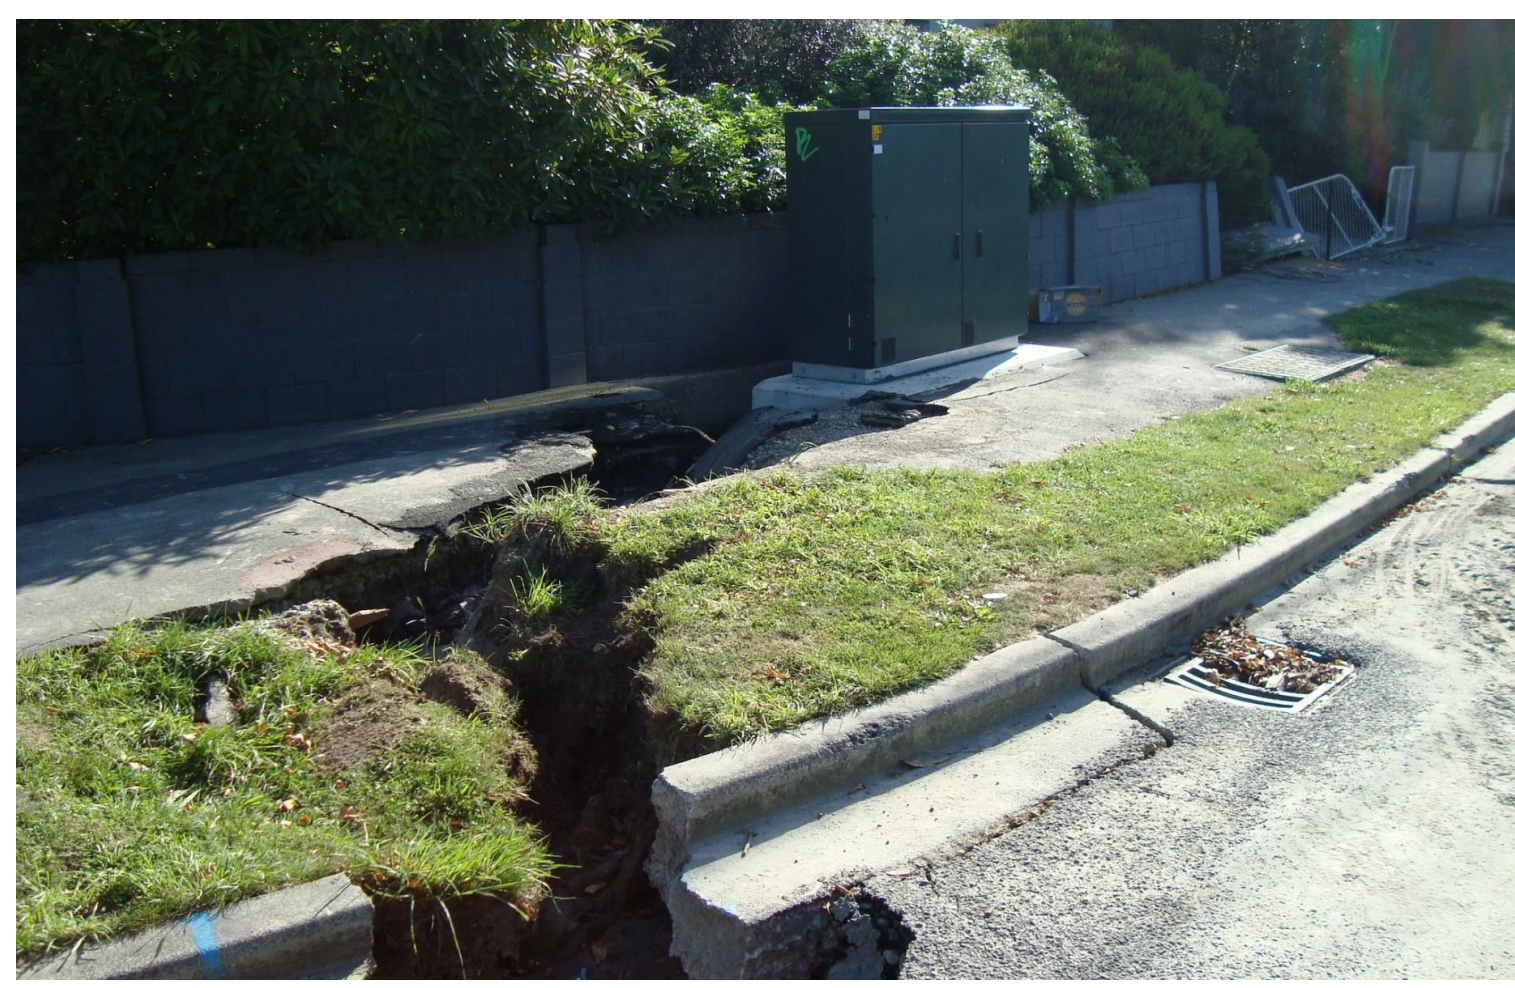
Figure 1 – Damage to a roadside cabinet in Christchurch (Courtesy of Chorus).

New Zealand, one of the most natural disaster-prone countries in the world, is regularly subject to **high-intensity earthquakes**, and its co-seismic events such as liquefaction and landslides, inflicting loss of lives and costly damage to the country's infrastructure (Figure 1 and Figure 2).
