# Mapping New Zealand's stopbank network: a standardised nationwide inventory

## ABSTRACT

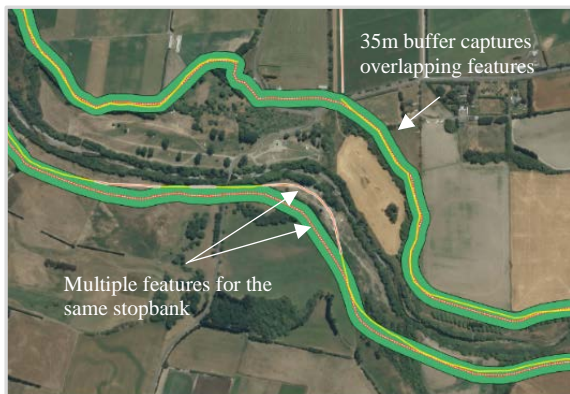
Fig. 3. Example of duplicated and overlapping stopbank features.

of stopbank features extended to ~50m. Other challenges arose from stopbank features crossing, overlapping and/or intersecting one another. To account for these discrepancies, a buffer distance of 35m was used to identify all stopbanks with potential duplicates or overlaps from multiple data sources – i.e. LINZ data and regional council / unitary authority data for NZIS v1.0 (Figure 3). Then a process involving comparison to satellite imagery and prioritisation of features containing greater geospatial information was implemented (Figure 3).

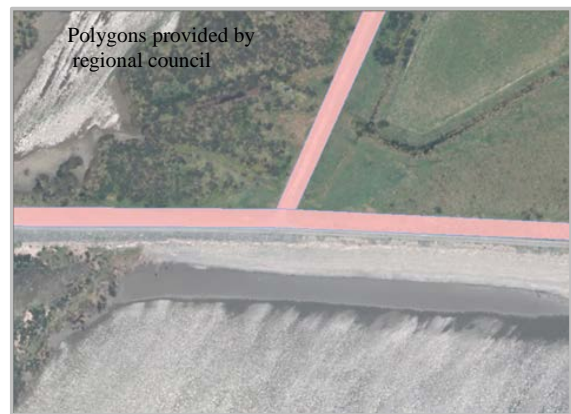
Fig. 4. Example of a conversion from a polygon to centerlines.

- **Conversions** were required due to differences in geospatial data formats in the original source information. This was to achieve LineStrings<sup>3</sup> for stopbanks nationwide in the New Zealand Transverse Mercator 2000 coordinate system. Figure 4 shows an example where such a conversion was required at the intersection of two stopbanks; in this case the stopbanks were represented as polygons in the source data obtained from a regional council. A conversion of polygons to rasters and then centerlines means that there are four resulting LineStrings for the two stopbank features (Figure 4). Conversions to LineStrings were also required when source data was provided in point format. In this case, attribute data such as the asset name and corresponding riverbank were used to create interpolations between grouped points.
