Liquefaction in Whakatane: Ground truthing Geotechnical Testing with Paleo-liquefaction Investigations

The 1987 Edgecumbe earthquake

Predicted and observed liquefaction in Whakatane

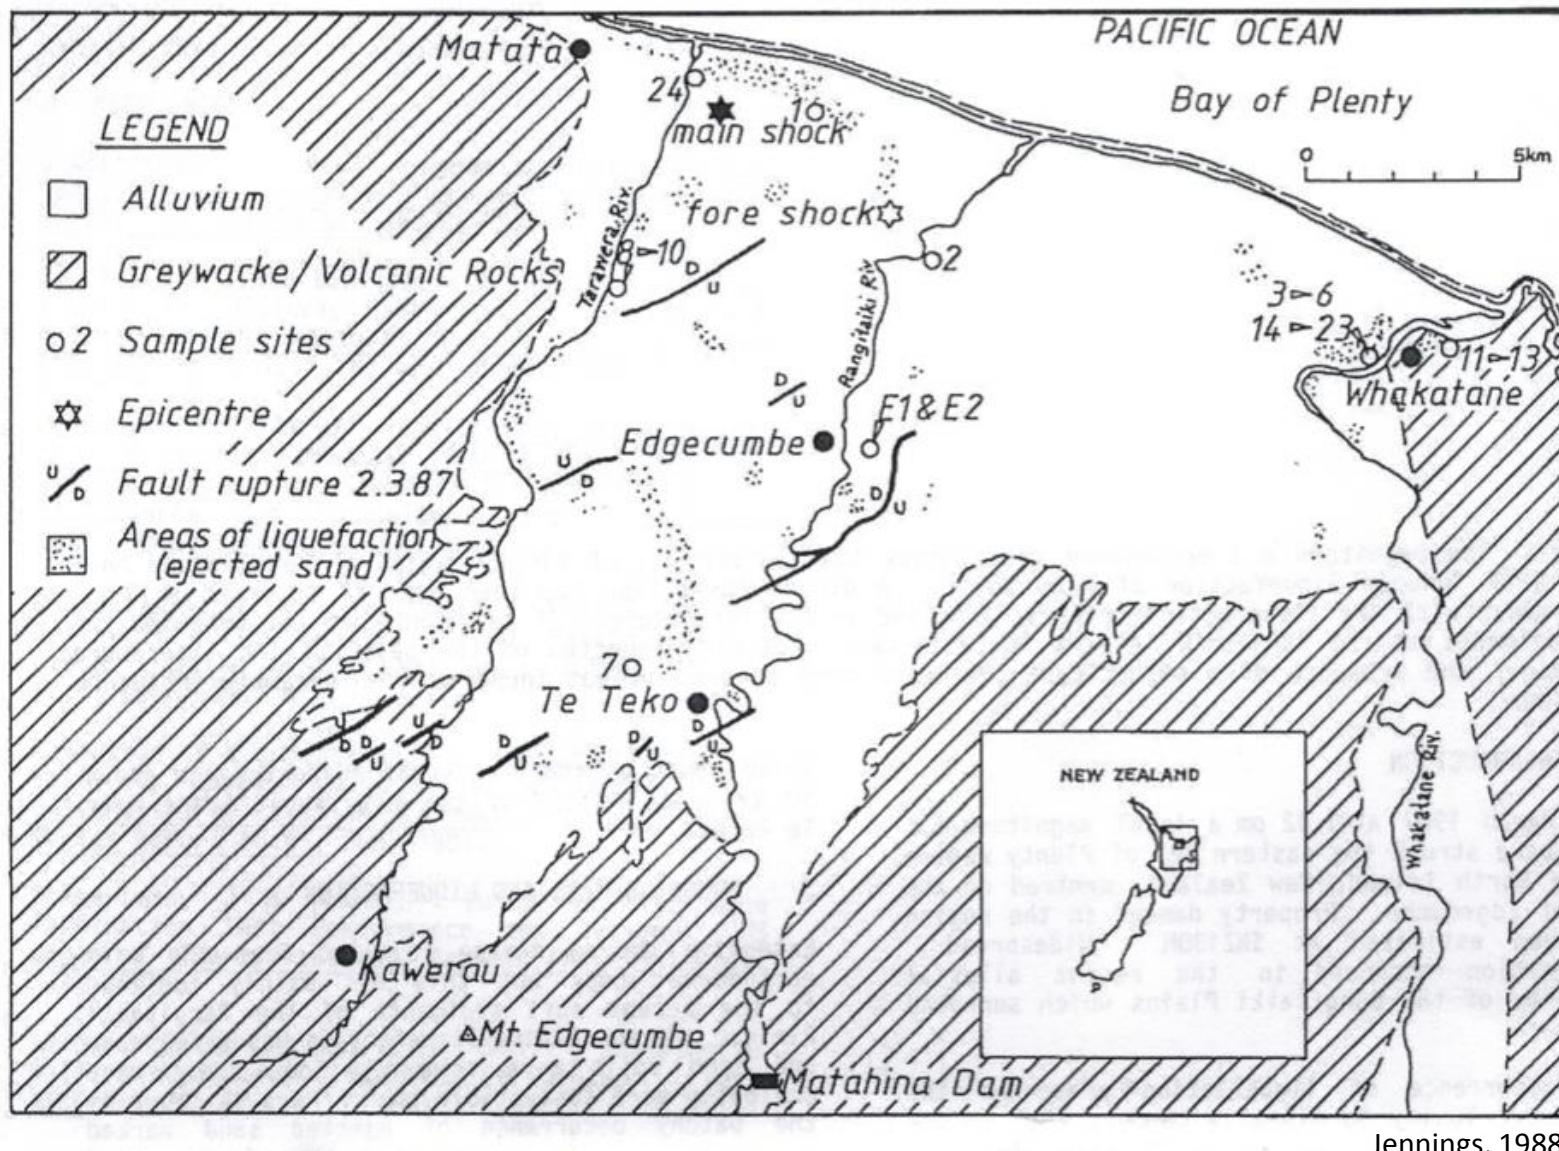
Figure 1 : Map of Epicentre Locations, Fault Traces and Areas of Liquefaction

- MM 9; M_L 6.1, M_W 6.5, M_S 6.6
- Localised liquefaction and lateral spreading across the Rangitaki Plains in the Bay of Plenty
- Severe damage to infrastructure and lifelines, including \$NZ 10 million worth of damage to flood control and drainage schemes

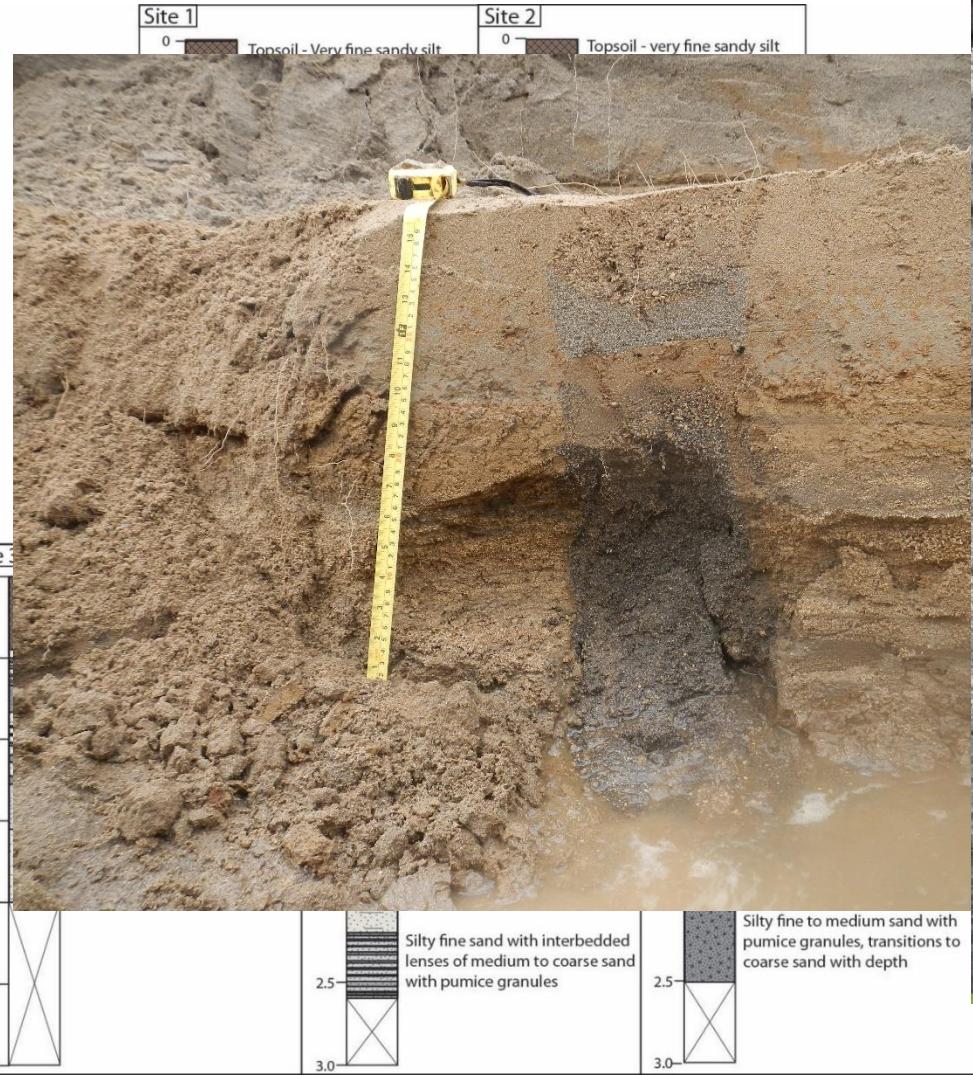
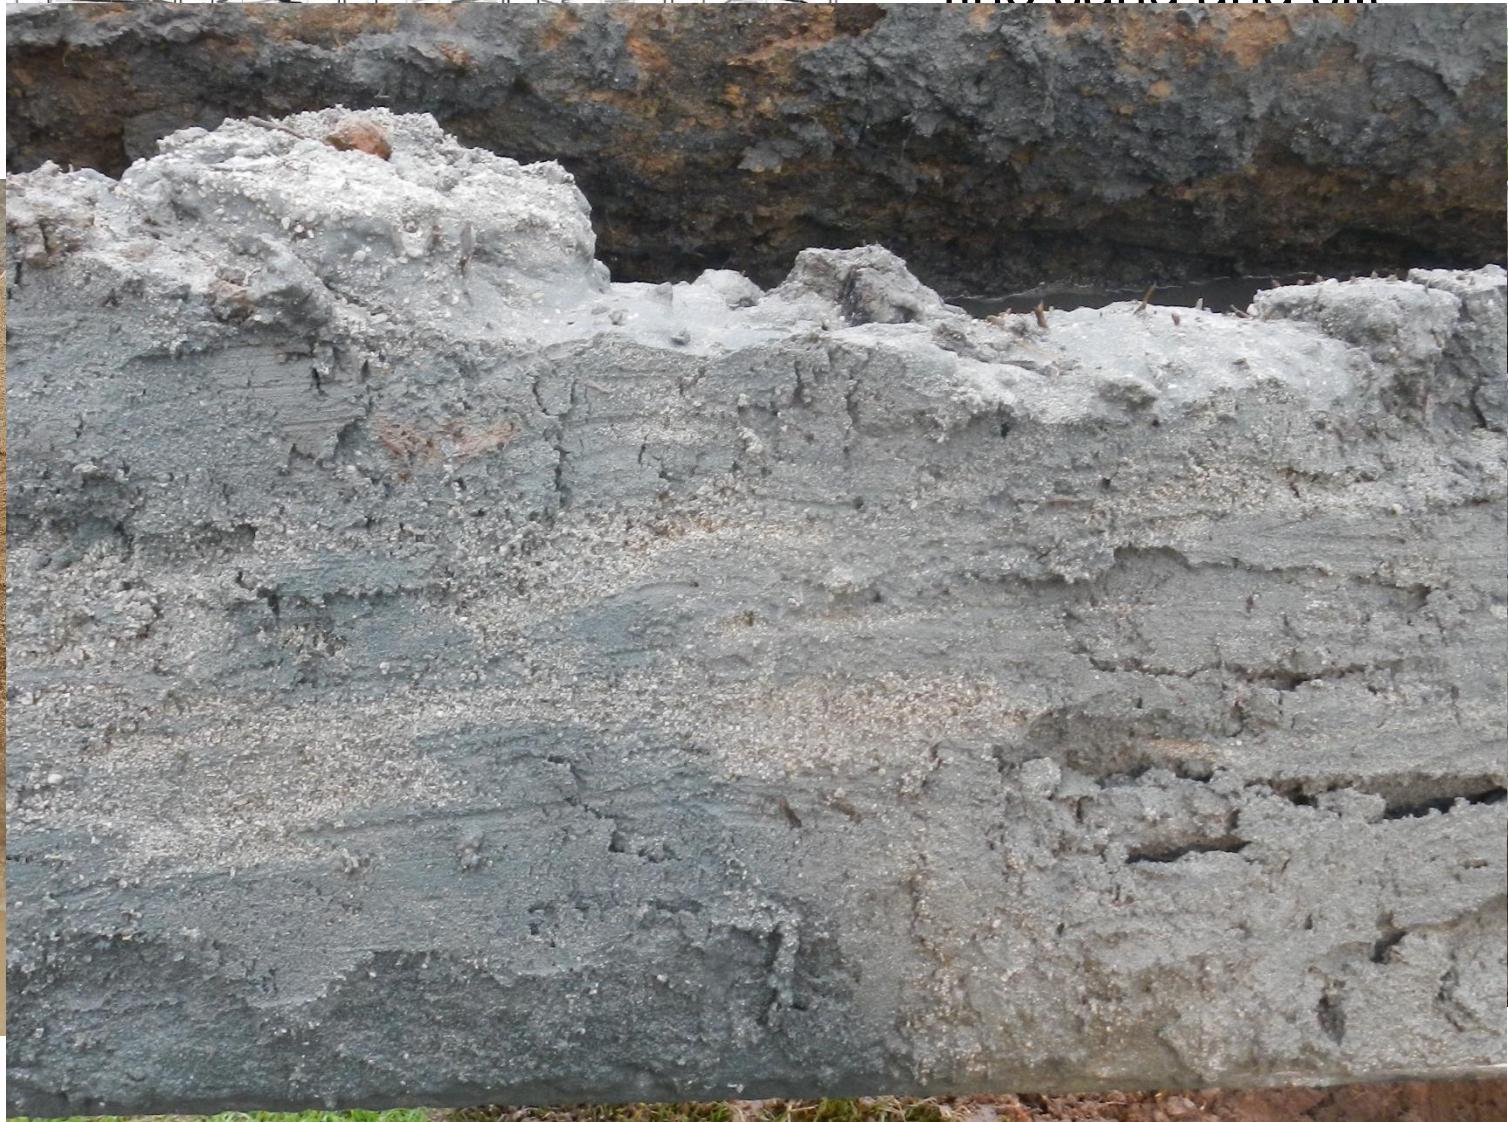
Variability in the subsurface sediments

- Potentially liquefiable sediment at Sites 1&2 composed of fine sand and silt
