QuakeCoRE
NZ Centre for Earthquake Resilience

RC Wall Residual Capacity and Repair

QuakeCoRE FP4 project

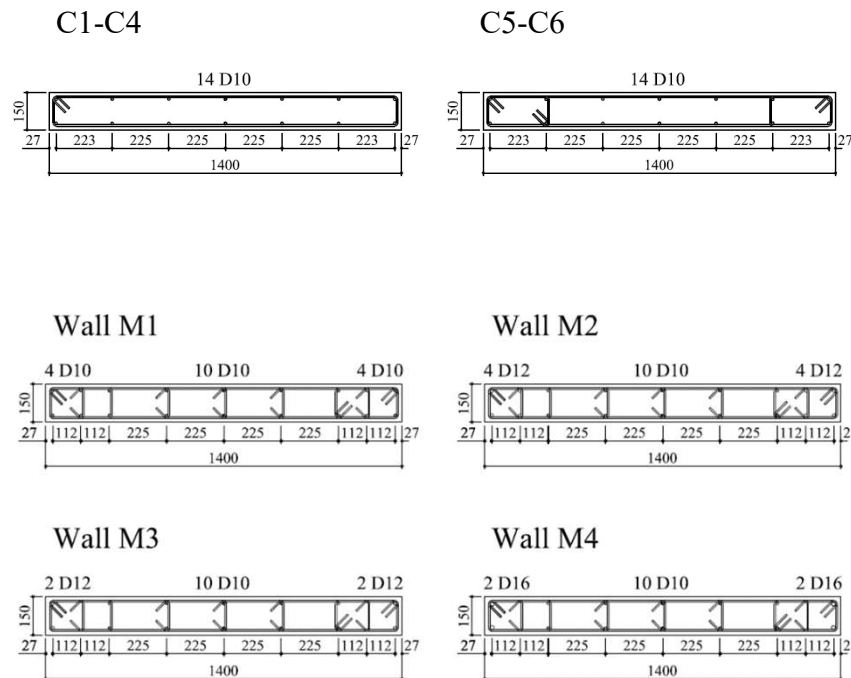
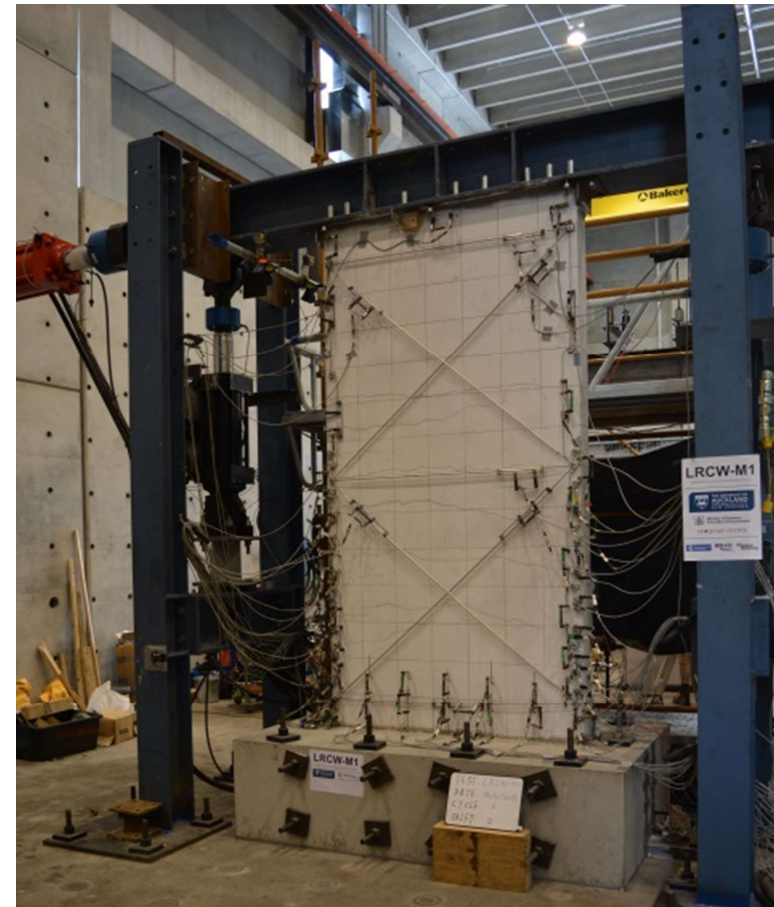
Lu et al. Tests (2014-2015)

- Minimum vertical reinforcement limits
 - C walls – NZS 3101:2006 A2
 - M walls - NZS 3101:2006 A3

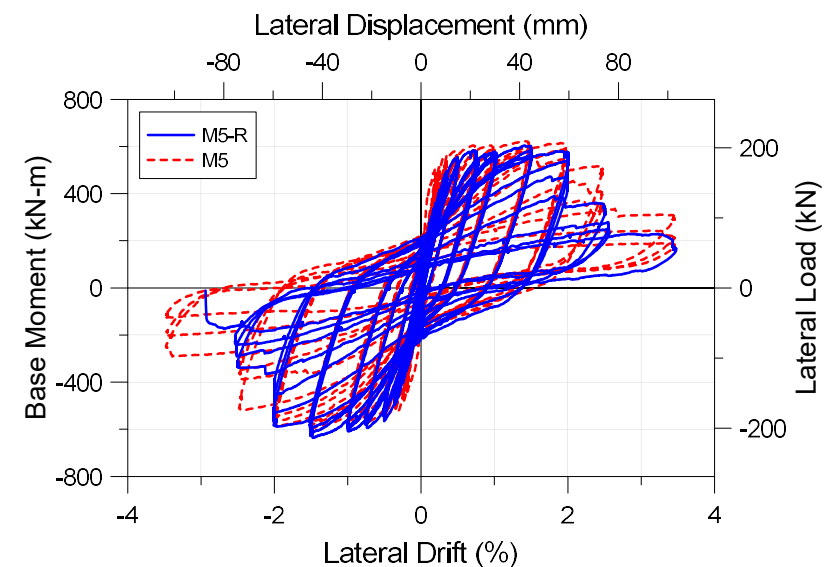
Motter et al. Repair Tests (2016)

- Repair of M walls
 - Heavily damaged

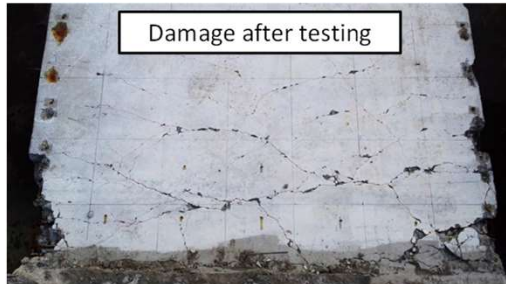
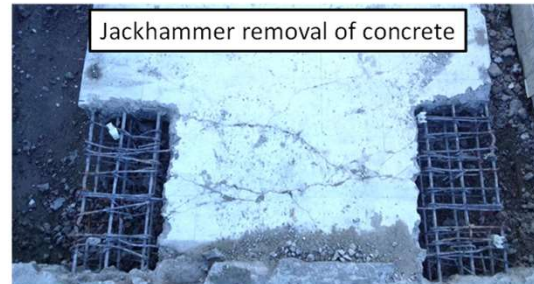
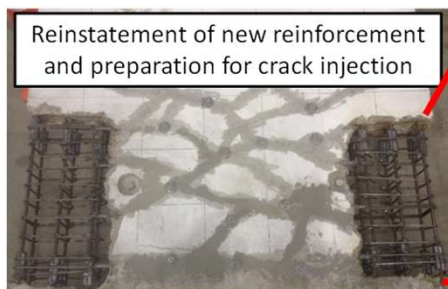
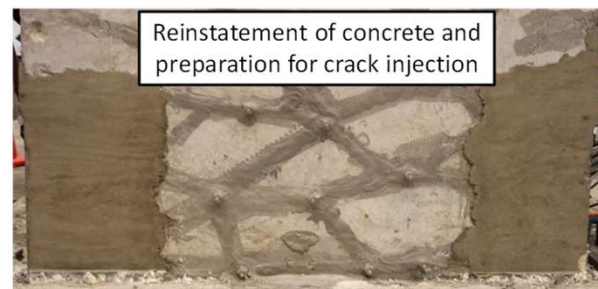
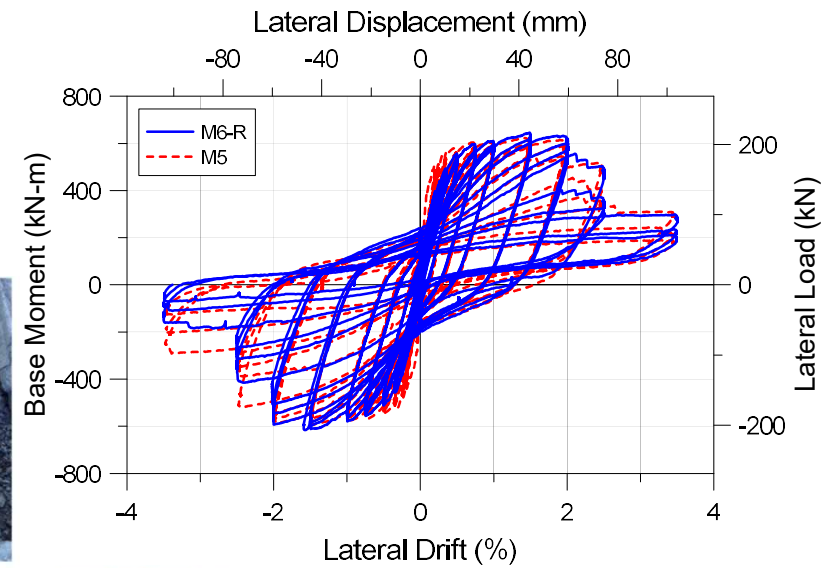
Motter et al. Repair Tests (2016)

- Repair of M walls
 - Moderately damaged

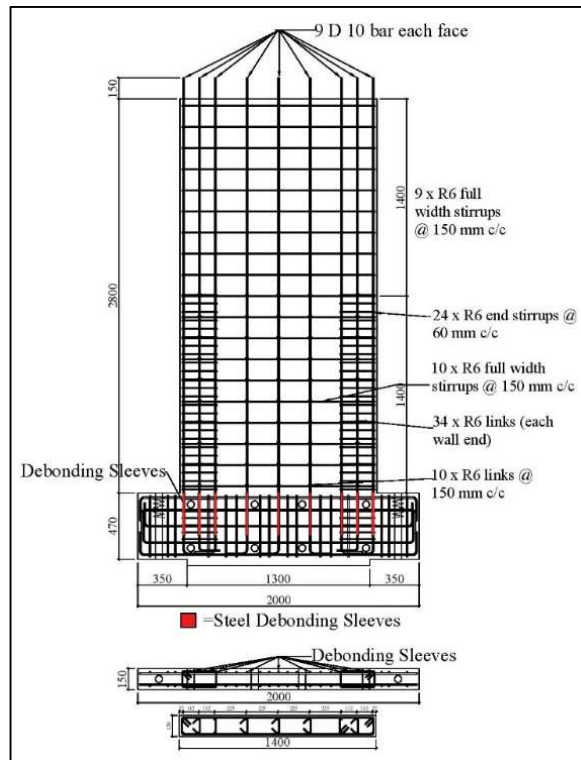
Debonding

- Modify M wall design to improve reparability

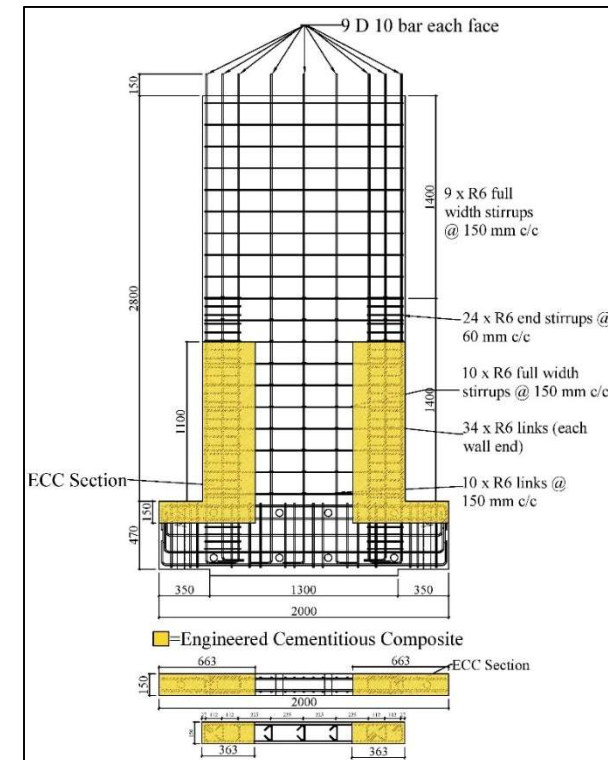
ECC

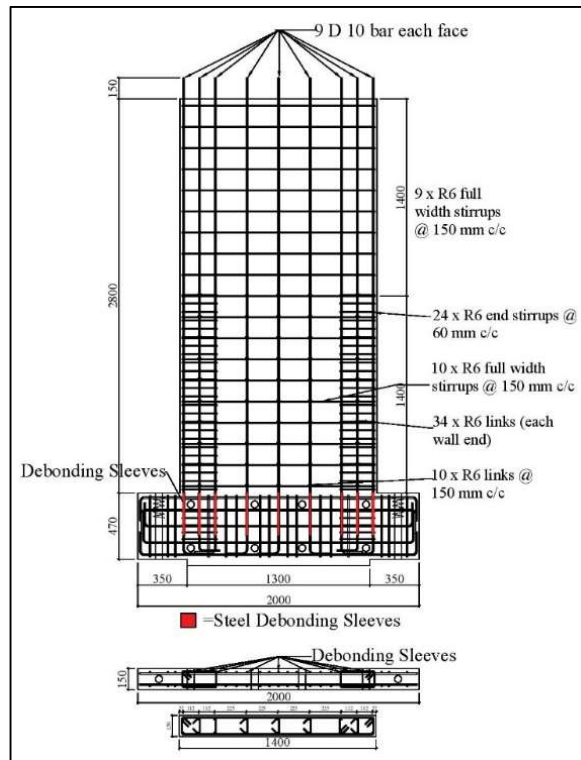
Debonding

- Modify M wall design to improve reparability
