# Characterization of soils at sites of historical liquefaction, West Coast, New Zealand

Sarah Bastin, Sjoerd van Ballegooy et al

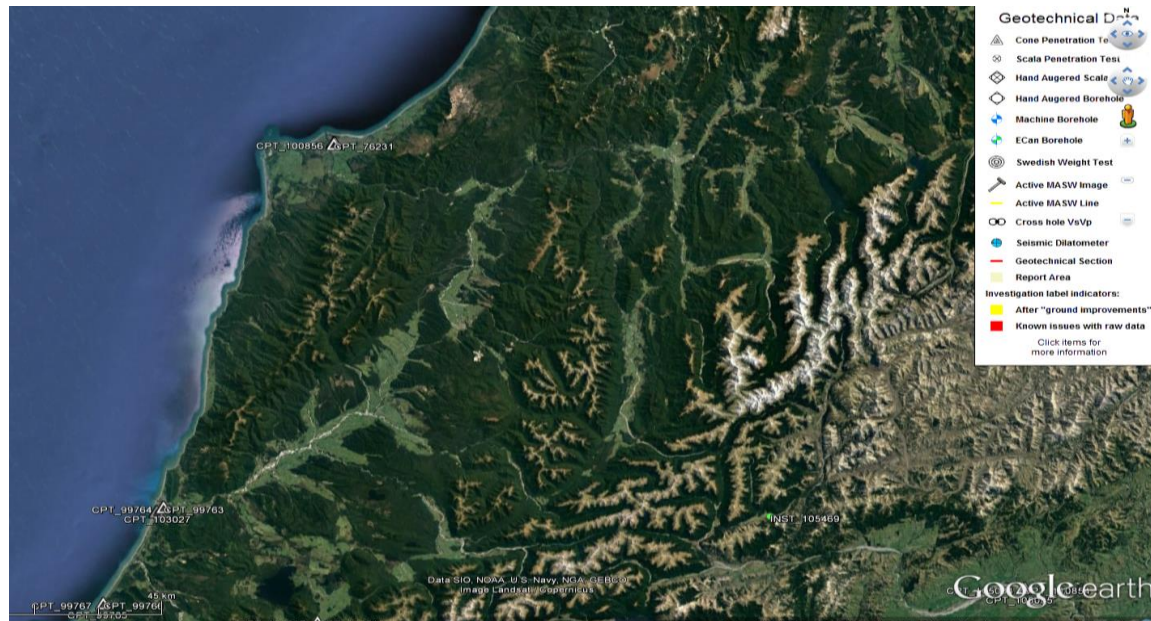
# CPT at sites of recurrent liquefaction and no liquefaction

- Limited geotechnical data on West Coast
- 2018 QuakeCoRE project to undertake CPT at sites where historical liquefaction documented, and no liquefaction documented

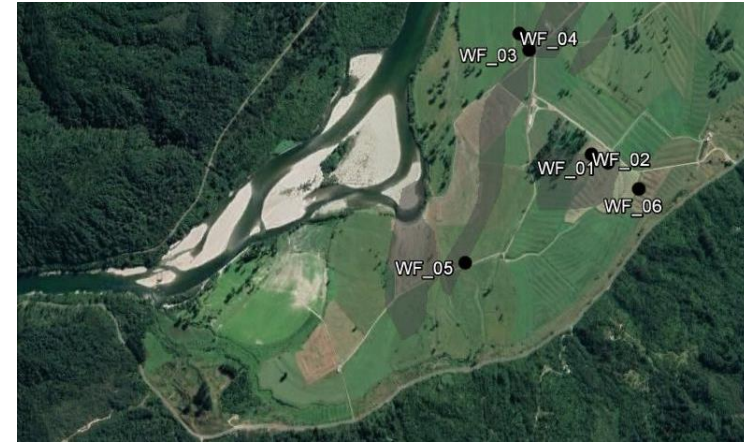
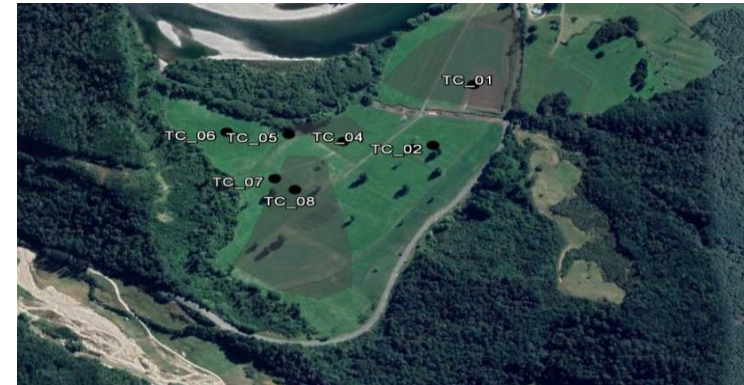
# Inangahua

- Liquefaction reported at the site during
  - 1968 Inangahua earthquake – site located 12-15 km from epicentre; distribution indicated by grey polygons
  - Minor liquefaction reported near WF\_06 following 1991 Hawks Crag earthquake

- Liquefaction reported at the site during
  - 1929 Murchison earthquake – site 23 km from epicentre
  - 1968 Inangahua earthquake – site 10 km from epicenter
  - 1991 Hawks Crag earthquake

- Located near Westport (indicated in Figure 6) however in similar setting to Inangahua sites.
- Liquefaction reported at the site during
  - 1968 Inangahua earthquake – located 30 km from epicentre
  - Minor liquefaction reported following 1991 Hawks Crag earthquake - Testing targeted these areas
    - Shallow gravels encountered during testing suggesting may have missed location where liquefaction was reported

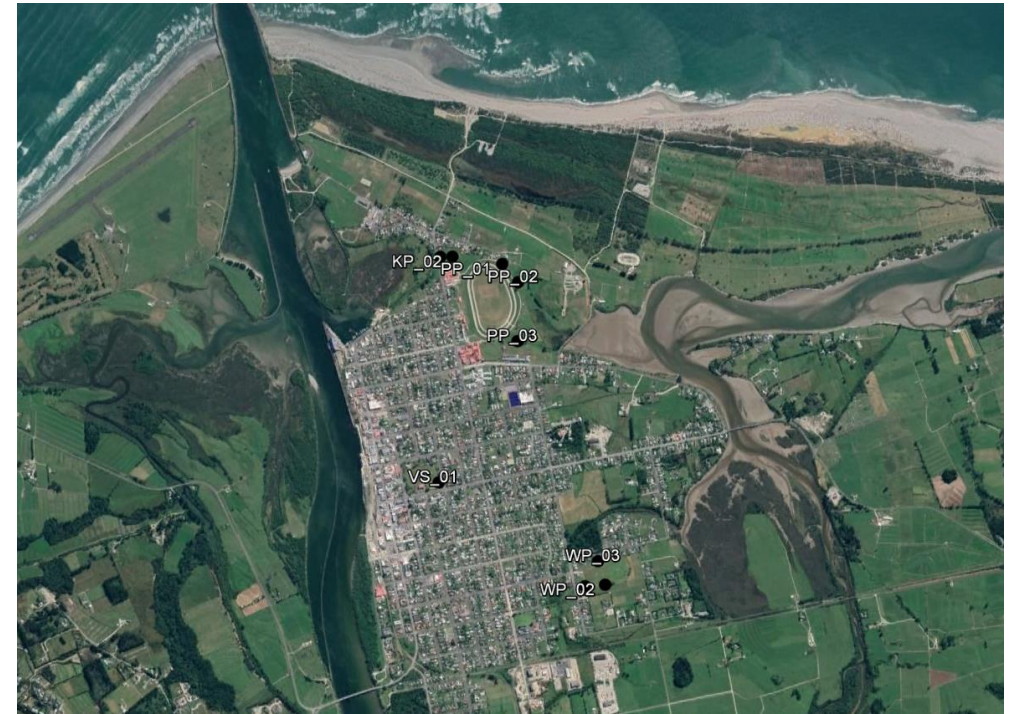
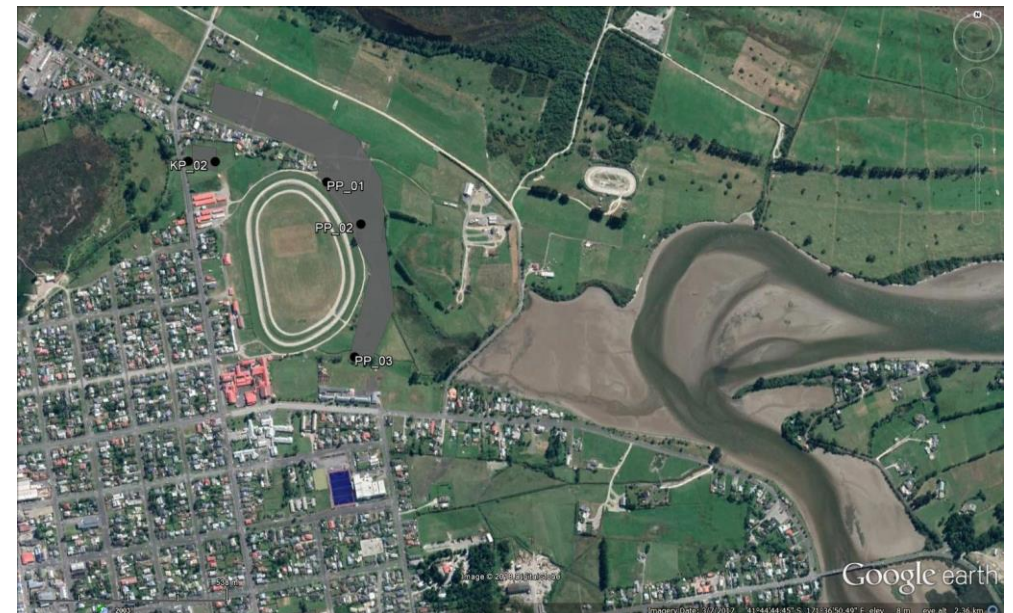
# Westport

- Liquefaction reported following Murchison, Inagahua, and Hawks Crag earthquakes
- Testing undertaken at sites where liquefaction was and was not reported
  - No liquefaction
    - George Craddock Memorial Park (WP)
    - Victoria Square (VS)
  - Liquefaction reported
    - ***Kilkenny and Patterson Parks***
      - Liquefaction reported following 1968 Inangahua earthquake – site located 34 km from epicentre; distribution indicated in figure
      - Likely liquefied during 1929 Murchison earthquake although report not conclusive in exact location
      - Nothing reported following 1991 Hawks Crag earthquake
      - Testing targeted areas where liquefaction ejecta was mapped as reports suggest that much of the area experienced liquefaction

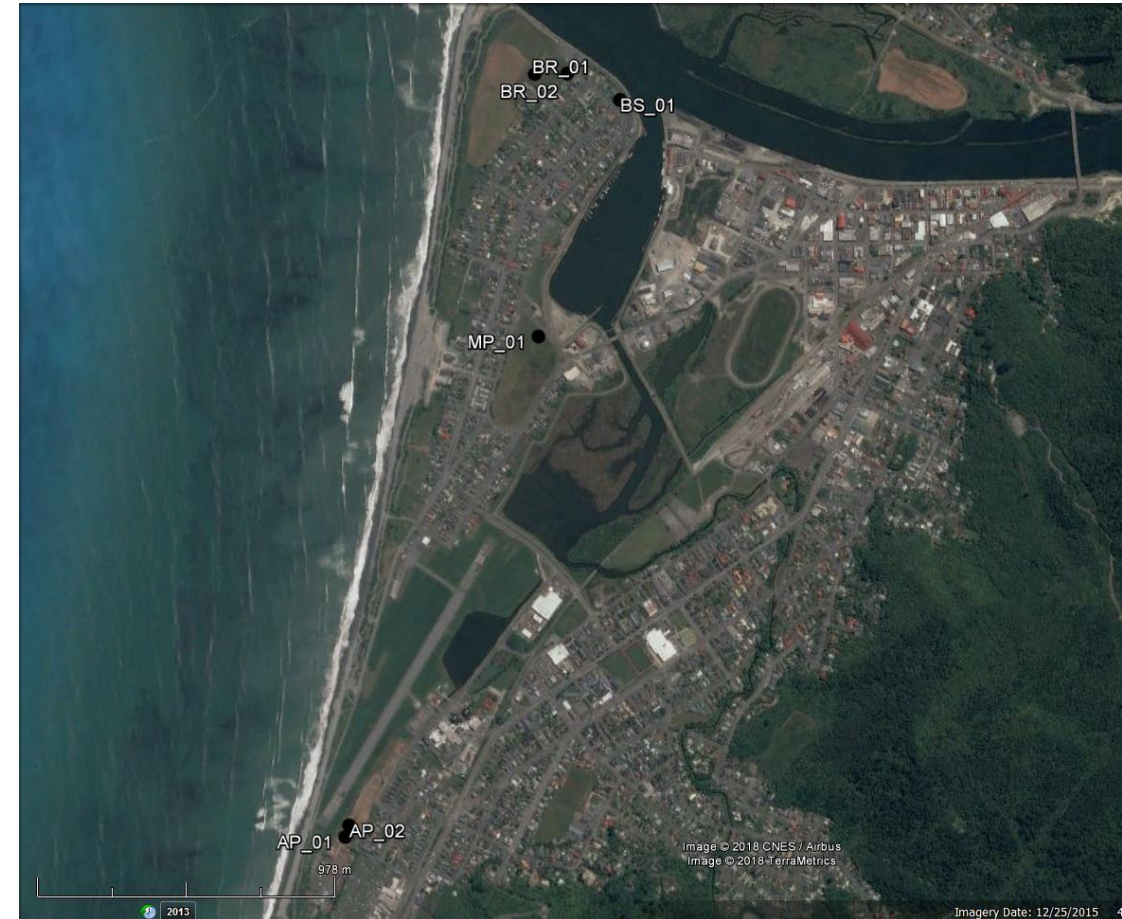
# Greymouth

- Liquefaction reported during Murchison earthquake
- No liquefaction reported following Inangahua earthquake
- Testing targeted sites where liquefaction was documented and sites where no damage was reported
  - Liquefaction sites
    - Airport
    - Blake Street
    - Messenger Park
  - No Liquefaction sites
    - Blaketown Rugby club
- Site selection was limited by the availability of greenfield sites in which testing could take place, and inability to pinpoint exact localities of reported liquefaction
