Dam Resilience Research Programme (DRRP)

Understanding the whole-life performance of our dams in a seismic setting

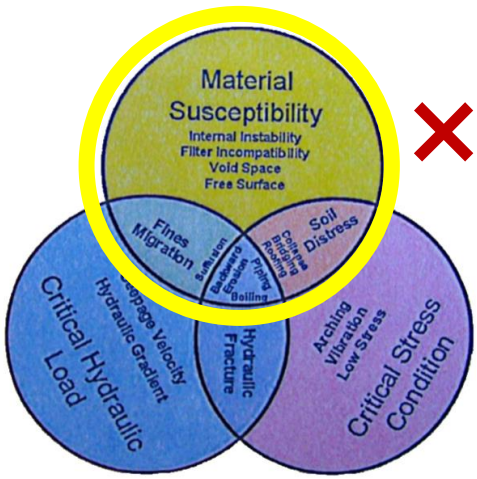
Continuing Erosion

“Common sense”?

Some (?) Erosion

Dams that do not meet modern design criteria?

No Erosion

Modern design criteria (post 1990)

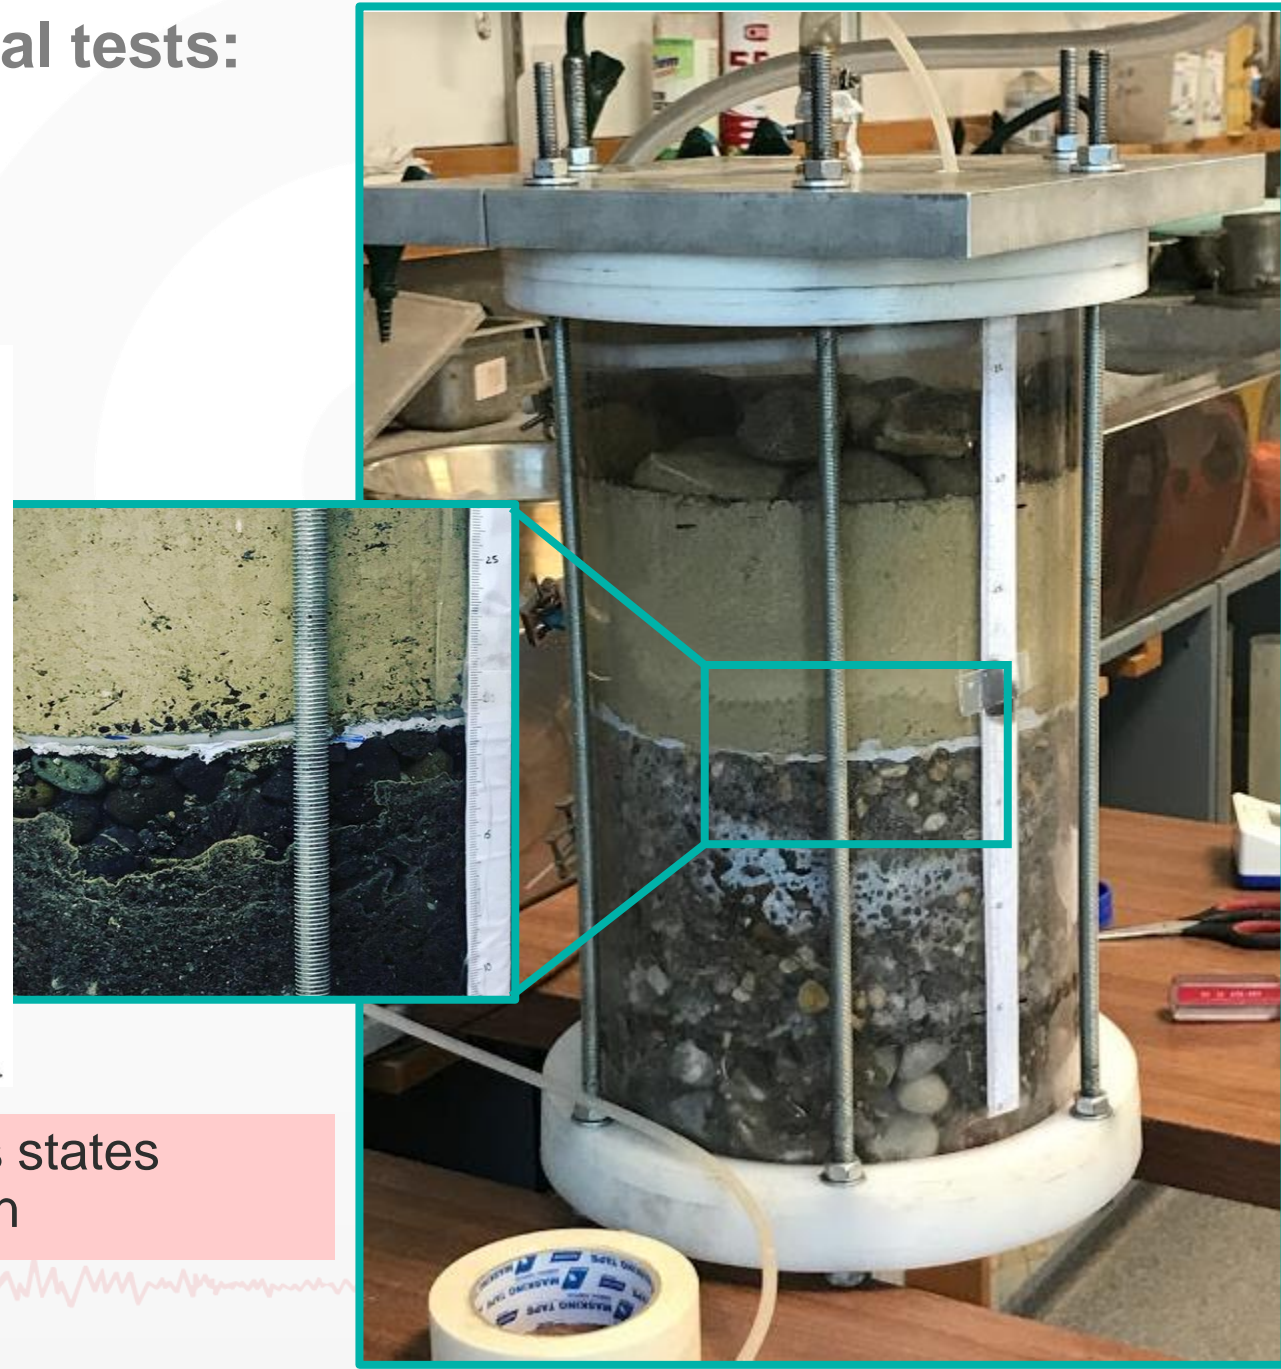
Pointy end: Dynamic Triaxial Permeameter (TXP)

✓ Designed to accommodate wide range of NZ dam soils

- ✓ Seepage capability/control (downward flow),
- ✓ Capacity for particle migration

- ✓ Triaxial stress control/quantification
- ✓ Static and dynamic stress states

Currently:
Commissioning/verification

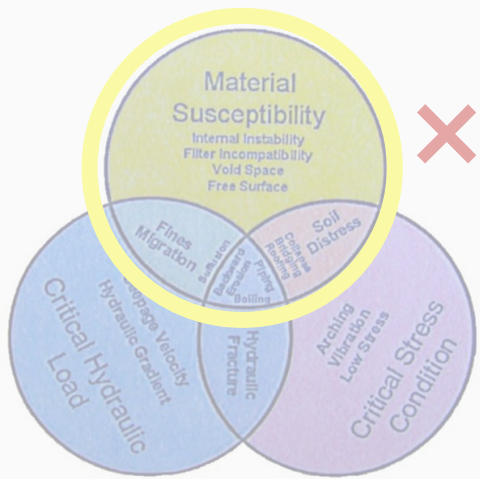
understanding
“META-STABILITY”

Continuing Erosion

“Common sense”?

Some (?) Erosion

Dams that do not meet modern design criteria?

No Erosion

Modern design criteria (post 1990)

Observations and information from Tekapo Canal were assessed to better understand the active internal erosion behaviour. Stable and unstable cyclic behaviour has been denoted as “meta-stable” internal erosion behaviour... **Understanding of the meta-stable internal erosion behaviour is prerequisite to assess dam safety conditions**, risks of failure, and possible mitigation requirements... (Benson, 2011)

... in the case of dams with filters coarser than no-erosion filters, **the filtering action often leads to a meta-stable condition or partial seal such that erosion can re-occur as new pathways break out** into the adjoining ‘unsealed’ portions of the core-filter interface. (Foster, Ronnqvist, Fell, 2018)
