Te Hiranga Rū | QuakeCoRE
Aotearoa New Zealand Centre for Earthquake Resilience

Assessment of the liquefaction potential of loess soils, Banks Peninsula

Dr Katherine Yates

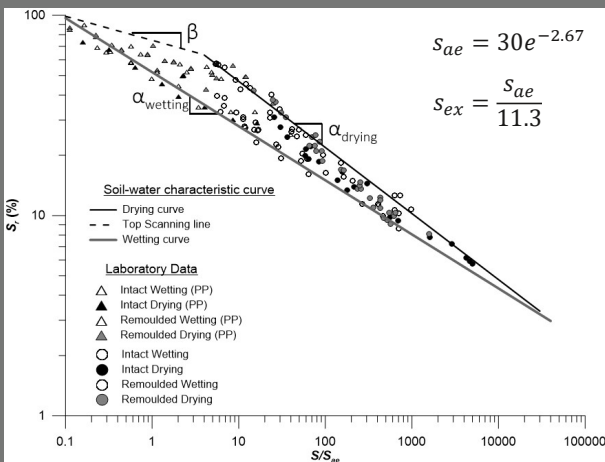
Soil Water Characteristic Curve (SWCC) for intact and remoulded loess:

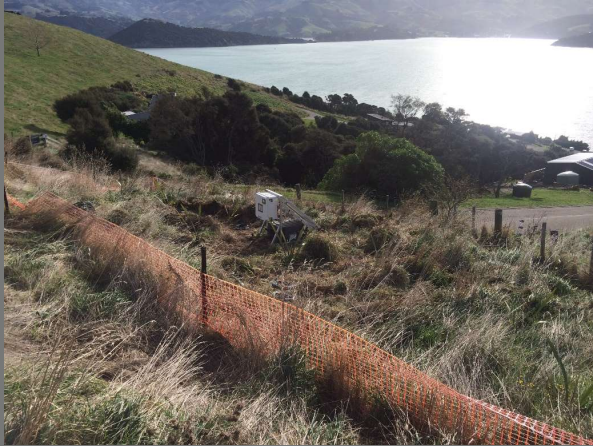
Field instrumentation site: Takamatua

MPS-6 x 12 at varying depths

CS616 x 12 at varying depths

Rain gauge

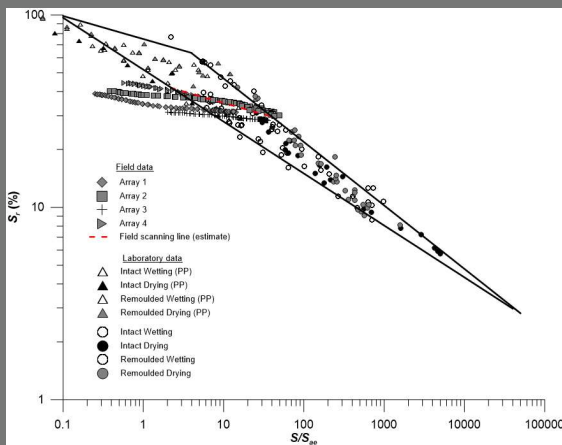
Yates & Russell (2022), *Geotechnique*

Overlay of field drying data (Summer 2019) on SWCC

- In field conditions, wetting and drying of the loess causes the hydraulic state to remain on a scanning curve
- Using the field scanning line, field VWC data was used to calculate suction - comparison between calculated and measured suction values (right plot) is good. This validates treatment of loess as a fractal soil

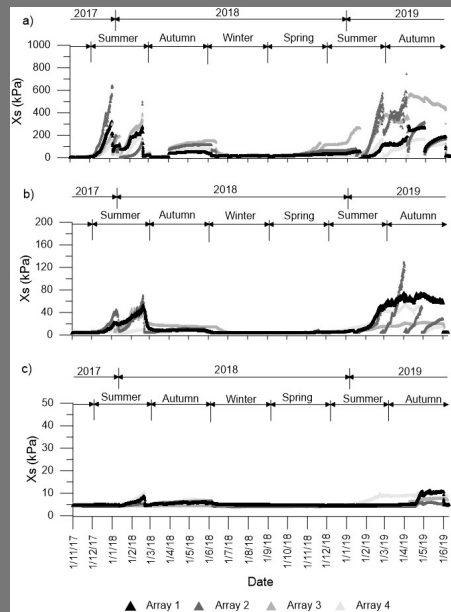
Yates & Russell (2022), *Geotechnique*

Temporal change in χ_s with seasonal changes

Bishop (1959): $\tau = c' + ((\sigma - u_a) + \chi(u_a - u_w)) \tan \phi'$

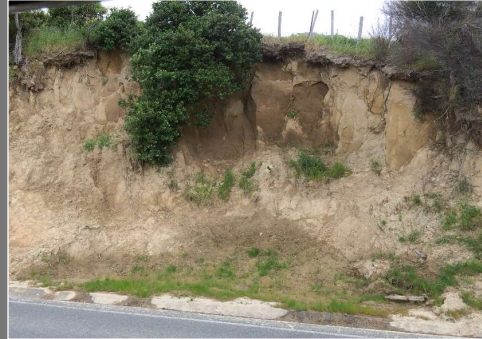
Ground truthing of slope models:

- Results from seepage analysis were comparable to moisture changes observed on site. This validated the calculated hydraulic conductivity function and SWCC.
- Simplified slope stability analysis (incorporating the changes in χ_s observed on site) showed the role of suction and microstructure in slope stability. This highlights the importance of understanding the seasonal moisture regime at a site for design optimisation.
- Demonstrated the use of the derived unsaturated parameters in seepage and stability analysis in a New Zealand soil context for engineering practice.

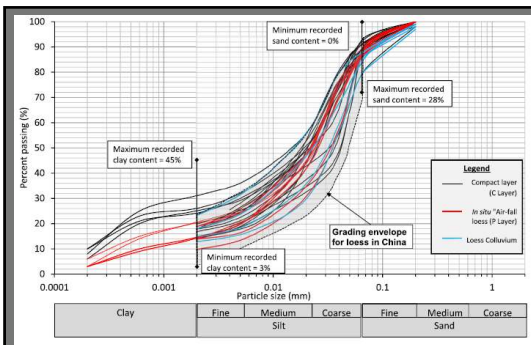
Loess particle size distribution (Yates *et al.* 2018)
