# SHAKE-TABLE TEST OF A 2-STOREY LOW-DAMAGE CONCRETE WALL BUILDING

Richard S. Henry<sup>1</sup>, Ying Zhou<sup>2</sup>, Yiqiu Lu<sup>1</sup>, Geoffrey W. Rodgers<sup>3</sup>, Anqi Gu<sup>2</sup>, Kenneth J. Elwood<sup>1</sup>, Tony Y. Yang<sup>4</sup>

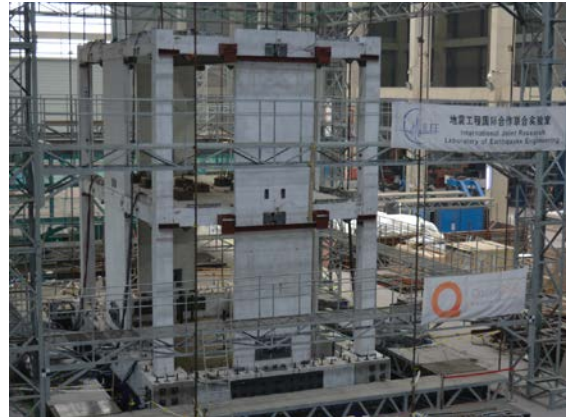
The constructed 2-storey building on the shake-table prior to testing is shown in Figure 1. The building was designed in accordance with the New Zealand Concrete Structures Standard<sup>14</sup> and the PRESSS Design Handbook<sup>15</sup> using the Direct Displacement-Based Design (DDBD) procedure<sup>31</sup>. The building was assumed to be used for general office purpose in a region of high seismicity, specifically Wellington, New Zealand.

Figure 1 Test building

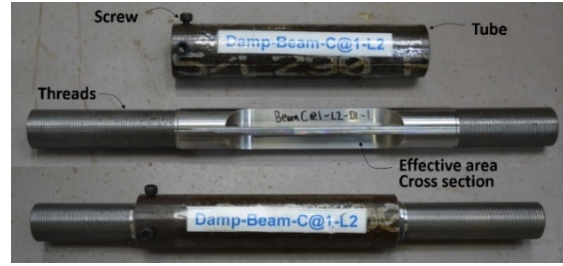
Three types of energy dissipating devices were used for different design configurations during the test, including steel fuse dissipaters, HF2V lead-extrusion dampers, and viscous dampers. The steel fuse dissipaters used in the test were manufactured from a Grade 300E reinforcing round (reinforcing bar without deformations) that were milled to create a reduced groove-type active section where yielding was intended. A confining steel tube was positioned around the fuse to prevent buckling. Drawings and photos of an example steel fuse dissipaters used in the Grid A/C beam-column joints for Design 1 are shown in Figure 5. Table 3 lists the key target force and displacement design parameters and the cross-sectional area and length of active section of each steel fuse dissipater used in the different building design configurations. Additional test reports for the energy dissipating devices are available in the published dataset on DesignSafe-CI<sup>30</sup>. The HF2V and viscous dampers were designed for an equivalent response to the steel fuses and the test results for building D1b and D1c configurations that used will be published separately.

Figure 5 Example of steel fuse dissipater

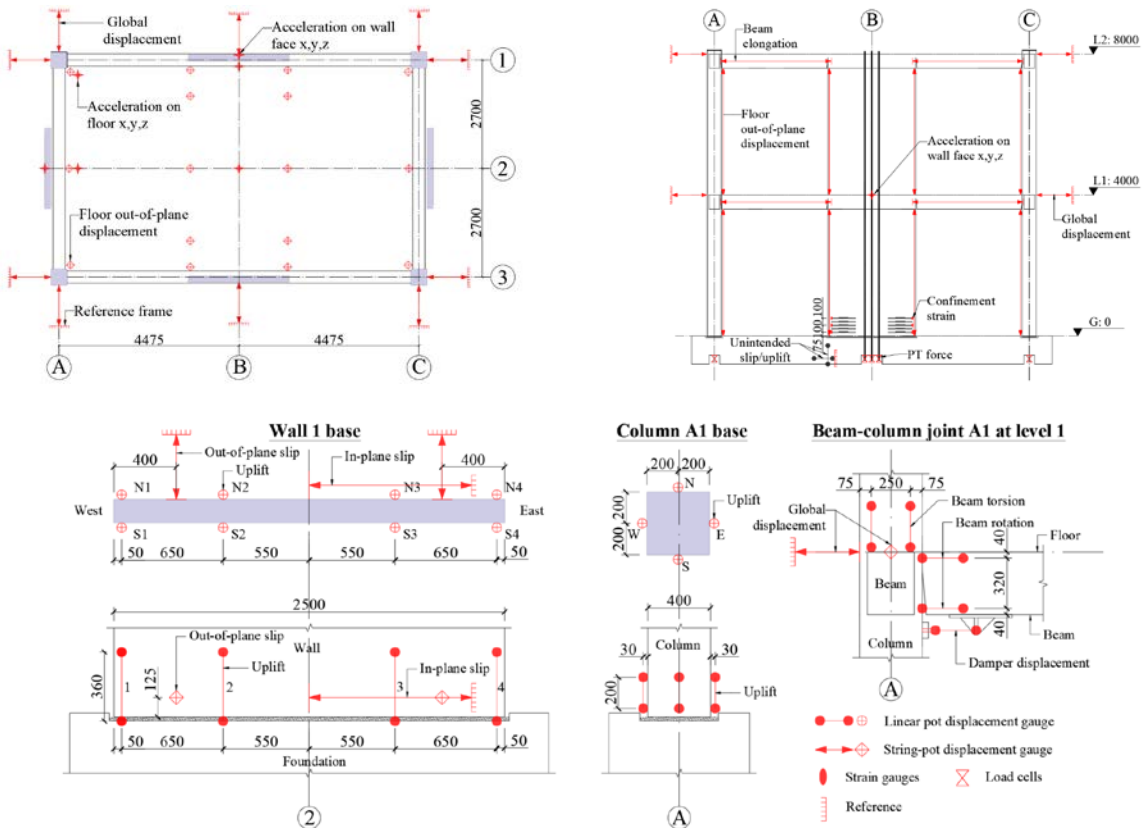
The test building was instrumented with a dense array of sensors consisting of a total of 360 channels of data recorded at 256 Hz to monitor the overall building response as well as local component responses. Figure 6 illustrates key instrumentation locations, where the arrangements shown applied to all floors, elevations, and components. Full instrumentation drawings and descriptions are available in published dataset on DesignSafe-CI<sup>30</sup>.

Figure 6 Instrumentation drawings

Triaxial accelerometers were placed in two corners of the foundation, four locations on each floor slab, and on one wall in each direction at the floor levels. Global building lateral displacements were measured using high tension string-pot displacement gauges (SPDG) that were mounted on a reference frame that surrounded the entire building with wires connected to the foundations, columns, and walls on all grid lines and levels. Rows of linear-pot displacement gauges (LPDG) were installed on both sides of each wall base allowing the in-plane and out-of-plane uplift profiles and base rotations to be calculated and four LPDGs were installed at the center of four faces at each column base. The slotted beam joint opening and rotations were monitored by a pair of LPDGs across the top and bottom of all beam slots. Out-of-plane floor deflections at 16 locations were measured by SPDGs extending vertically from the shake-table to the bottom of the level 1 floor and from the top of the level 1 floor to the bottom of the level 2 floor. Axial elongation of all the beams were measured by SPDGs mounted either beside or above the beam. Torsional rotations and shear slip at the beam joints were measured with a pair of LPDGs installed between the column and top of the beam for four joint locations. Unintended uplift and horizontal slip at the base of each foundation was monitored with LPDGs. SPDGs were installed at bases of all four walls to monitor both potential in-plane and out-of-plane slip at the wall-to-foundation joints. Strain gauges were attached in a number of reinforcing bars prior to concrete pouring to monitor the strain of shear hangers and top longitudinal reinforcement at three slotted beam-column joints, floor starter bars at two ends of wall 1 at each level, and confinement reinforcement at the base of wall 1 and wall A. The forces in all PT bars were measured by load cells that were installed at the PT anchor at the foundation.

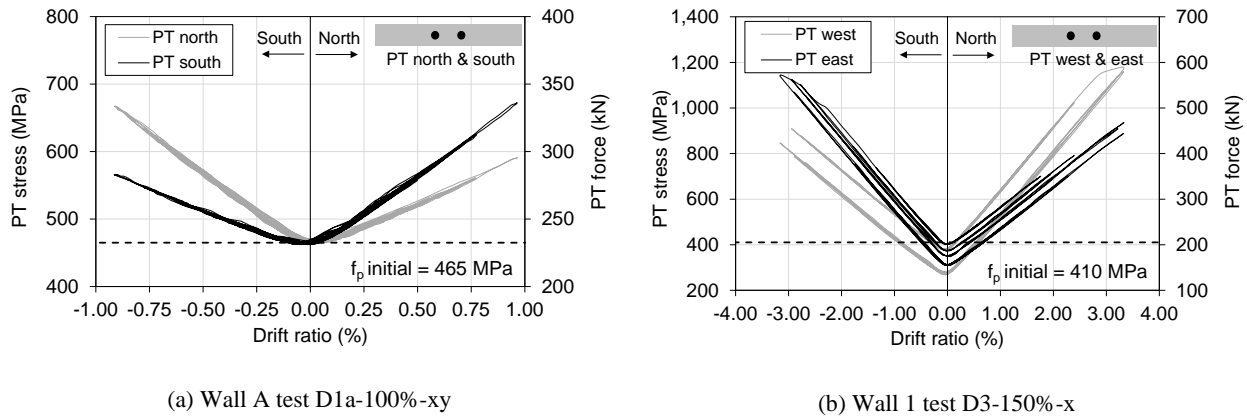
The wall PT bars displayed typical trends during tests with the force increasing as the wall uplifted during lateral drifts, as shown by the examples plotted in Figure 11. For most tests the PT bars followed a linear response as the wall uplifted with no significant prestress loss occurring (see Figure 11a). As summarised in Table 5, the PT bar stresses in Walls A and C remained below  $0.9f_y$  for all tests, whereas the Wall 1 and 3 average PT bar stresses reached close to  $0.9f_y$  during D2-180% tests and close to  $1.0f_y$  during the final D3-150%-x is visible in Figure 11b, resulting in a partial loss of initial PT force. The variation in initial PT stress for Wall A throughout the entire test sequence is plotted in Figure 12. The Wall A PT bars were stressed slightly above the target stress during D1a and remained consistent through the test series with no significant prestress loss. The Wall A PT bars were stressed to the new target at the start of the D2 tests and experienced some minor prestress loss during D2-100% tests dropping to 98% of the target initial stress. During the D2-180% tests the Wall A bars experienced some additional prestress loss, ending at 95% of the target initial stress. The PT bars were restressed prior to the D3 tests, where they again experienced some minor prestress loss due to yielding.

Figure 11 Measured PT bar forces

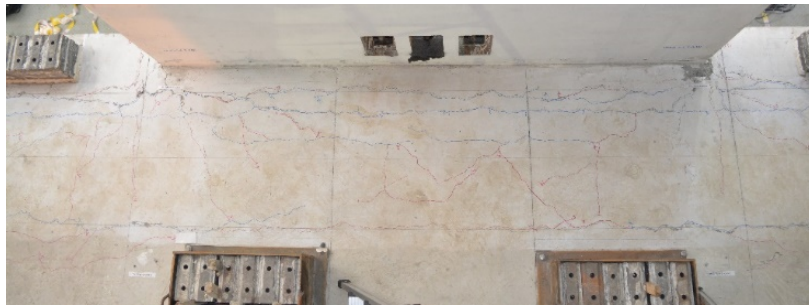
**Figure 16 Floor damage adjacent to Wall 3 on Level 1**
