# ILEE-QuakeCoRE Shake-Table Test of a Low-Damage Concrete Wall Building

QuakeCoRE has given New Zealand researchers the opportunity to access some of the world's top earthquake engineering facilities. A system level shake-table test of a full-scale low-damage concrete wall building has been conducted on the multi-functional shake-table array at Tongji University as part of the ILEE-QuakeCoRE international collaborative research project. The test aimed to verify the seismic response of a low-damage concrete wall building implementing state-of-art design concepts and practical construction details that are currently being used in New Zealand buildings.

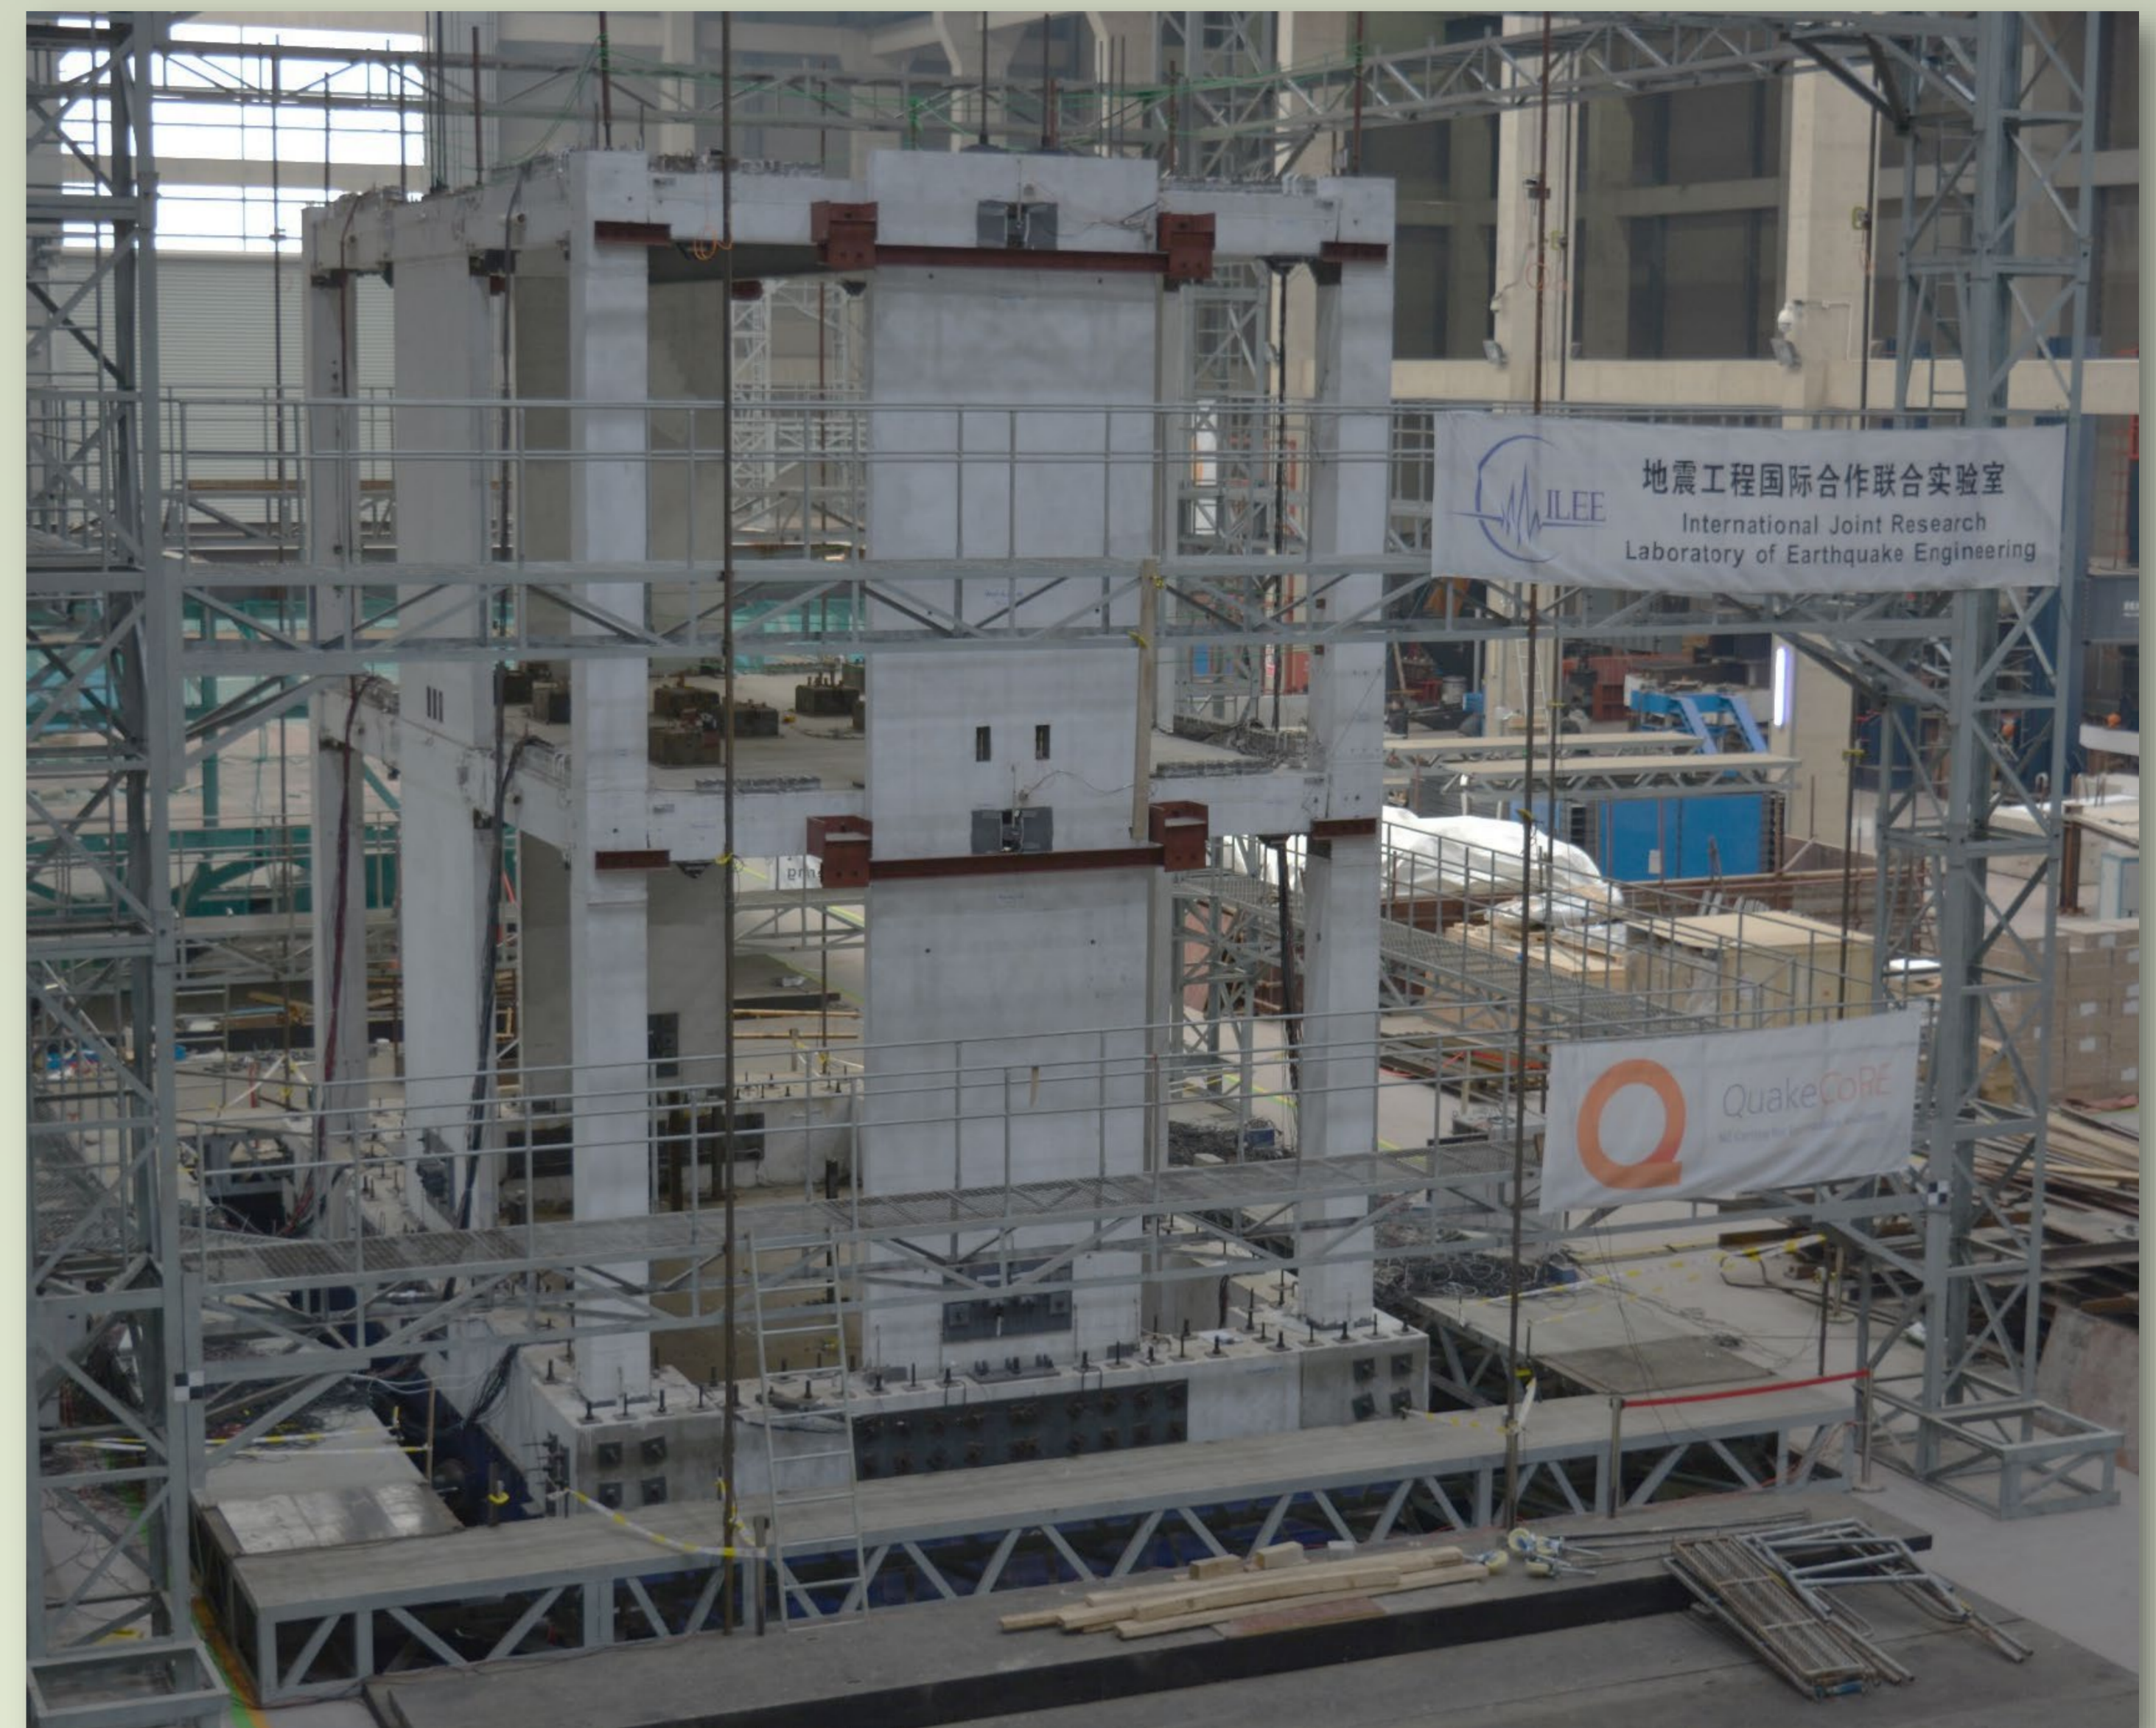
Figure 1 Building overview

The overview of the test building is shown in Figure 1. The test building is a two-storey building with plan dimensions of 5.4 x 8.95 m. The total height of the building is 8 m with each storey 4 m. The building consists of:

- Two exterior post-tensioned walls in each direction to resist lateral loads.
- One perimeter frame with slotted beams to carry gravity loads.
- Level 1: Long-span precast concrete double tees with concrete insitu topping.
- Level 2: Composite floor with ComFlor steel decking as permanent formwork and concrete topping.

- Two wall armouring approaches: small steel angles and larger armoured end region.
- Three wall-to-floor connection approaches: link slab, flexible composite floor and isolated steel tongue connection.
- Two wall base details: a grouted joint detail with no shear dowels and a recessed steel pocket detail.
- The building were designed for three lateral drift targets with different wall strength and energy dissipating devices. The three design cases are listed in Table 1.

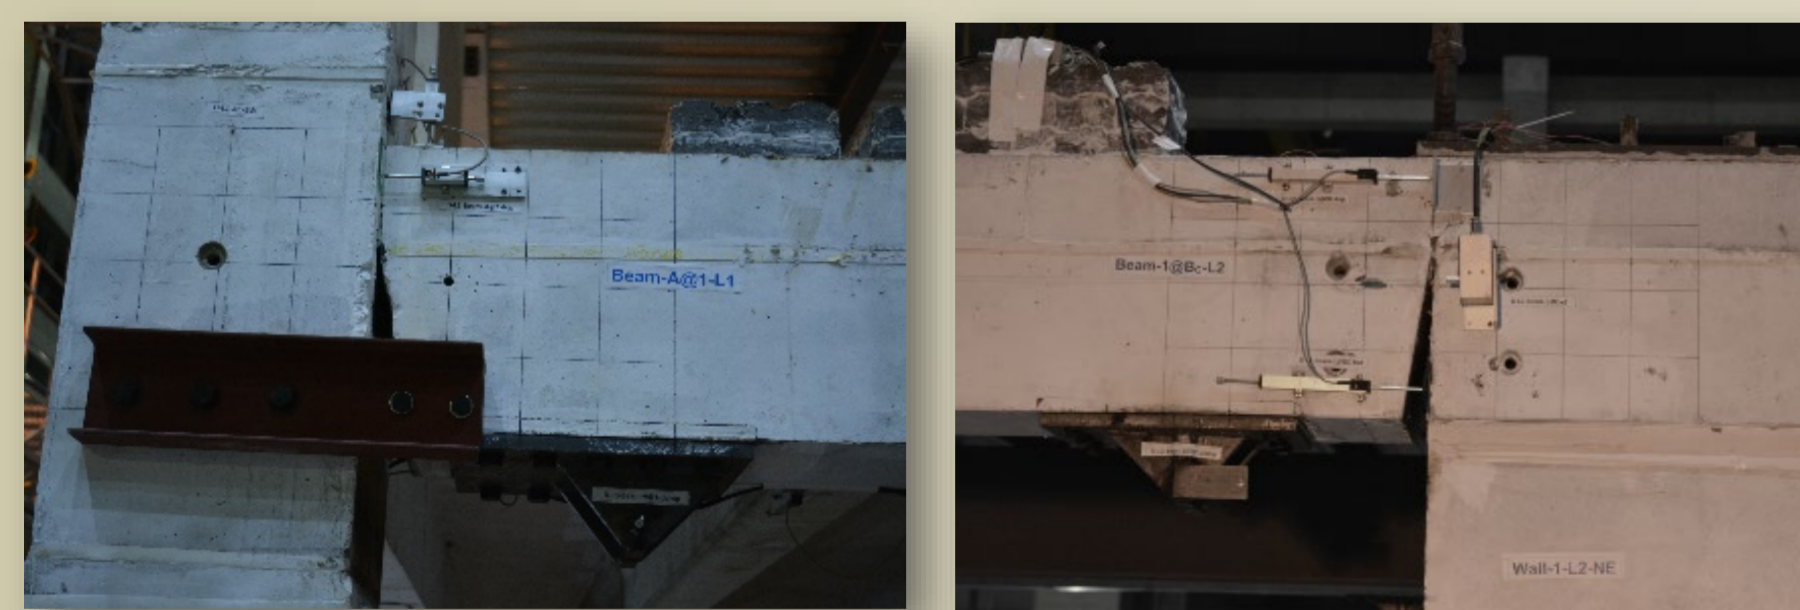
Figure 4 Final condition of slotted beam joints

The slotted-beam connections performed well, minimising beam-elongation (frame dilation) demands on the floors and limiting residual crack widths. Figure 4 shows examples of the damage progression for the slotted beam joints. Only 1-2 diagonal cracks extended from the top of slot to the floor surface with maximum residual crack widths less than 1 mm.

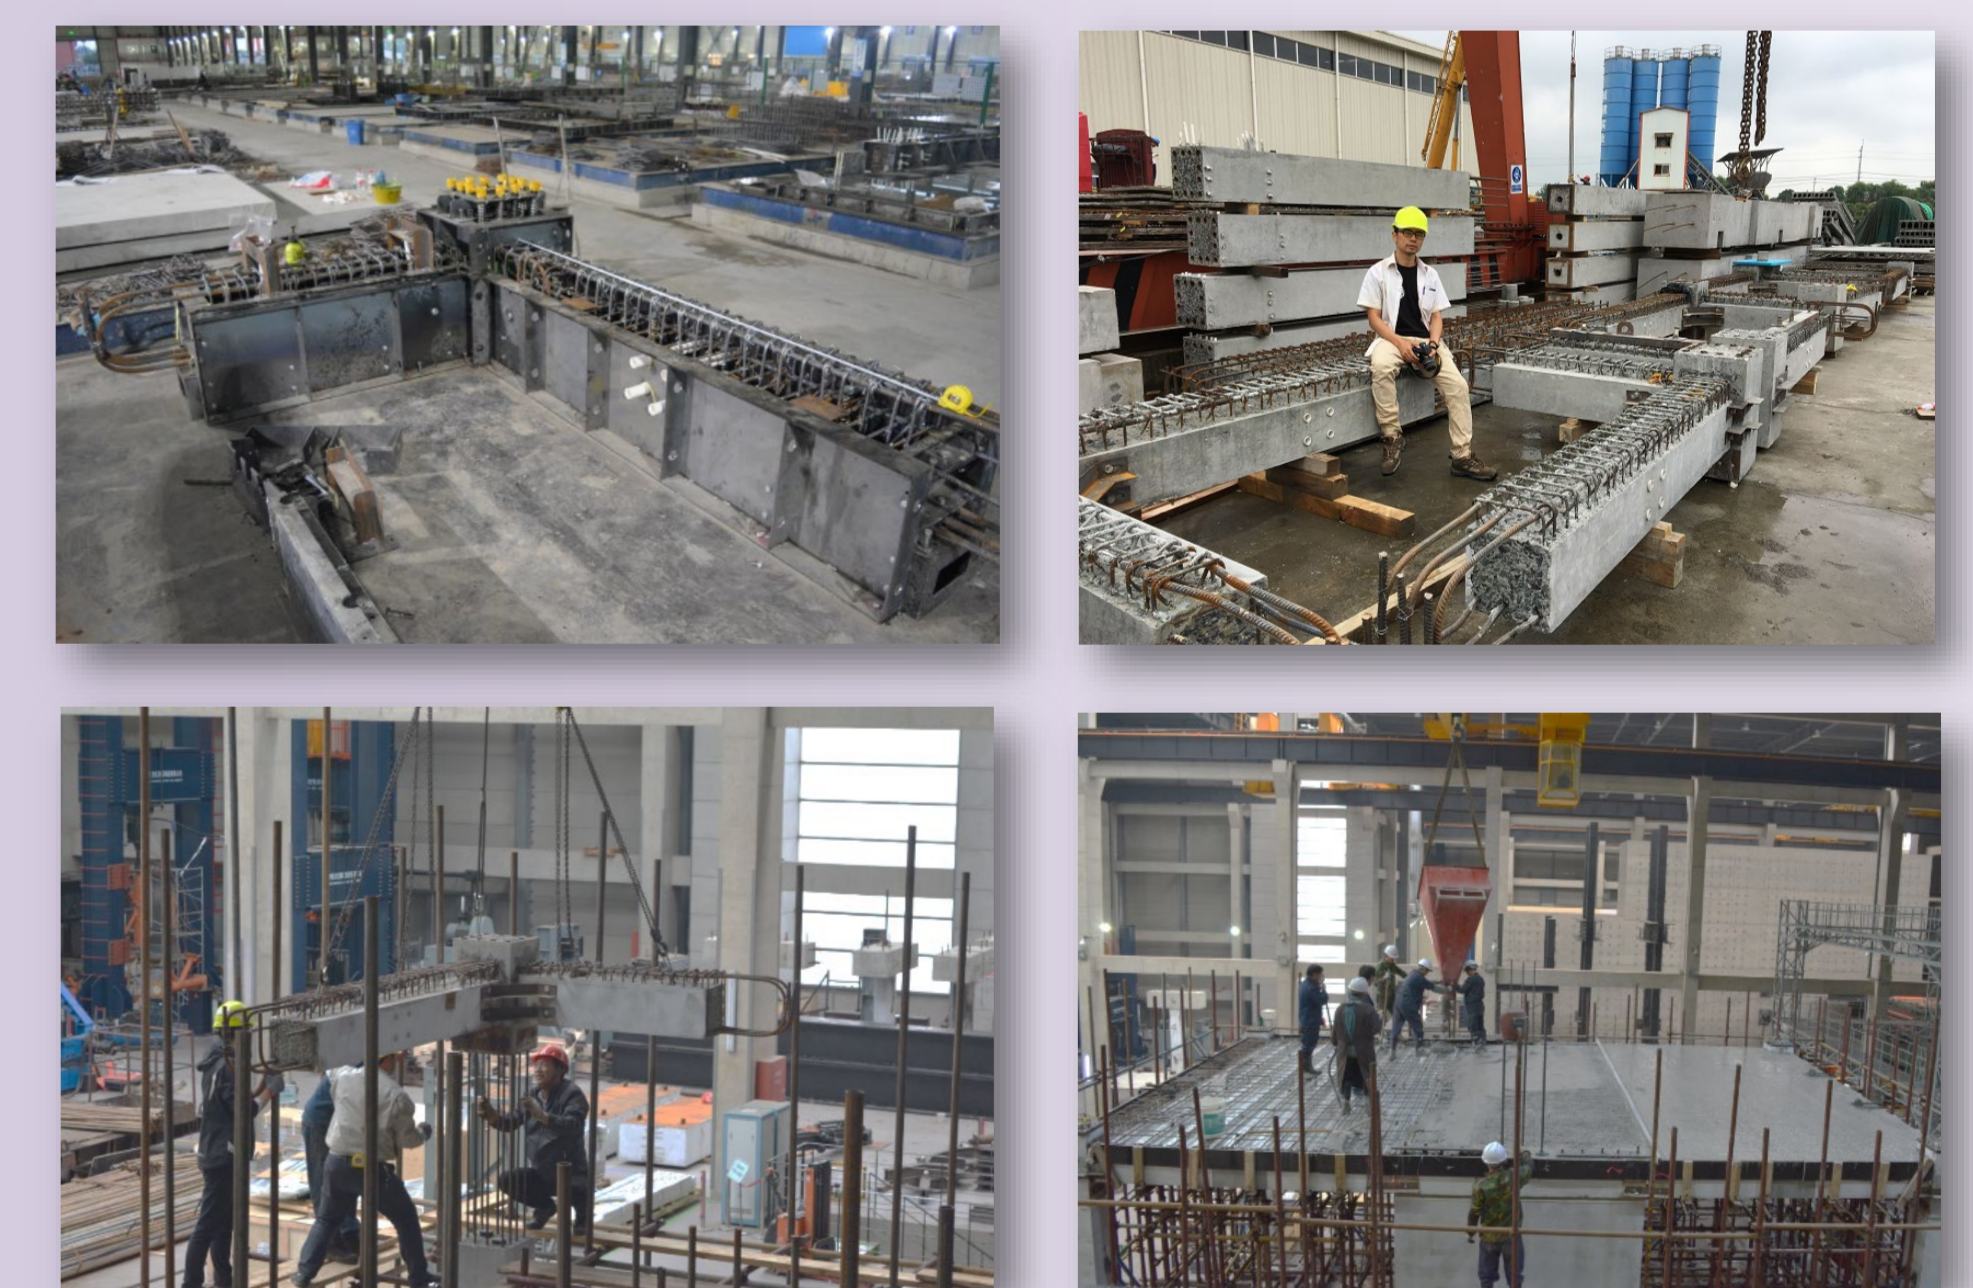
Figure 2 Building construction

The construction was separated into two phases that were precast component construction and assembly construction. The precast component construction was conducted in a precast factory in Shanghai, China and the building was assembled on the shake-table at the ILEE lab using a construction process similar to that used in New Zealand building construction. Chinese materials were used for the precast component construction in Shanghai.
