# SEISMIC PERFORMANCE OF CONCRETE WALL-STEEL FRAME HYBRID BUILDINGS

**CLAIRE PASCUA**

Waipapa Taumata Rau - University of Auckland

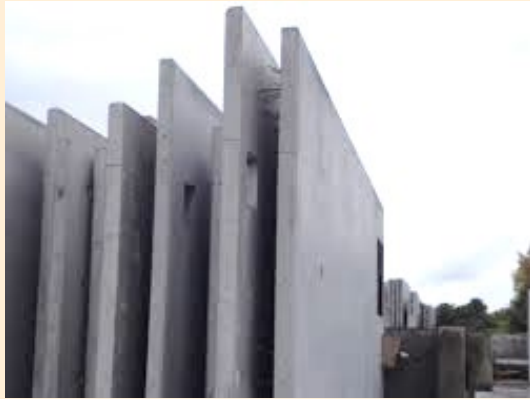
## CONCRETE WALLS

- Stiffness, drift control
- Built-in fire rating and insulation
- Functionality

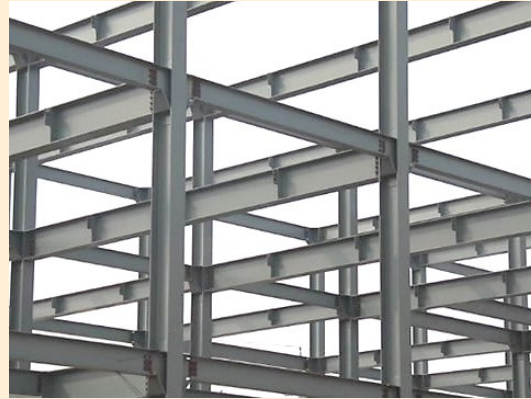
## STRUCTURAL STEEL

- Flexibility
- Good strength-to-weight ratio
- Reparability

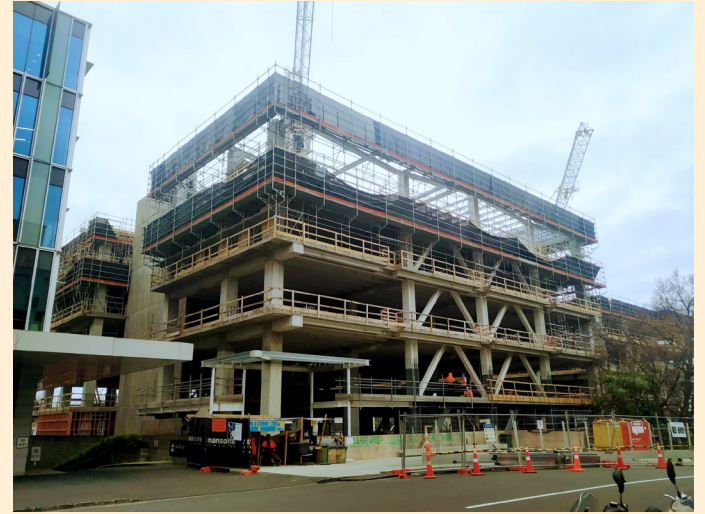
## HYBRID BUILDINGS WITH CONCRETE WALLS AND STEEL FRAMES

- Economy \$\$
- Efficiency

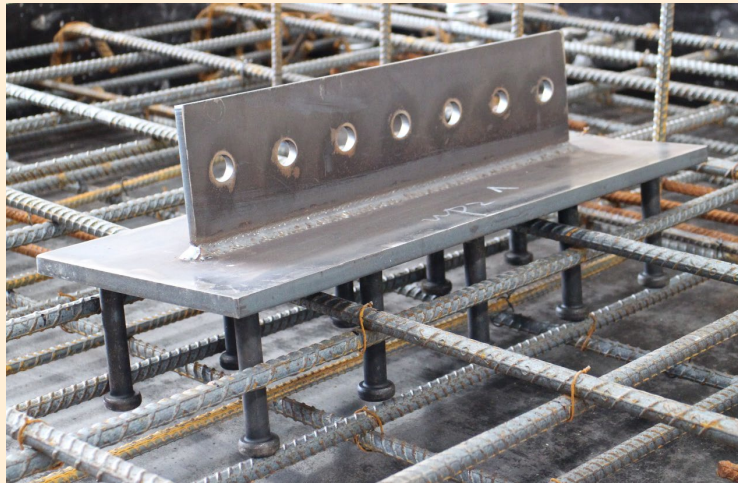
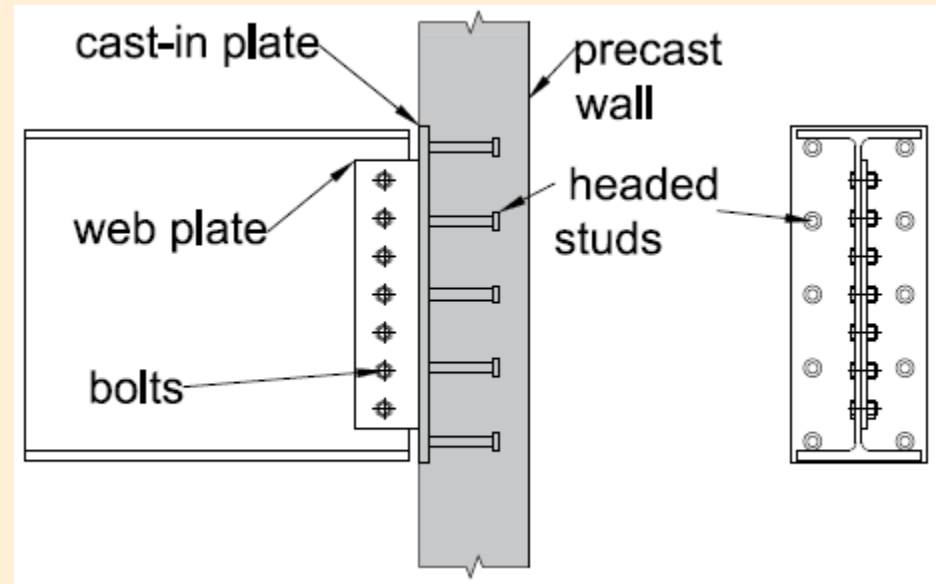
- Lack of connection design guidelines
- Few tests conducted previously
- Bolted web plate connections are usually assumed to act like a pin

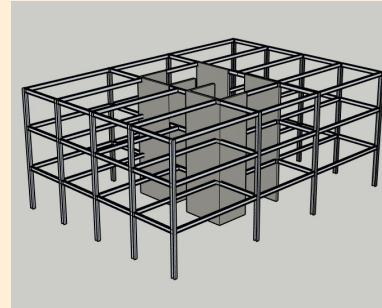
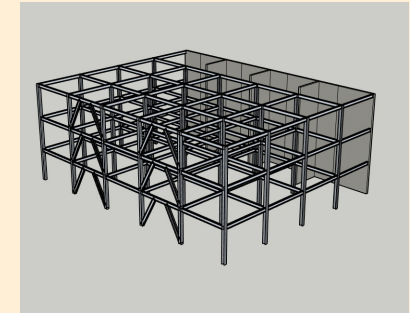
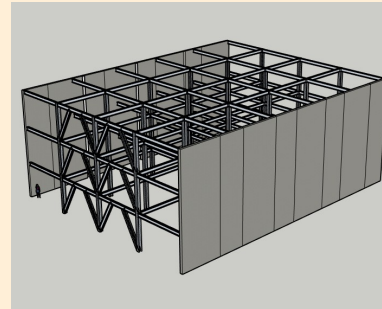
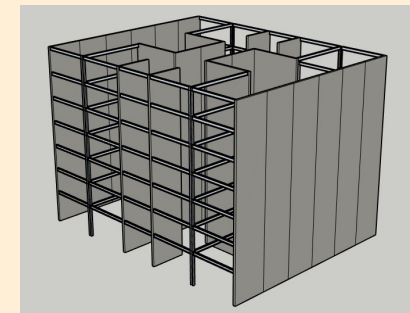
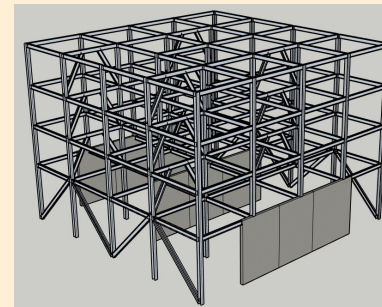
- **Survey** of 50 buildings in Auckland and Christchurch + **interviews** with engineers
- **Variety** of wall configurations and steel framing systems.
- Different **trends in structural features** in Christchurch and Auckland.
- Categorized buildings into **five typologies**.

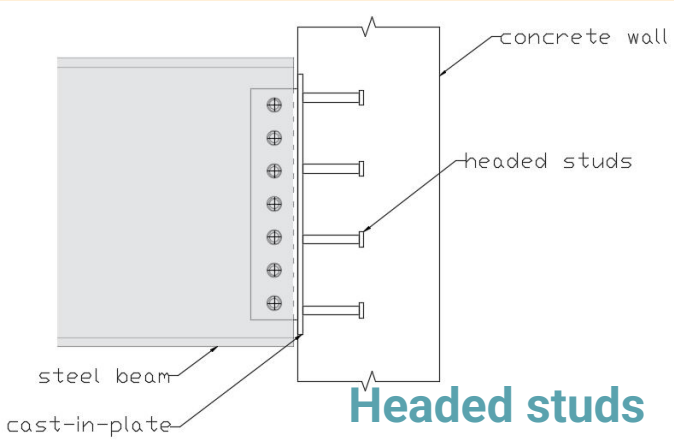
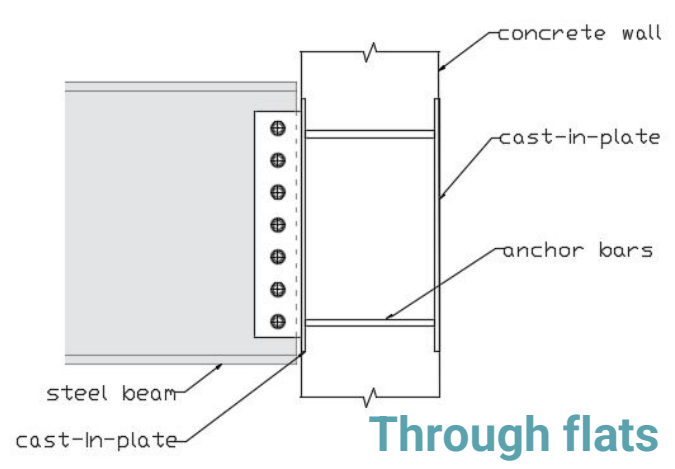
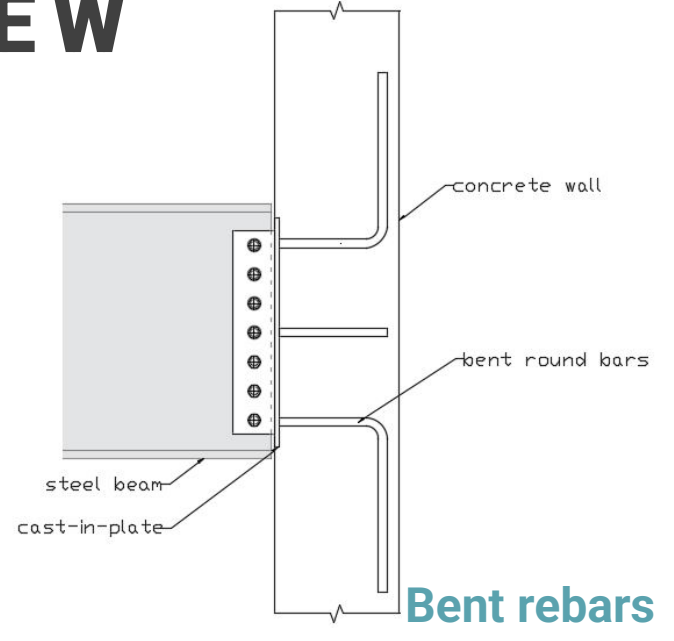
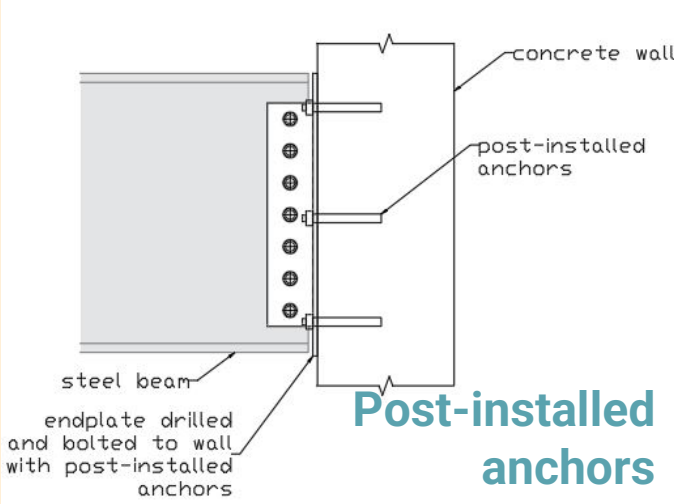
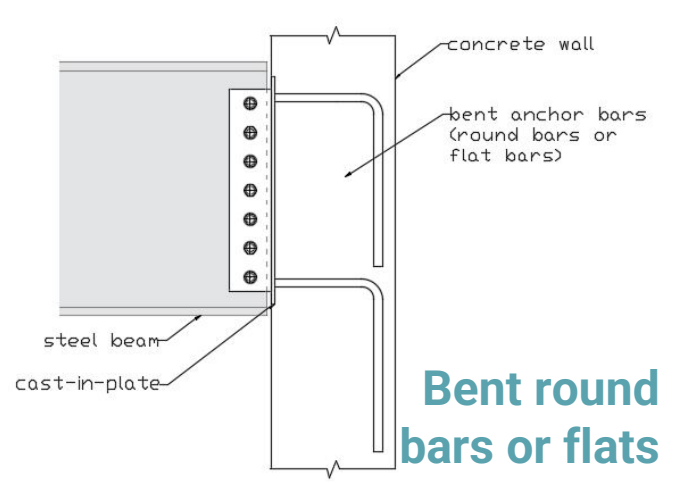
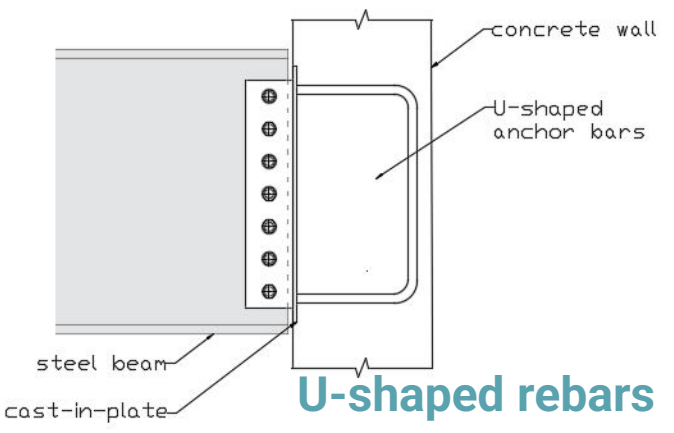
- Wide range of **connection detailing** highlights lack of design guidelines.

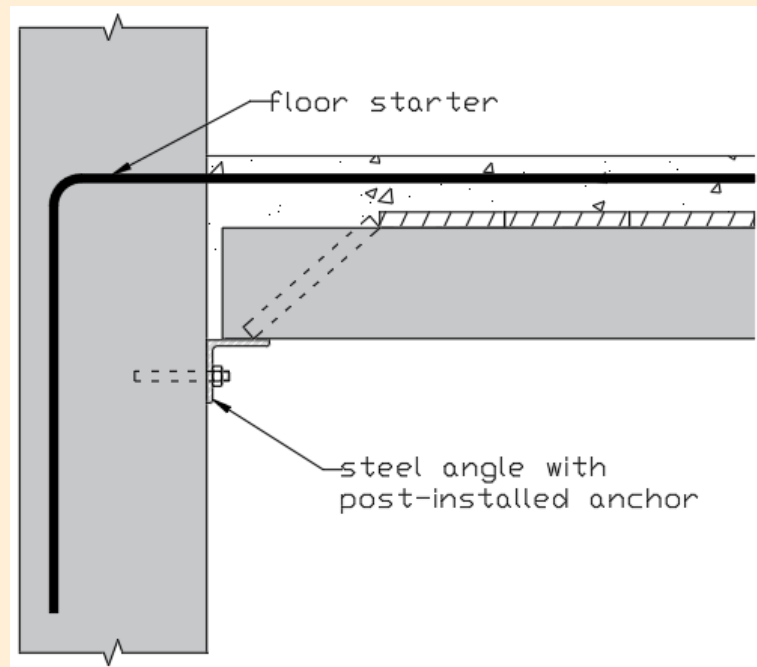
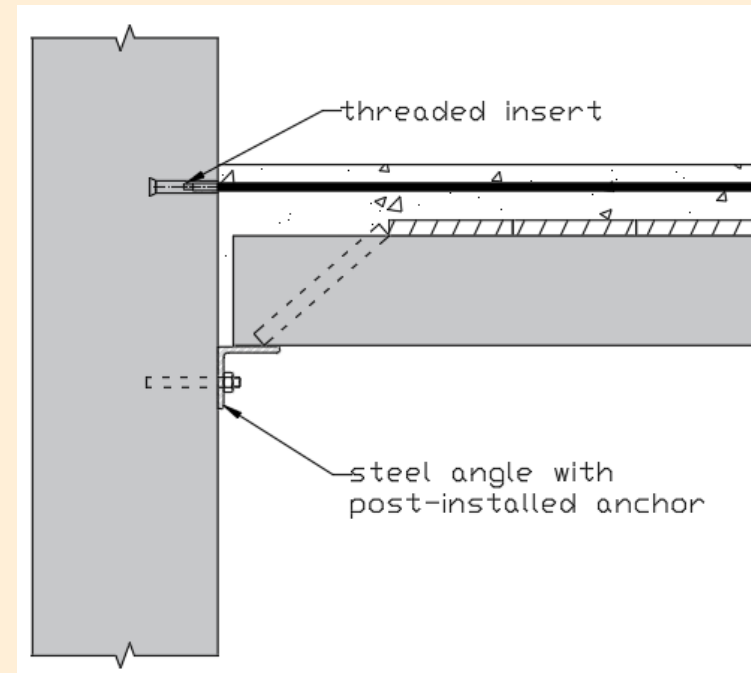
- Wide range of **connection detailing** highlights lack of design guidelines.

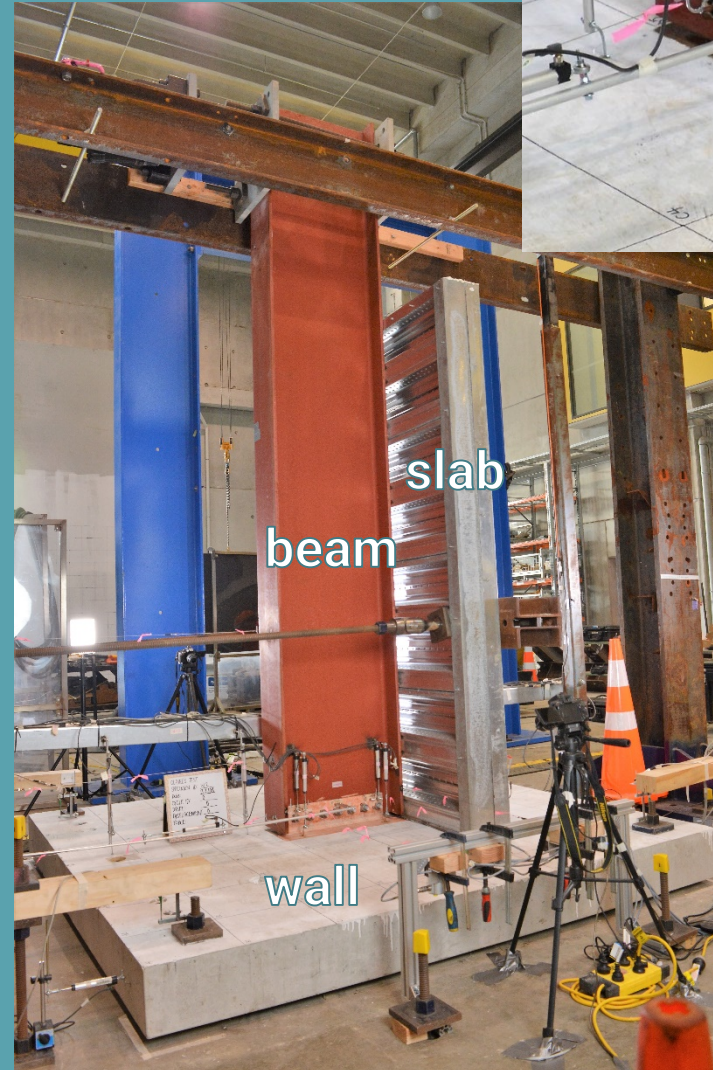
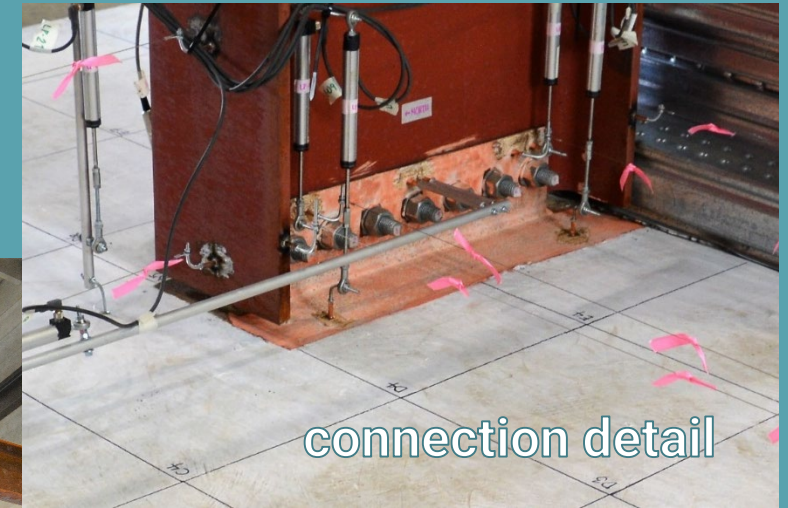
- Four full-scale specimens designed according to current practice
- Test variables:
  - Floor slab and starters
  - Round vs slotted holes
  - Headed studs vs bent rebar anchors

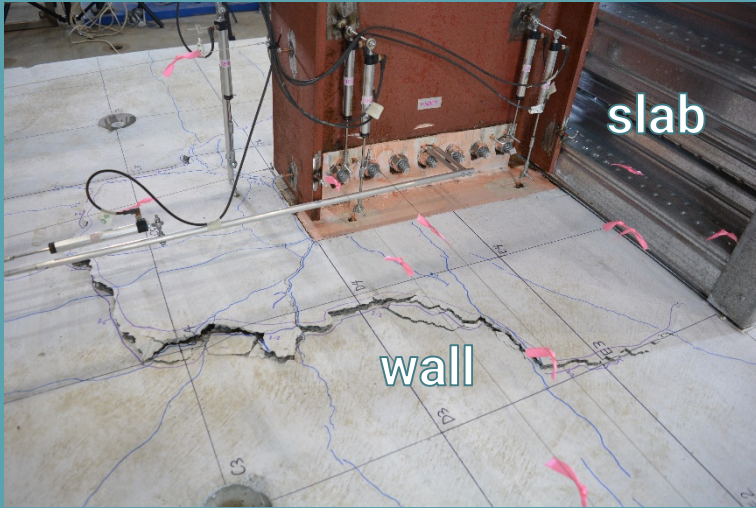
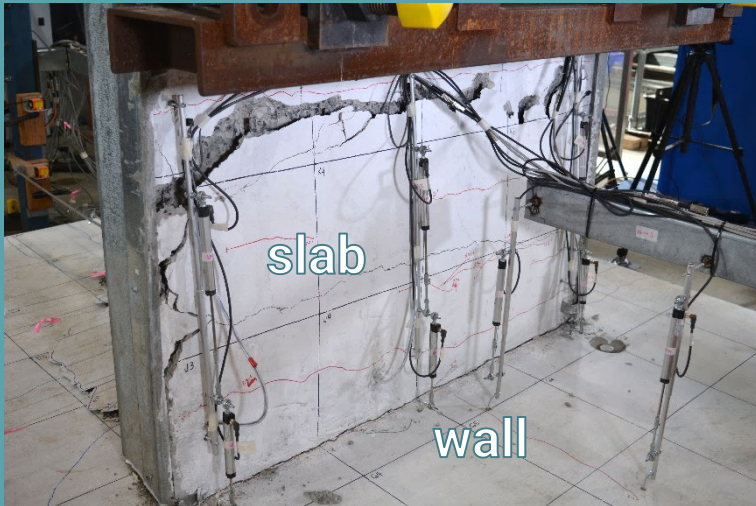
- **Brittle failure** by concrete breakout.
- **Rotation capacity** is dictated by bolt slippage, web plate bearing, and wall deformation.
- **Floor slab and starters** drastically reduced rotation capacity and increased connection stiffness.
- **Slotted holes** and **bent rebar anchors** improved rotational capacity.

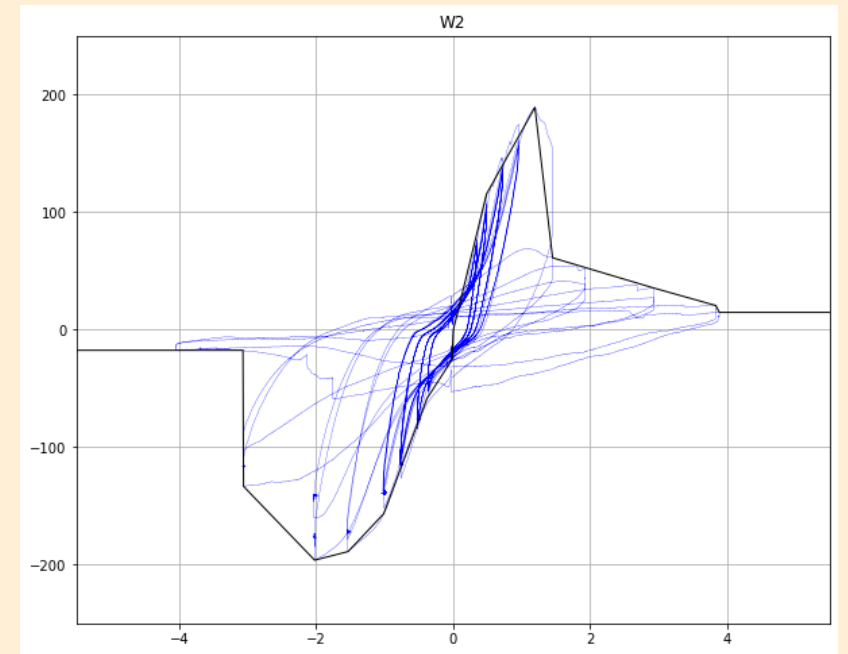
- In progress
- **Pushover analysis** on a six-storey office building located in Christchurch using OpenSeesPy.
- Results of experimental testing is used to simulate **different connection conditions**.
- **Parametric study** will be conducted to benchmark seismic performance and to quantify **connection and wall demands**.
