Quasi-static cyclic testing of a low-damage, drift- sensitive, non-structural components sub-assembly

Robert Clement, MEQ, University of Canterbury

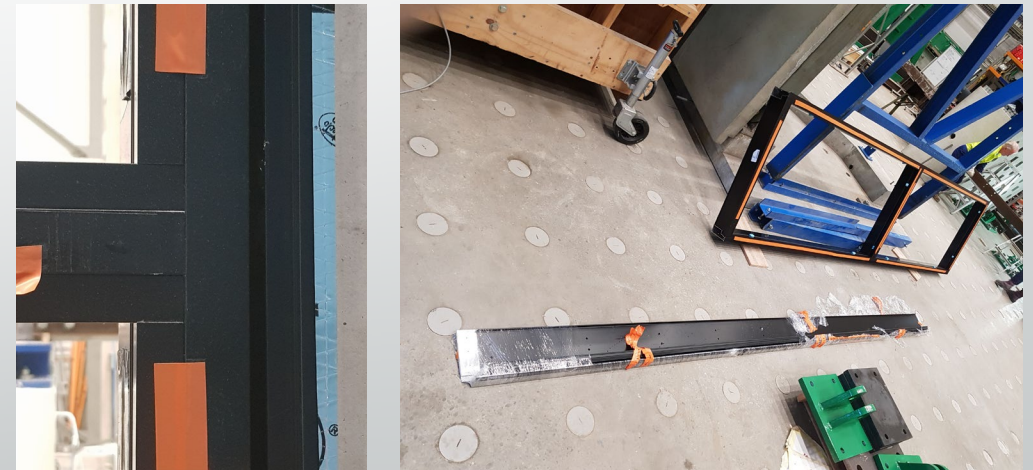
Figure 5: Photos of A) The glazing seismic frame in place B) The unassembled two sections of the seismic frame.

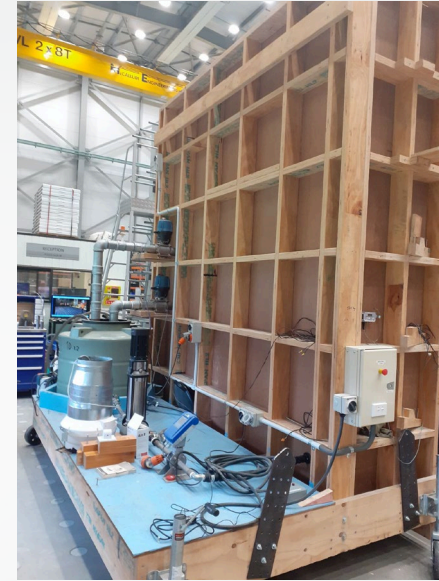
Figure 6: Photo of the waterbox used for weather-tightness testing

- Sub-assembly of all the low-damage NSE's within a pin-pin experimental frame
 - Quasi-static cyclic testing to 4.2% Inter-story drift
 - Weather-tightness (water-tightness and air leakage) testing at the end of each cycle
 - Instrumentation to monitor the relative movement between components, and relative to the strongfloor / strongwall

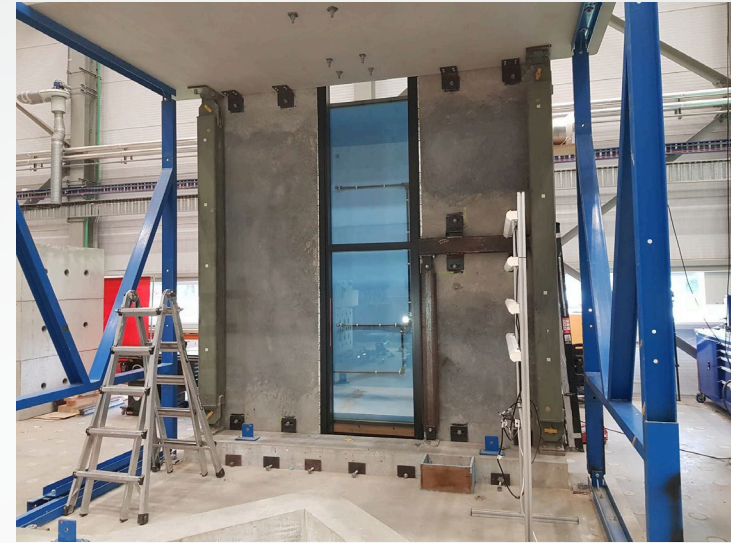
Figure 8: Photo of the current progress of the test setup, with the precast panels and the seismic glazing system installed.

- Precast panels and the seismic glazing system have been installed, working with the partition company to source materials
- Initial testing with just the precast panels has been done up to 2.5% drift
 - Early locking of the precast panels was noticed, so the slots were widened to accommodate larger horizontal translation
