# RESILIENCE AND FRAGILITY OF THE TELECOMMUNICATION NETWORK TO SEISMIC EVENTS: EVIDENCE AFTER THE KAIKŌURA (NEW ZEALAND) EARTHQUAKE

## ABSTRACT

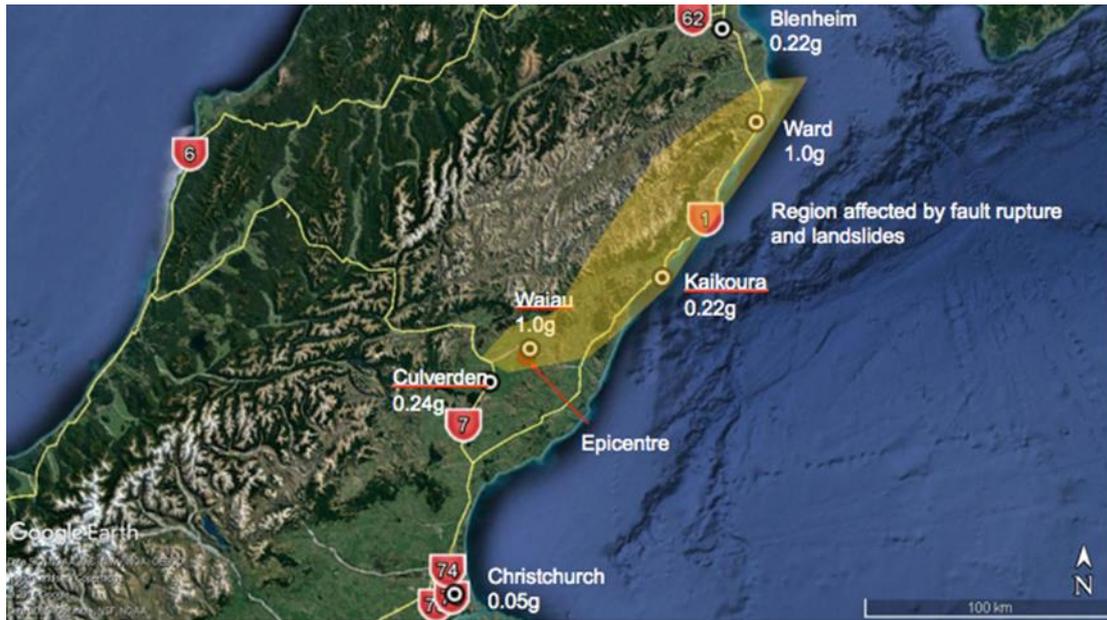
**Figure 3:** Map of part of New Zealand South Island, location of the epicentre of the events and of the main town/locations mentioned in the paper with recorded PGA (g). The approximate region that was impacted by landslides and fault rupture is summarized in this figure. Yellow lines indicate the main road links, with red shields representing the State Highway numbers.

The geometric mean peak ground accelerations (PGAs) from strong motion stations in the area where telecommunications infrastructure was most affected are summarised in Figure 3 [11], along with the epicenter of the earthquake. A more comprehensive summary of the ground motion characteristics across the region can be seen in [12].

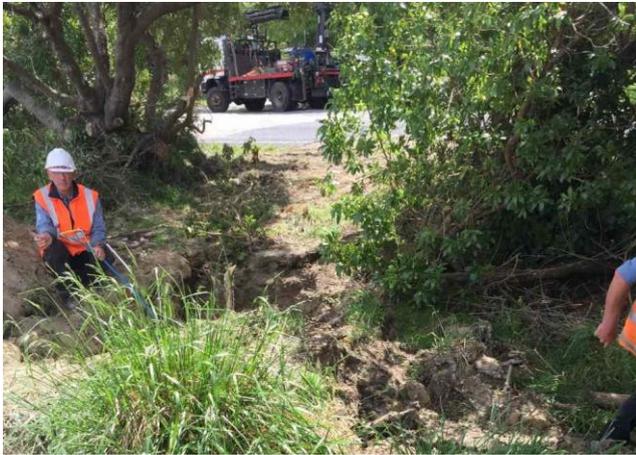
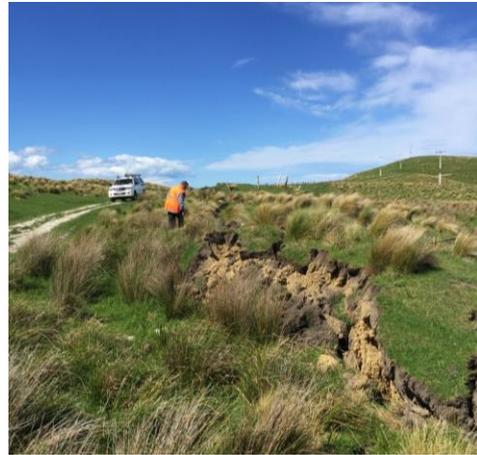
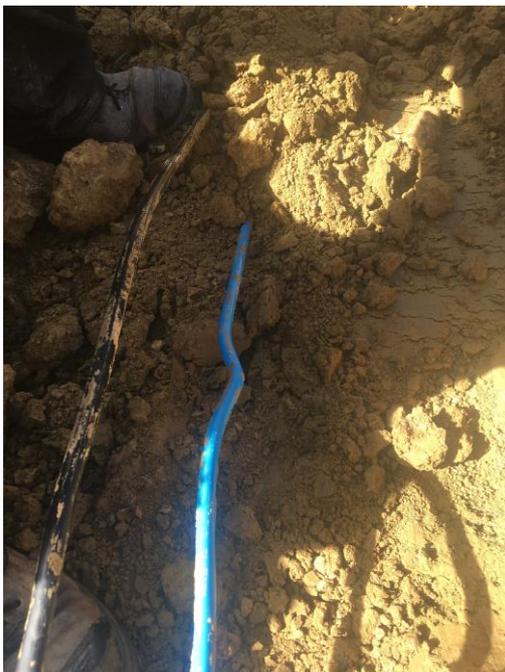
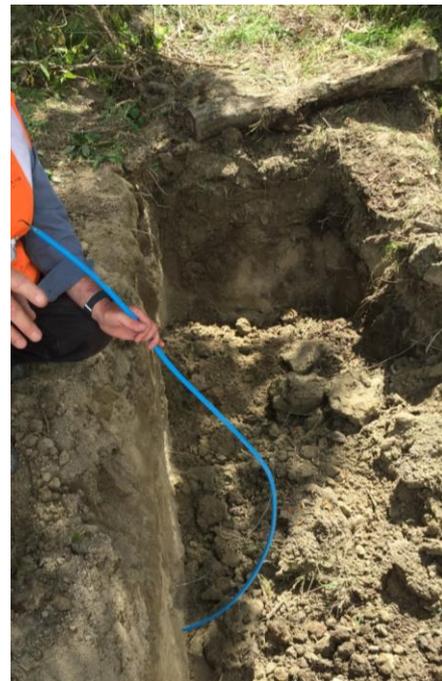
**Figure 5: Damage of cables after the Kaikōura earthquake: a), b) Instances of permanent ground deformation and fault ruptures at cable locations; c) example of stretched cable; d) example of broken cable (Photos courtesy Rob Ruiter, Chorus).**

- *The East Coast Link*, a major fibre optic cable, was severely damaged. Six breaks were identified along the East Coast Link cable [18].
- *Cables* many (mainly copper) were severely damaged. Overall, most of the damage identified on the network was on cables and it was due to cables being stretched and broken as a result of both transient ground motion, permanent ground movements and fault rupture at cable locations (Figure 5). Where cables were stretched, faults

were identified not only in the immediate vicinity of ground cracking, but also in some cases 100 m plus along the cable length away from the main source of the displacement. This was due to the internal wires being stretched. In some instances, the extent of stretching was to a degree that changed the cable characteristics quite markedly.

As for the time required to repair/replace cables, spot repairs in damaged cables usually took around half a day and included digging, putting a joint in and filling. For cables that were stretched or damaged at multiple locations and had, therefore, to be replaced, the temporary replacement cables were run on the ground and each replacement could take a full day of work even for a relatively short cable length (e.g. 200-metre cable). The timeline was similar for repair/replacement activities related to fibre optic cables.

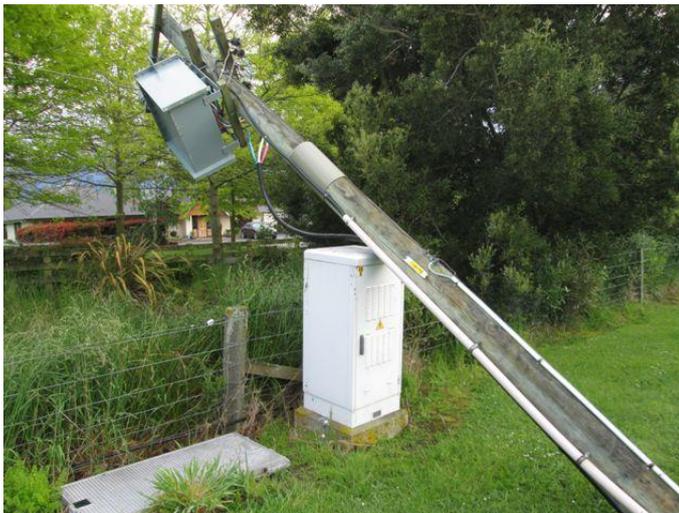
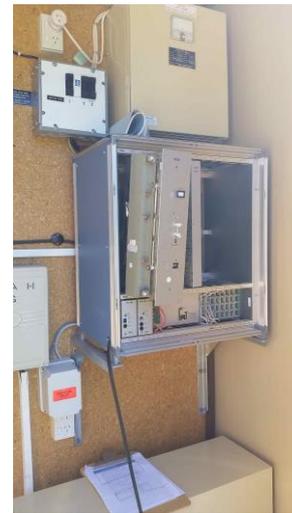
One roadside cabinet was damaged with a power pole falling on to it (Figure 6a); others had instances of electronic card dislodgement (rattled) while the cabinet itself remained undamaged.

**Figure 6: Damage of above-ground components after the Kaikōura earthquake: a) power pole falling on a roadside cabinets; b) effect of the ground-shaking on one of the remote radio terminals where the radio transceiver card has dislodged from its rear connector causing service loss (Photos courtesy Rob Ruiter, Chorus).**

Instances of toppled cell sites were observed (Figure 6b). Also multiple cell sites were immediately impacted by power outages in a number of regions on both the North and South islands of New Zealand.

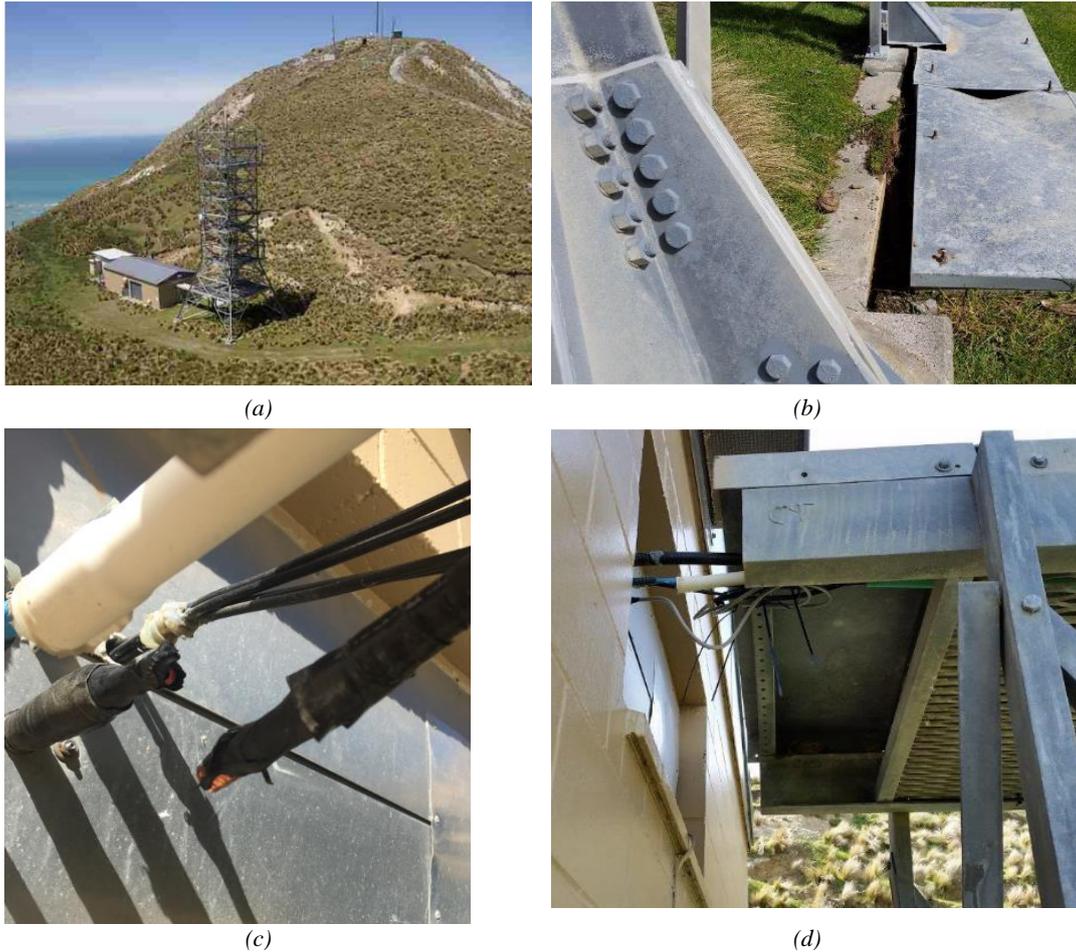
**Figure 7: Microwave Station building at Weld Cone, damage: a) building, tower and waveguide bridge between the two; b) permanent ground movement at the tower base; c) broken original coax cable; d) temporary fix for the coax cable (the thin grey cable splicing between the ends of the failed coax cable) and extent of the separation between the building wall and the waveguide bridge caused by earthquake (Photos courtesy of Brent Jones, Chorus).**

There was one instance of failure at Weld Cone near the town of Ward (Figures 7) due to ground displacement between the microwave tower and the equipment building. A coaxial cable was broken with associated loss of service. As shown in Figures 7c and d, the coaxial cable between the DMR (Digital Microwave Radio) indoor unit in the Microwave Station building at Weld Cone and the DMR outdoor unit (attached to the rear of the parabolic antenna) up the lattice microwave tower stretched and failed near the “waveguide window”. Lateral movement between the building and the tower had been so significant that there was insufficient slack in the coaxial cable between its captive point at the waveguide window and where the coax was clamped via “hangers” on the waveguide bridge out to the tower. There were no problems with antenna alignment [20]. An instance of tower misalignment was observed in one small station called Mt Lyford (north of Waiiau) where land slumping occurred at the radio site, causing the tower misalignment and some deterioration but no actual loss of service (Figure 8).
