QuakeCoRE  
NZ Centre for Earthquake Resilience

# Lower-damage Walls

QuakeCoRE FP4 2017 project

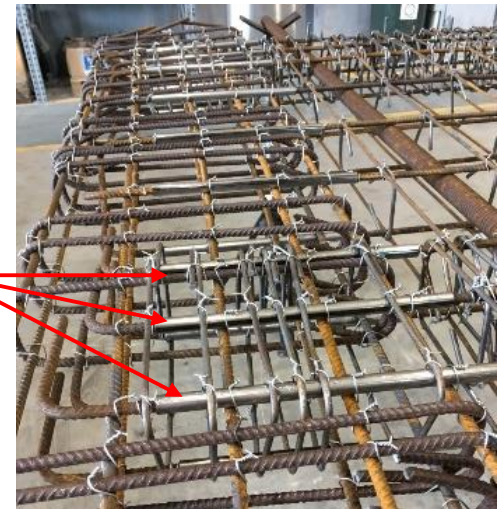
Debonding  
Tubes

- Promote single crack at wall base
- Prevent strain localization in reinforcement

- Debonded bar within sleeve to prevent buckling
- Debonding extends from base to 300 mm length into foundation

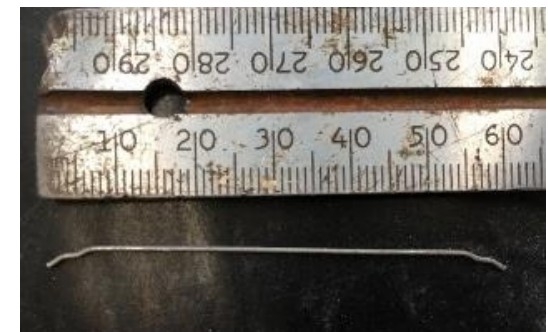
# Wall #2: Fiber Reinforced Concrete (FRC)

- Add steel fibers at 1% volume ratio to conventional concrete

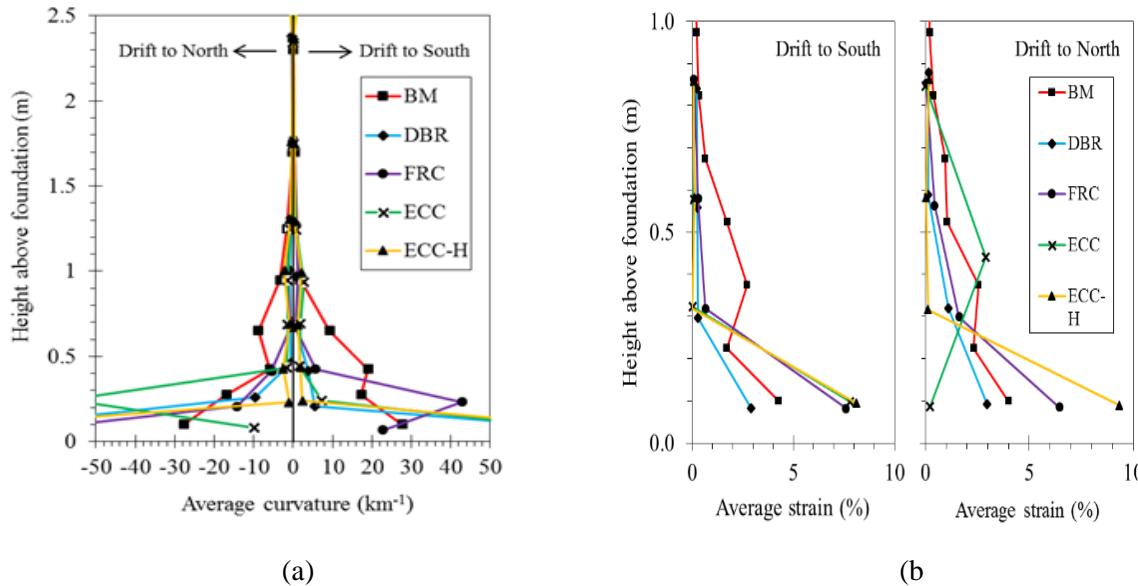
Comparison of (a) average curvature and (b) average reinforcement strain at 1.50% drift for all walls.

- BM 2-3 dominant cracks
- Four LD walls localized to one crack
- BM better distribution of curvature & reinforcement strain
- DBR reduced reinforcement strain

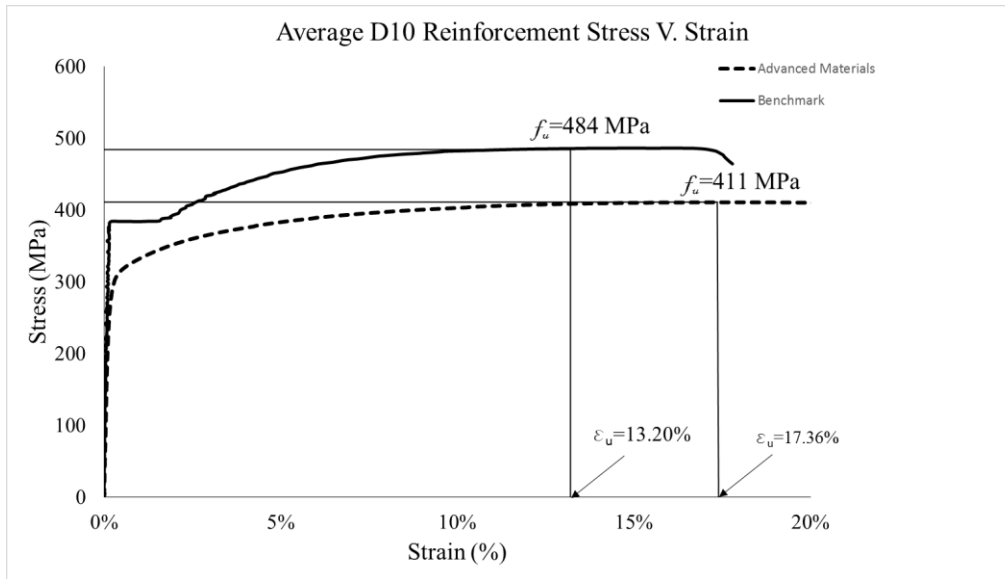
Comparison of D10 vertical steel characteristics.

- Coiled steel in advanced material walls
- ECC walls tested 3 months later than other tests
- FRC and ECC had increased tensile properties
