# RNC/QuakeCoRE Distributed Infrastructure

13<sup>th</sup> May 2019

## 2010 -2011 Canterbury Earthquake Sequence Impact on 11KV Underground Cables – Research Update

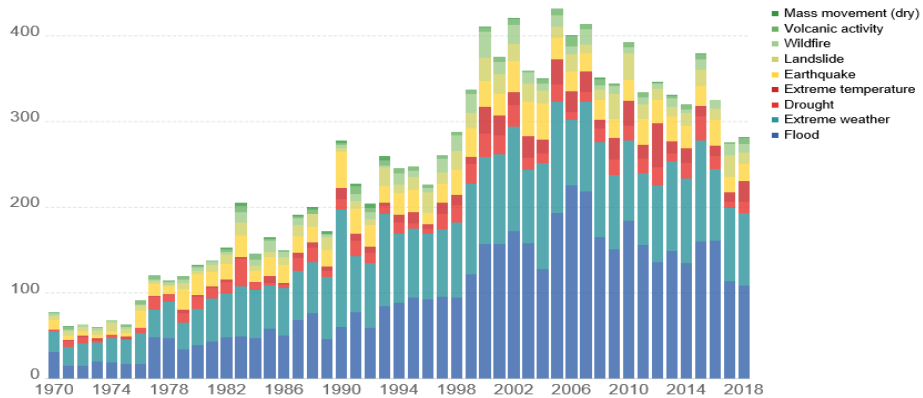
## Global reported natural disasters by type

The annual reported number of natural disasters, categorised by type. This includes both weather and non-weather related disasters.

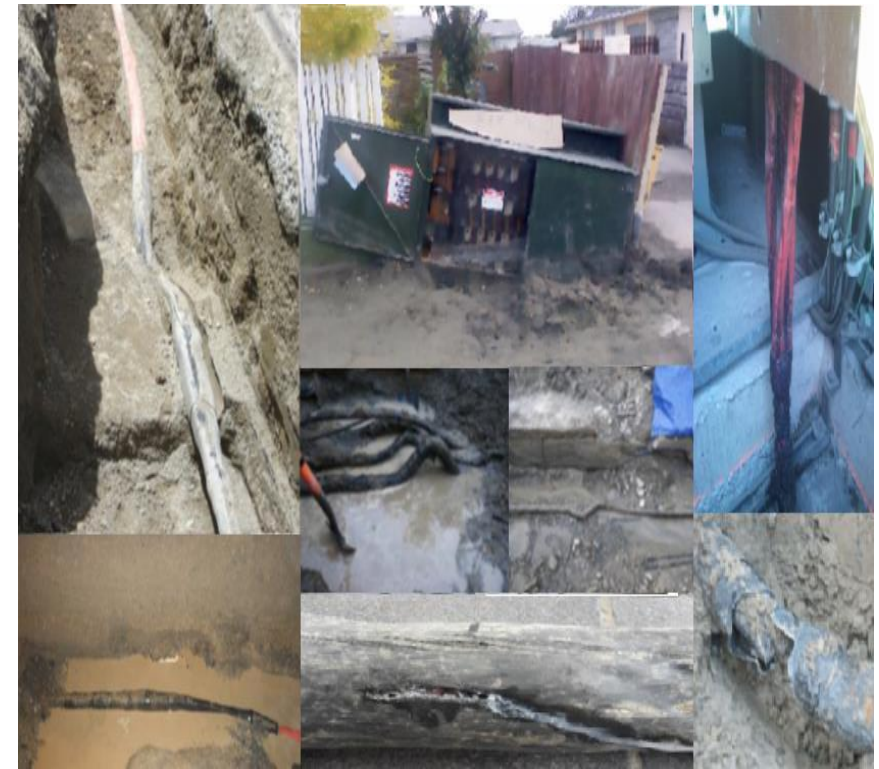
# Rationale

Impact	Darfield Earthquake	Christchurch Earthquake
Date & Time	04 Sep 2010 4:36AM	22 Feb 2010 12:51PM
Magnitude & Depth	7.1 Mw, 10 KM	6.2 Mw, 5 KM
Location	40 KM west	10 KM south-east
Damage (%)	1-3	7-10
Restoration Time (90%)	1 Day	10 Day
Direct Cost	\$4 Million	Over \$40 Million
Customer Minutes Lost	88 Million	630 Million

Hazard	Overhead Asset	Underground Asset
Liquefaction	Minor/Moderate	Major
Lateral Spreading	Minor/Moderate	Major
Ground Deformation	Minor	Major
Tectonic Uplift	Minor	Major

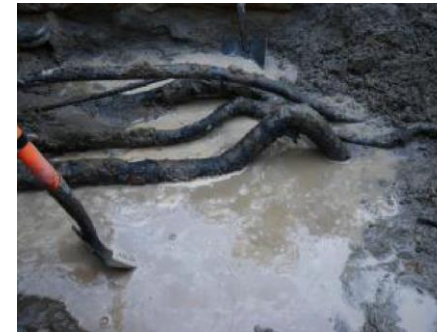
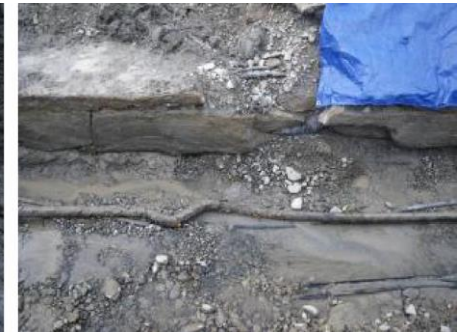
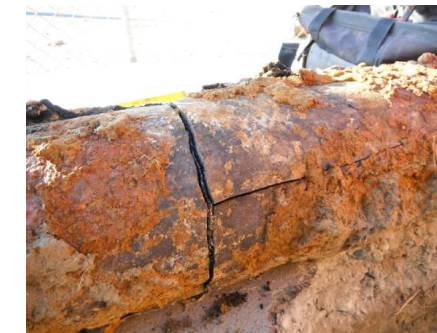
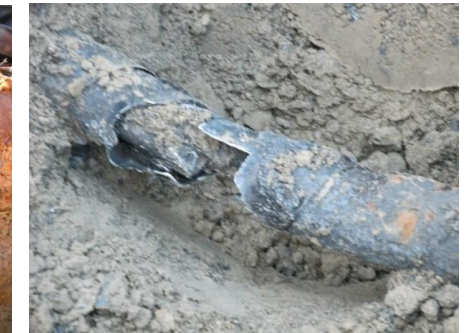
## Damage to 11KV underground cables

- Bending
- Stretching
- Insulation damage
- Being pulled-off equipment
- Joints breaking

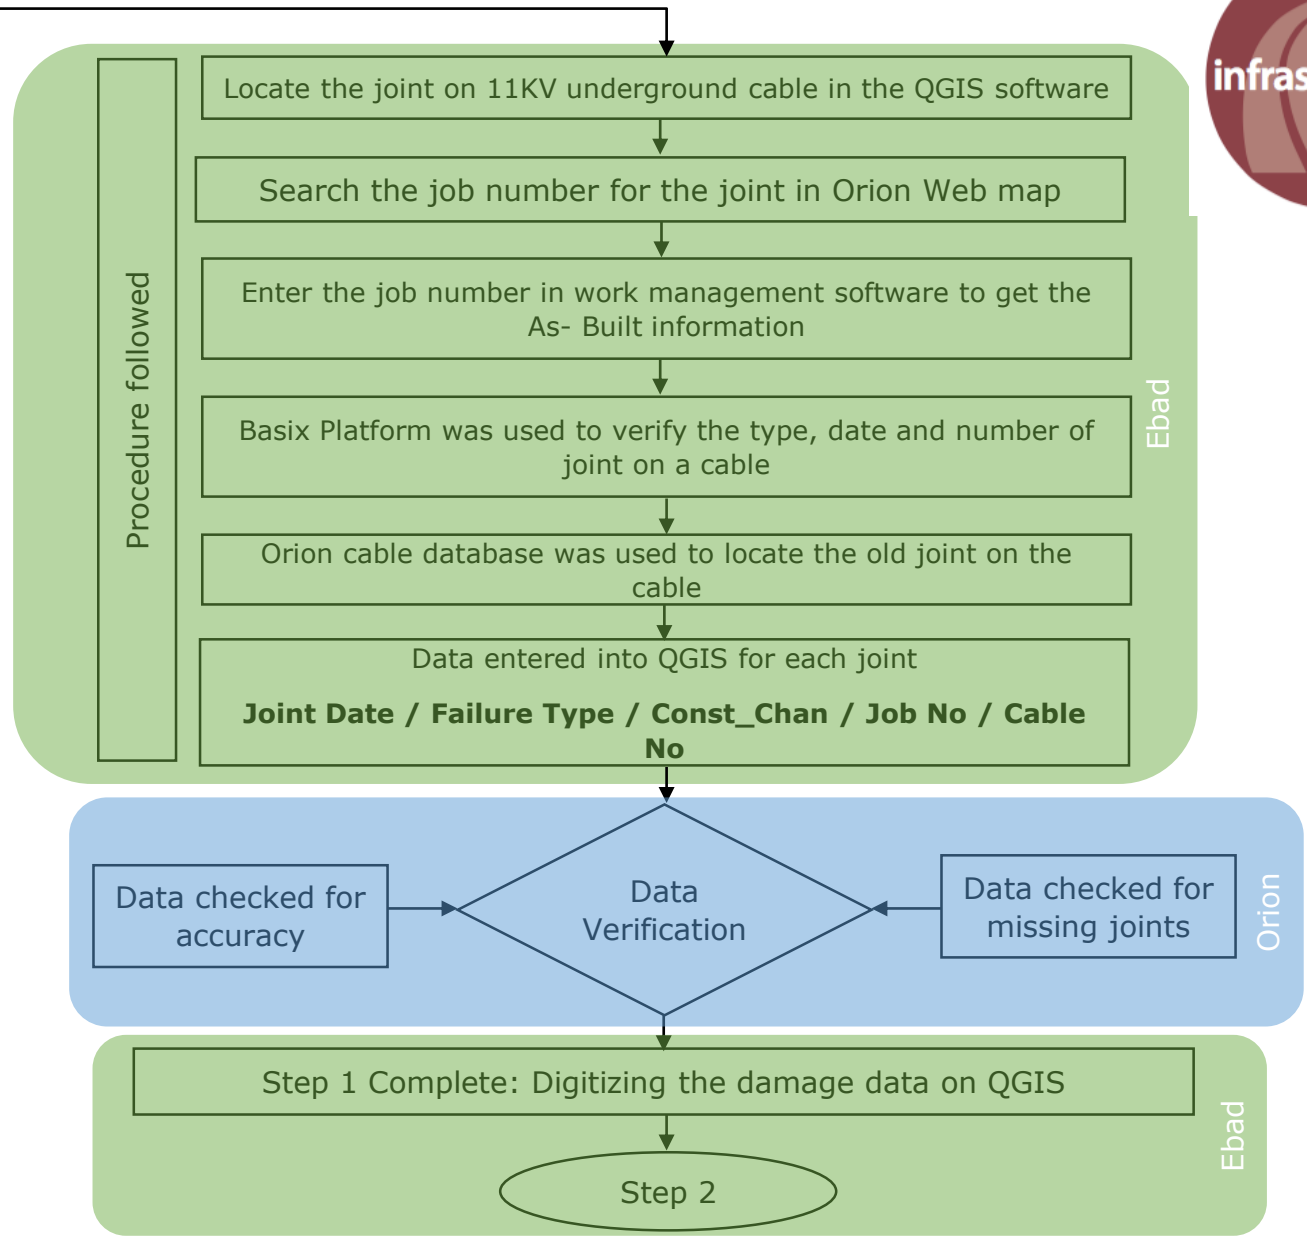
# Step 1: Digitising Repair Joints

Christchurch Earthquake  
2010-2011
