Edgecumbe 2017 Floods: A review and factors influencing stopbank/dam systems

THOMAS WALLACE

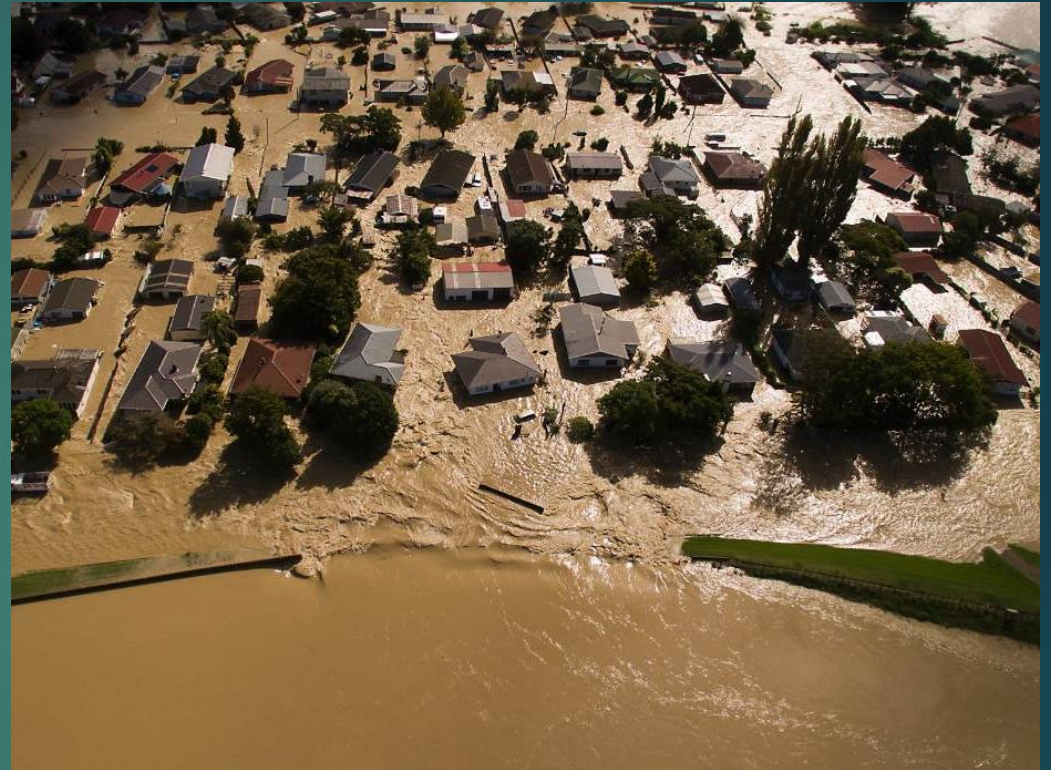
- ▶ April 2017 College Road floodwall breached
- ▶ “concrete wall opened like two gates, water flooding through”
- ▶ Hundreds of homes flooded
- ▶ \$91.5 million NZD in insurance costs
- ▶ 3 Components Discussed
 - College Road Floodwall
 - Matahina Dam
 - Reid’s Floodway

*Breached College Road Floodwall
Source: Chris McKeen, Fairfax New Zealand, 2017*

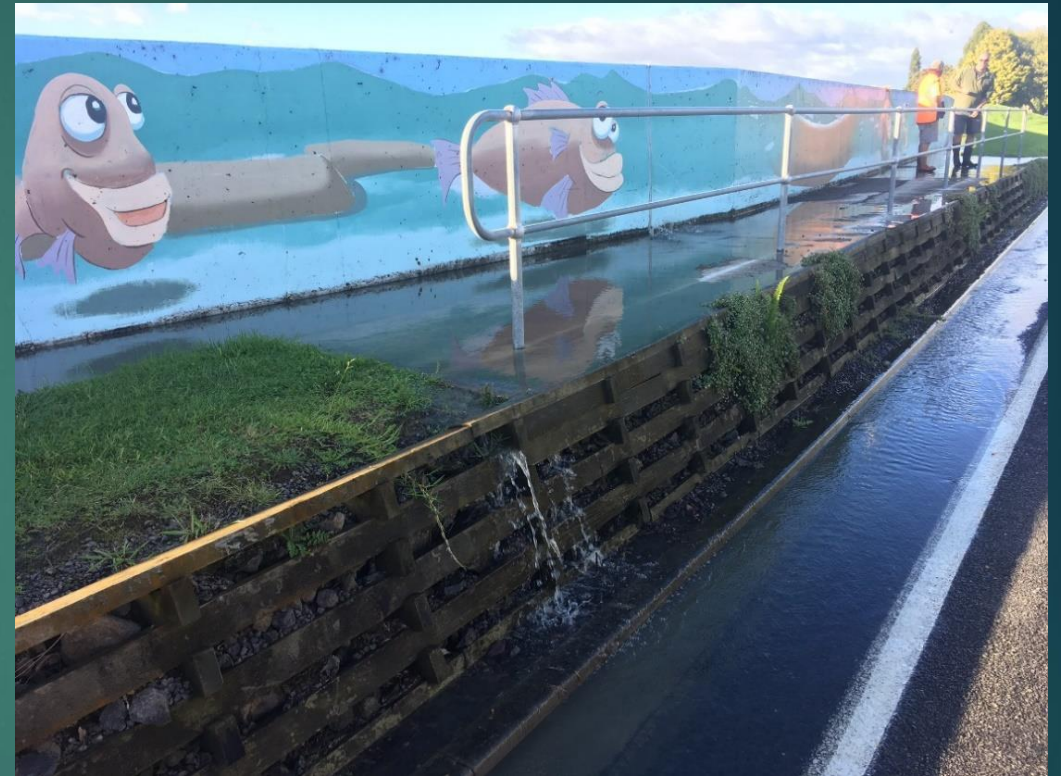
- ▶ 1973 College Road Floodwall built
- ▶ 1987 Earthquake followed with subsidence increasing the flood risk in Edgecumbe
- ▶ 1993 Floodwall replaced to increase protection
- ▶ 2000 Toe drain installed to increase drainage
- ▶ 2012 Hand Rail and concrete walkway

College Road Floodwall
Source: Bay of Plenty Regional Council, 2017

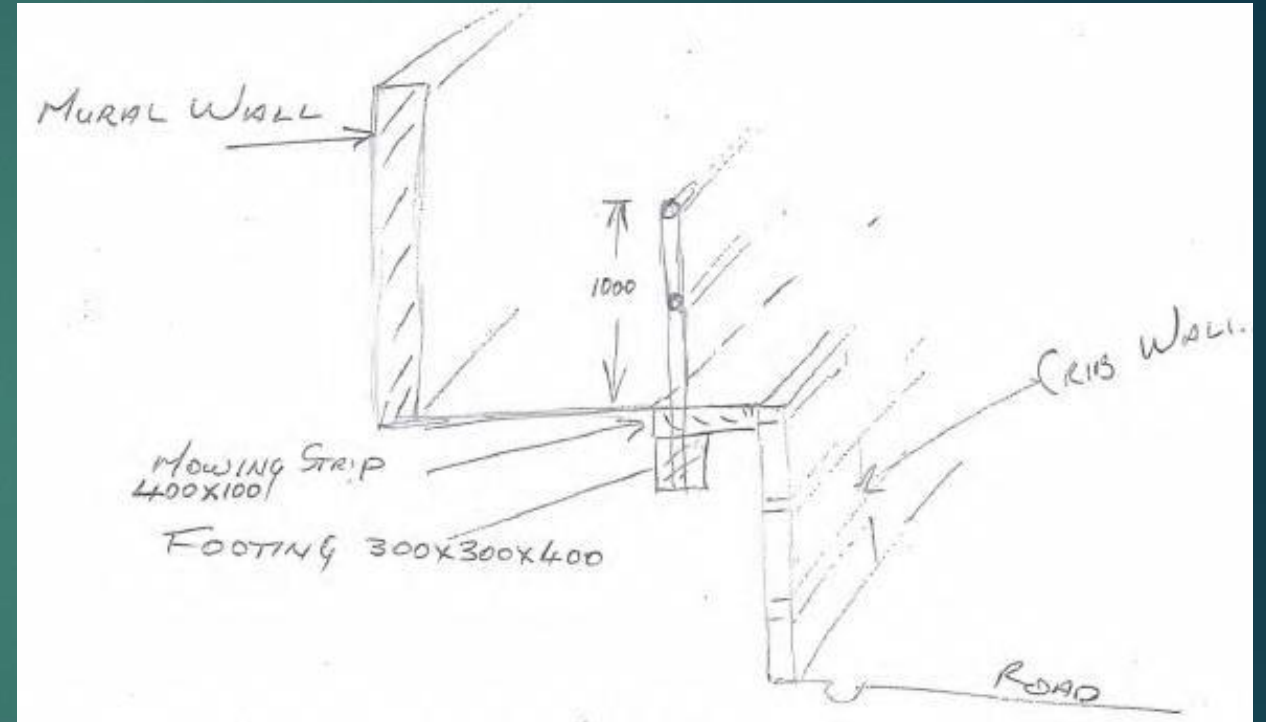
- ▶ High pore pressure could have caused the observed breach
- ▶ Fill compaction methods have changed over time
- ▶ Quarry floor scrapings (non-engineered material) could cause a preferential pathway
- ▶ The concrete walkway could act as a barrier to flow

Cross section of College road floodwall
Source: Bay of Plenty Regional Council, 2012

- ▶ Specifications drawn up for placement of fill for flood defence walls should recognise that a higher quality of fill is needed for floodwalls than for stopbanks, and should be subject to quality control.

- ▶ The College Road floodwall should not be replaced with another wall, but ways sought to enable a stopbank to be constructed in its place (noting that the properties closest to the breached wall have been acquired by the Regional Council).

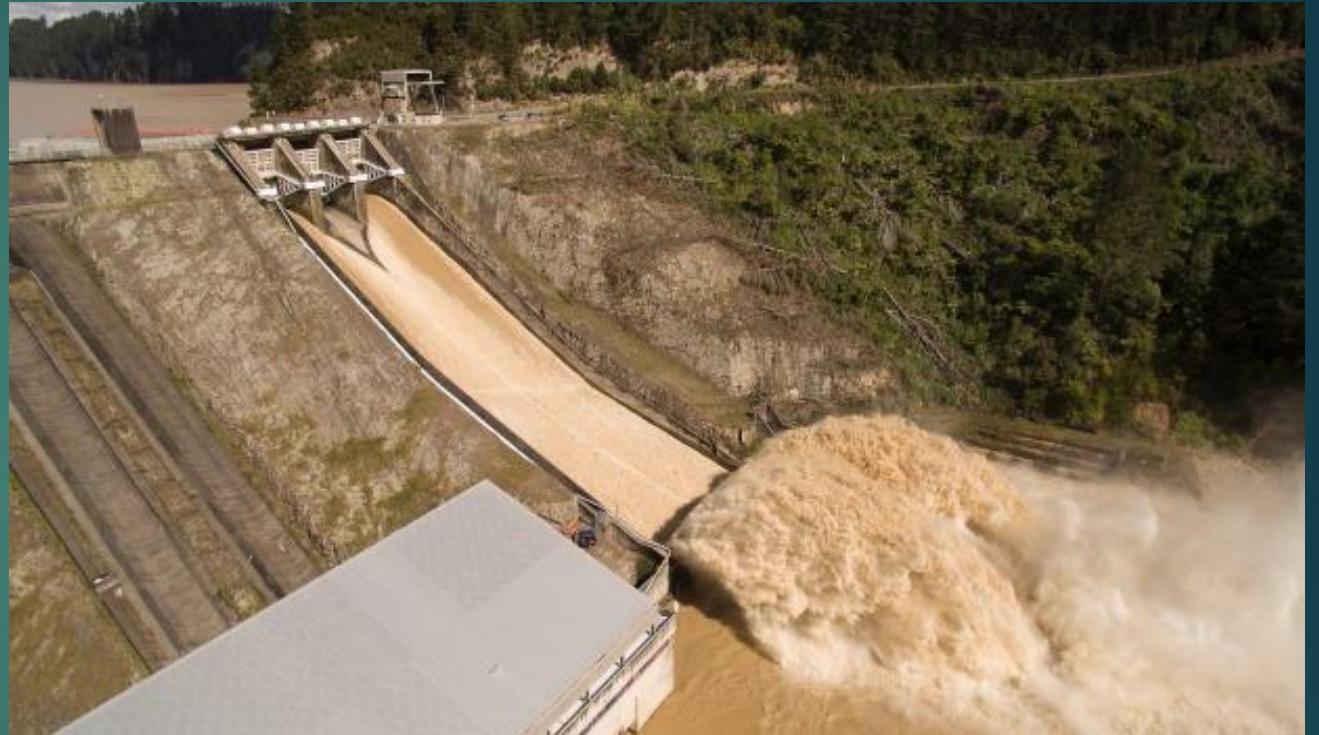
- ▶ “Inadequacies in the *Flood Management Plan*, around communications and clarity of roles”
- ▶ Operation of Matahina Dam reduced the downstream flow by 20%
- ▶ Aniwaniwa (Aniwhenua) Dam upstream was requested to be used for storage and denied

Matahina Dam spillway during 2017 event
Source: Chris McKeen, Fairfax New Zealand, 2017

- ▶ Review the Lake Matahina Flood Management Plan with the aim of:
 - ▶ discussing and agreeing a clear protocol around forecasts and timing that requires 70.0mRL as the target lake level.

- ▶ developing a template for use in written communications during flood drawdown mode that includes specific details on the timing and rate of outflows required to achieve specified lake levels at specified times

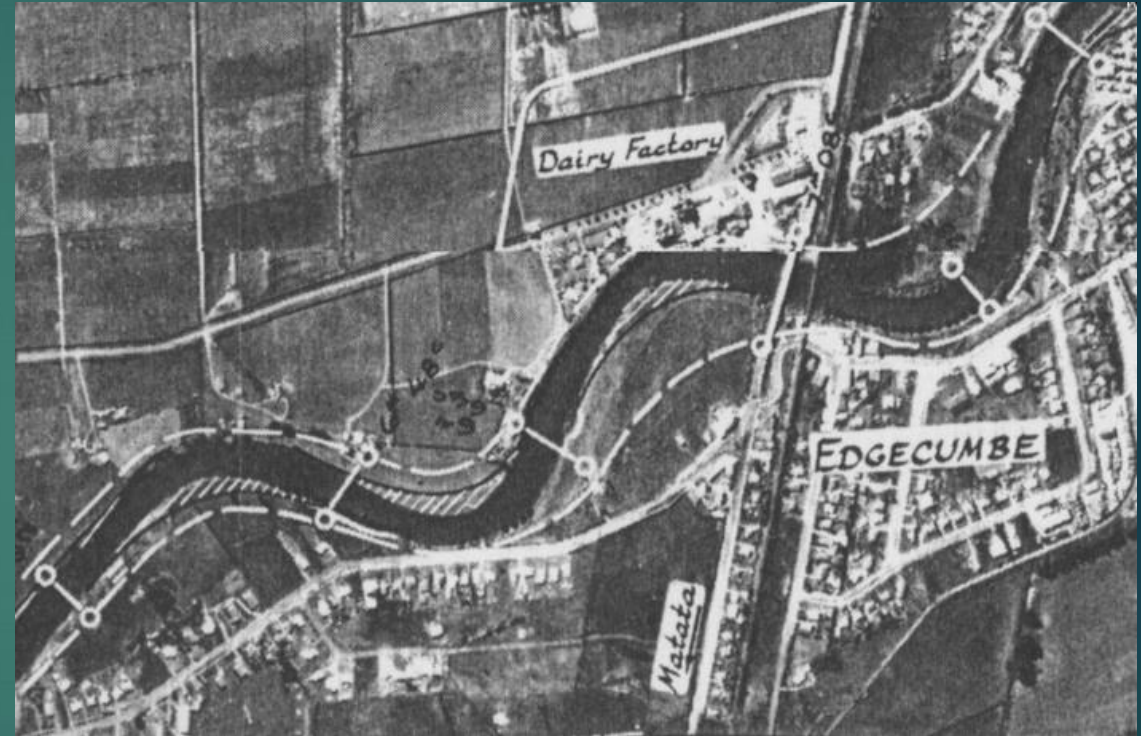
Source: 1968 Rangitāiki River Commission Volume 4 Plan No. R400

- ▶ Stopbanks built in the late 1800s in ad-hoc fashion
- ▶ Many unknowns of stopbanks
- ▶ Construction methods have changed since built
- ▶ Council has since construction issued stopbank guidelines

Edgecumbe in 1968

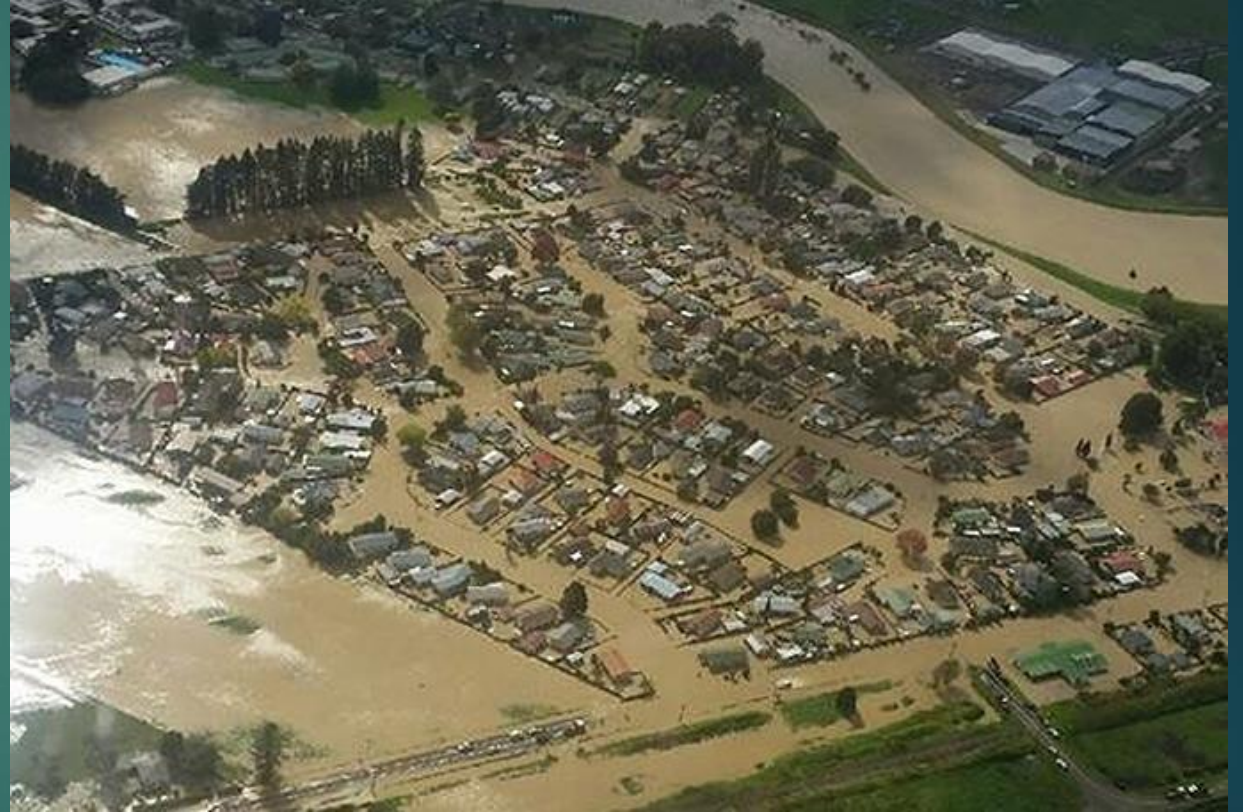
*Breached College Road Floodwall
Source: Malcolm Growden, 2017*
