Blenheim liquefaction reconnaissance

Overview of liquefaction damage in Blenheim

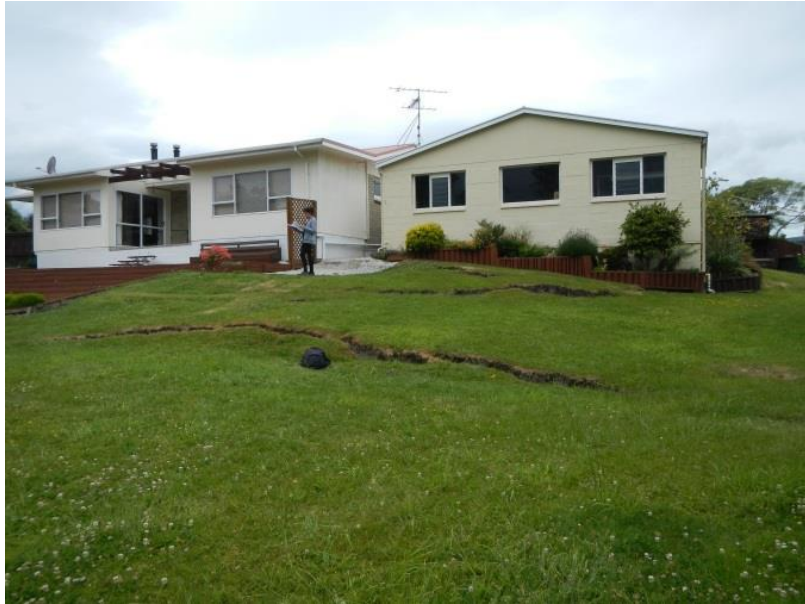
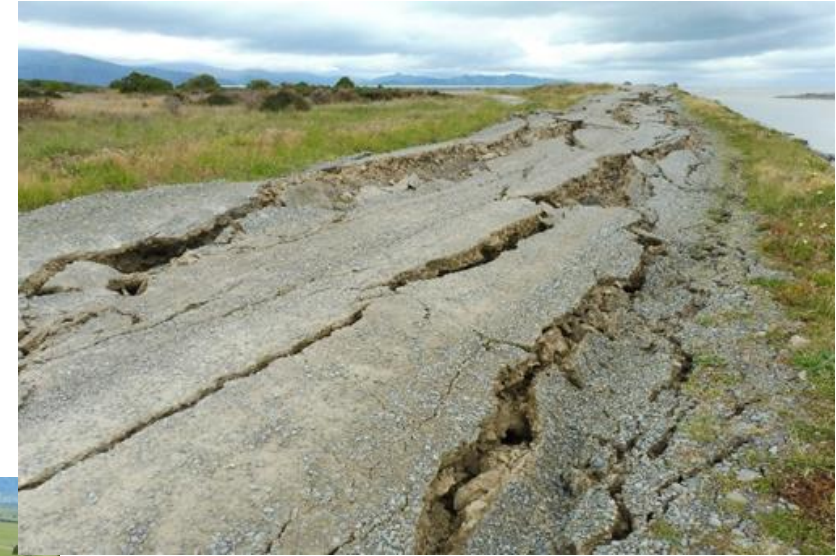
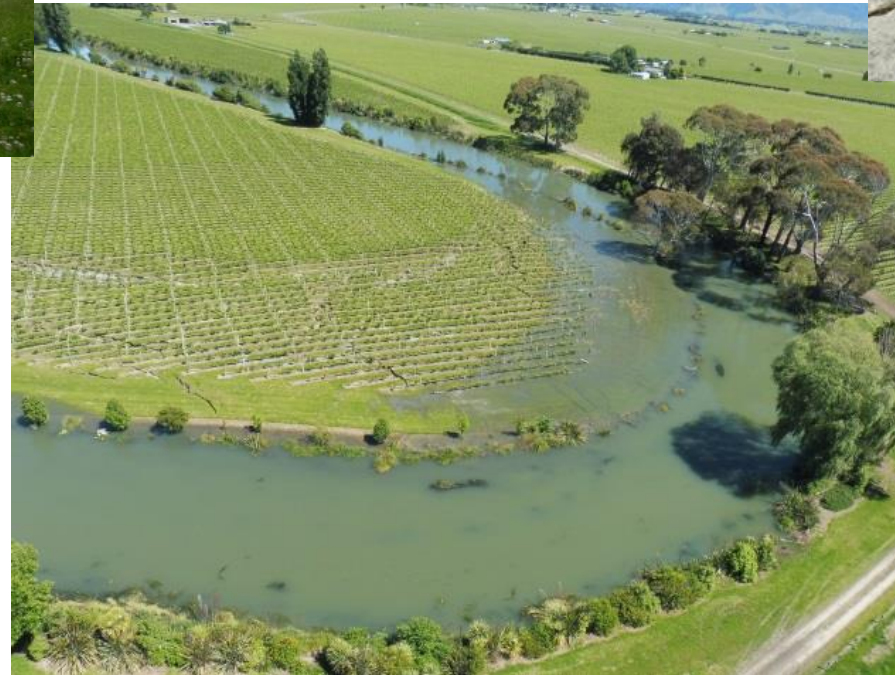
Liquefaction and lateral spreading observed adjacent to the Wairau, Taylor, and Opaoa Rivers to the east of Blenheim

Distribution closely linked to the current and paleo- river morphology i.e. inner meander bends and paleo-channels

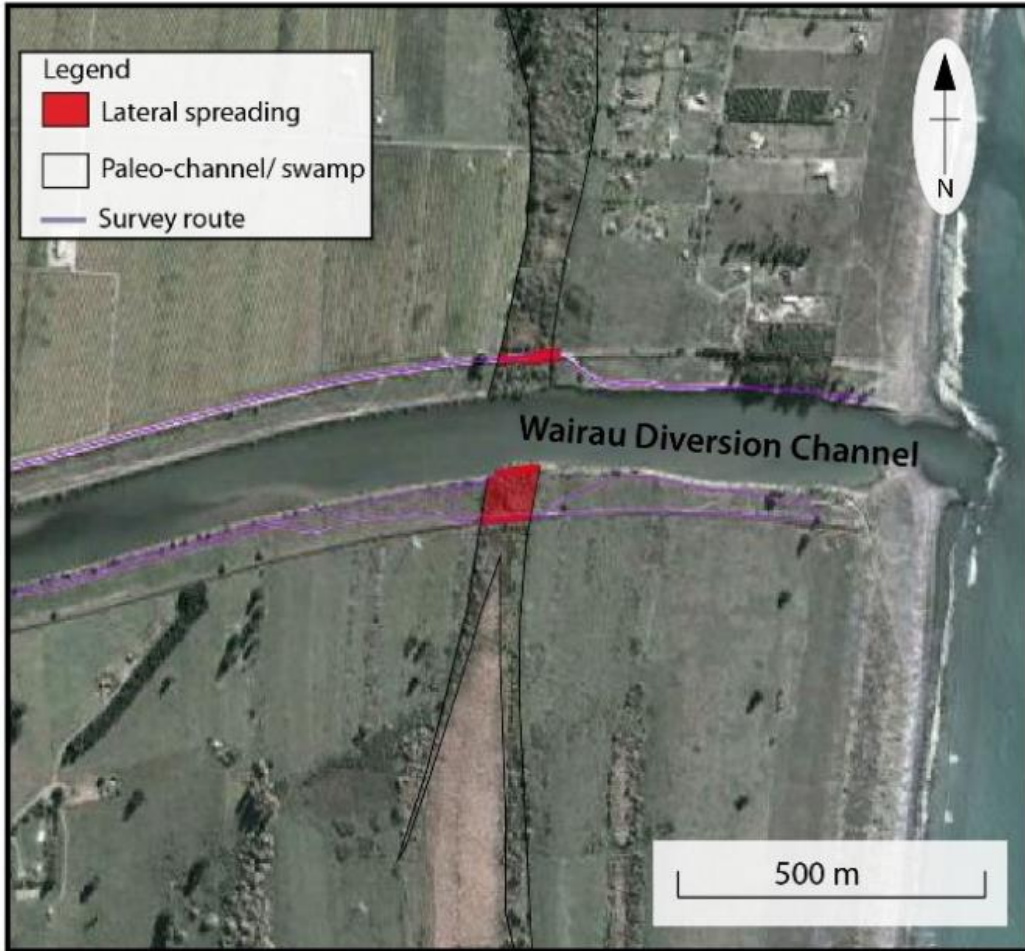
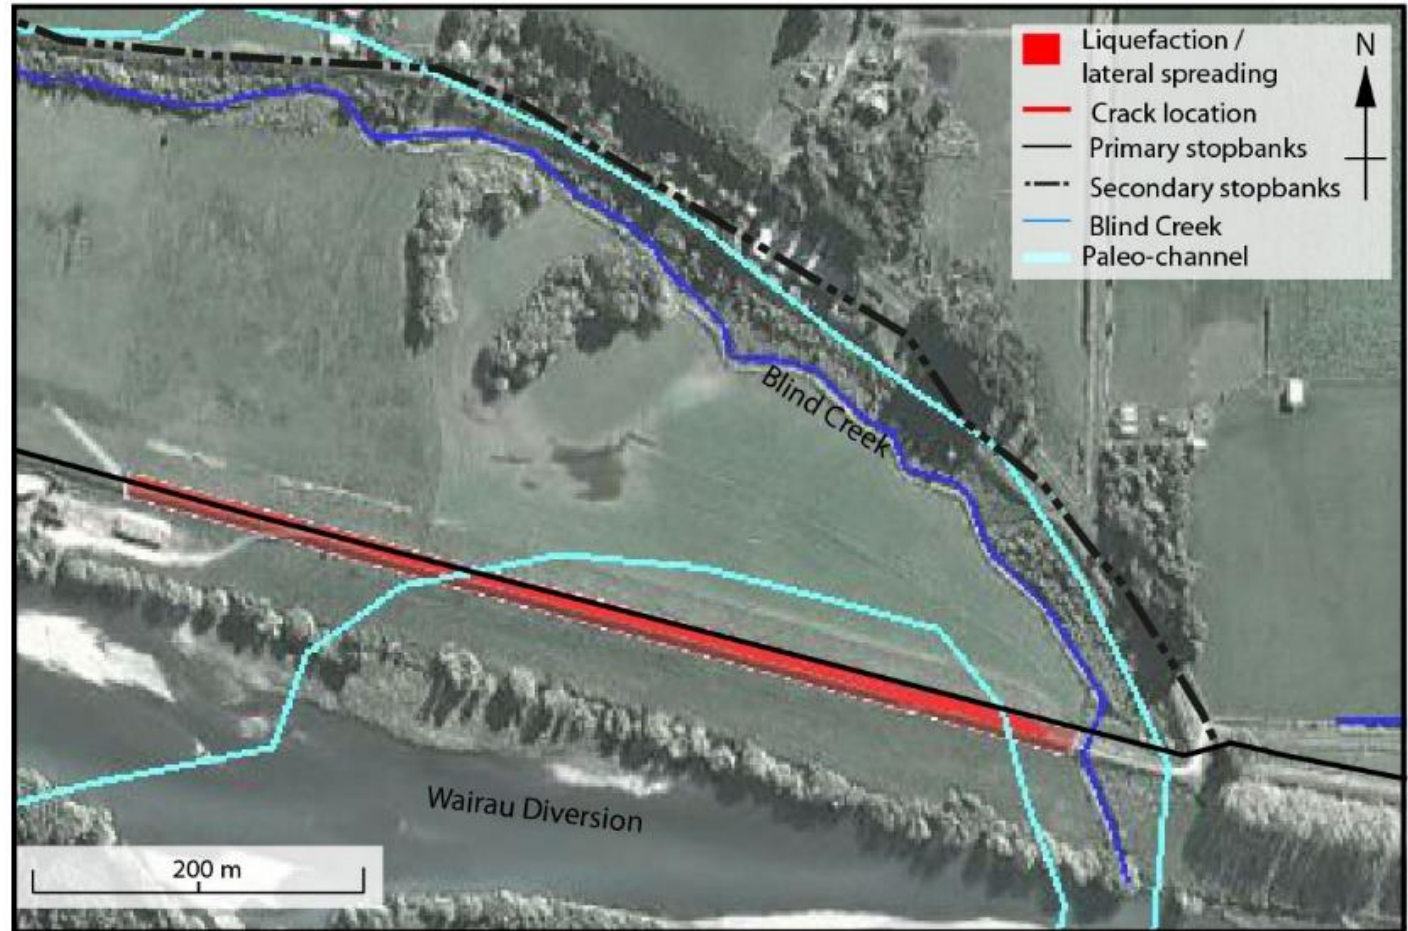
Stopbank damage around Blenheim

Liquefaction and lateral spreading induced damage to stopbanks corresponds with the location of paleo-channels and swamps along the Wairau River and Diversion, and with the inner banks of meander bends along the Opaoa River
