Impacts of the Kaikoura Earthquake on Three Waters Systems in Wellington, Marlborough and Kaikoura

Preliminary Observations

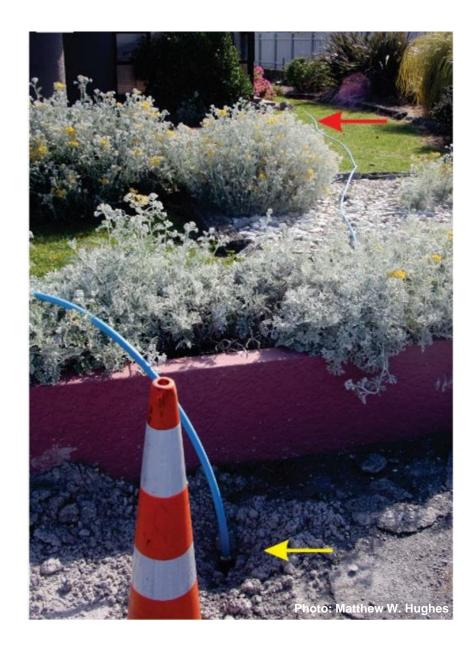
- The boil water notice was lifted for most of Kaikoura township, suburbs and outlying supply schemes on 23rd December.
- People returning to houses unoccupied since the earthquake were urged to conduct inspections of pipes and tanks on their properties and undertake the necessary repairs.

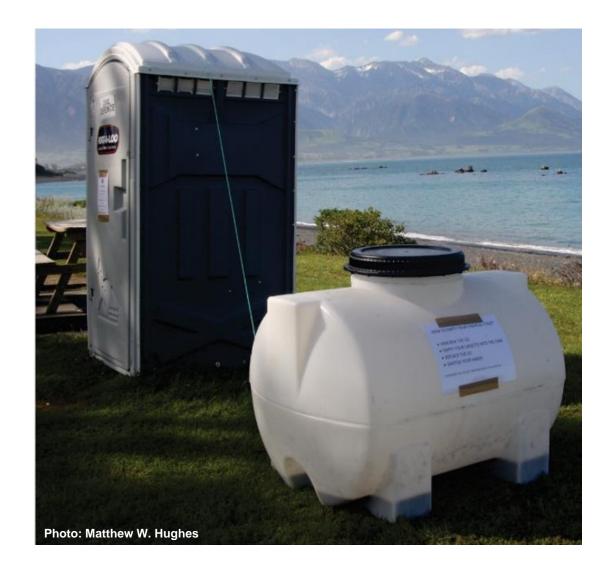
- Significant damage to pipes compromised most of the system.
- Residents were advised to use portaloos, buckets or holes dug in gardens to dispose human waste.
- On November 18th, chemical toilets were delivered by the Defence Force to be distributed to all households (the necessary supply of chemical solution was delayed by 2-3 days).
- By November 24th, there was a portaloo within 250 m of every property.

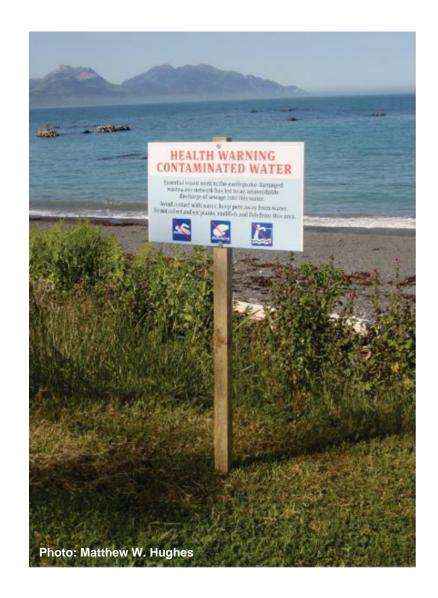
- Due to the inability of the waste water pipes to function from the 14th to 24th November, residents were urged not to flush toilets despite the return of reticulated portable water supply over this time.
- Restrictions on water use were also aimed at reducing environmental contamination.
- Environmental contamination by wastewater was recognised as a significant issue from 14th November, with attendant restrictions on entering waterways or swimming in the sea.
