Preliminary report on the investigation of the damage caused by the 2023 Turkey-Syria earthquake

JSCE Earthquake Damage Reconnaissance Team

03/05/2023 – 09/05/2023

Keisuke Ishikawa, Tokyo Denki University

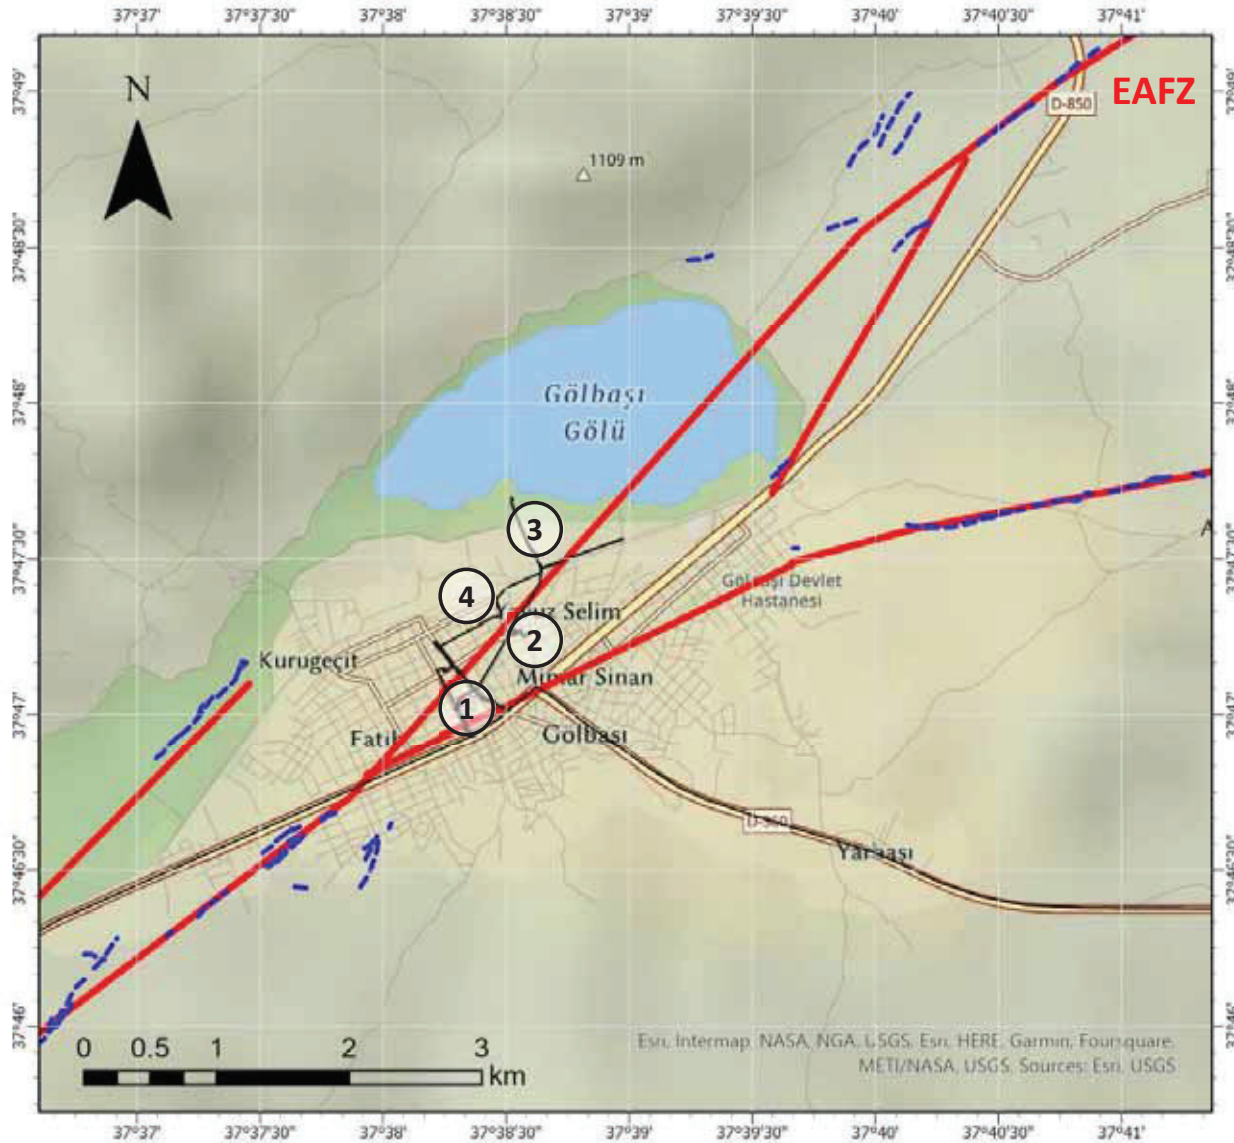
The Gölbaşı Basin is the largest basin along the East Anatolian Fault Zone and is classified as a pull-apart basin.

According to Onder Yönlü et al. (2013), it is believed that the Gölbaşı Basin was formed approximately 32,000 years ago due to a massive landslide that obstructed the flow of the Aksu River.

Within the basin, fluvial sediments and lacustrine deposits can be observed unconformably overlaying the basement rocks.

- ① Structural damage due to seismic motion/ fault displacement
- ② Building settlement and tilting due to liquefaction
- ③ Lateral spreading of the ground
- ④ Settlement and tilting of buildings due to loss of bearing capacity

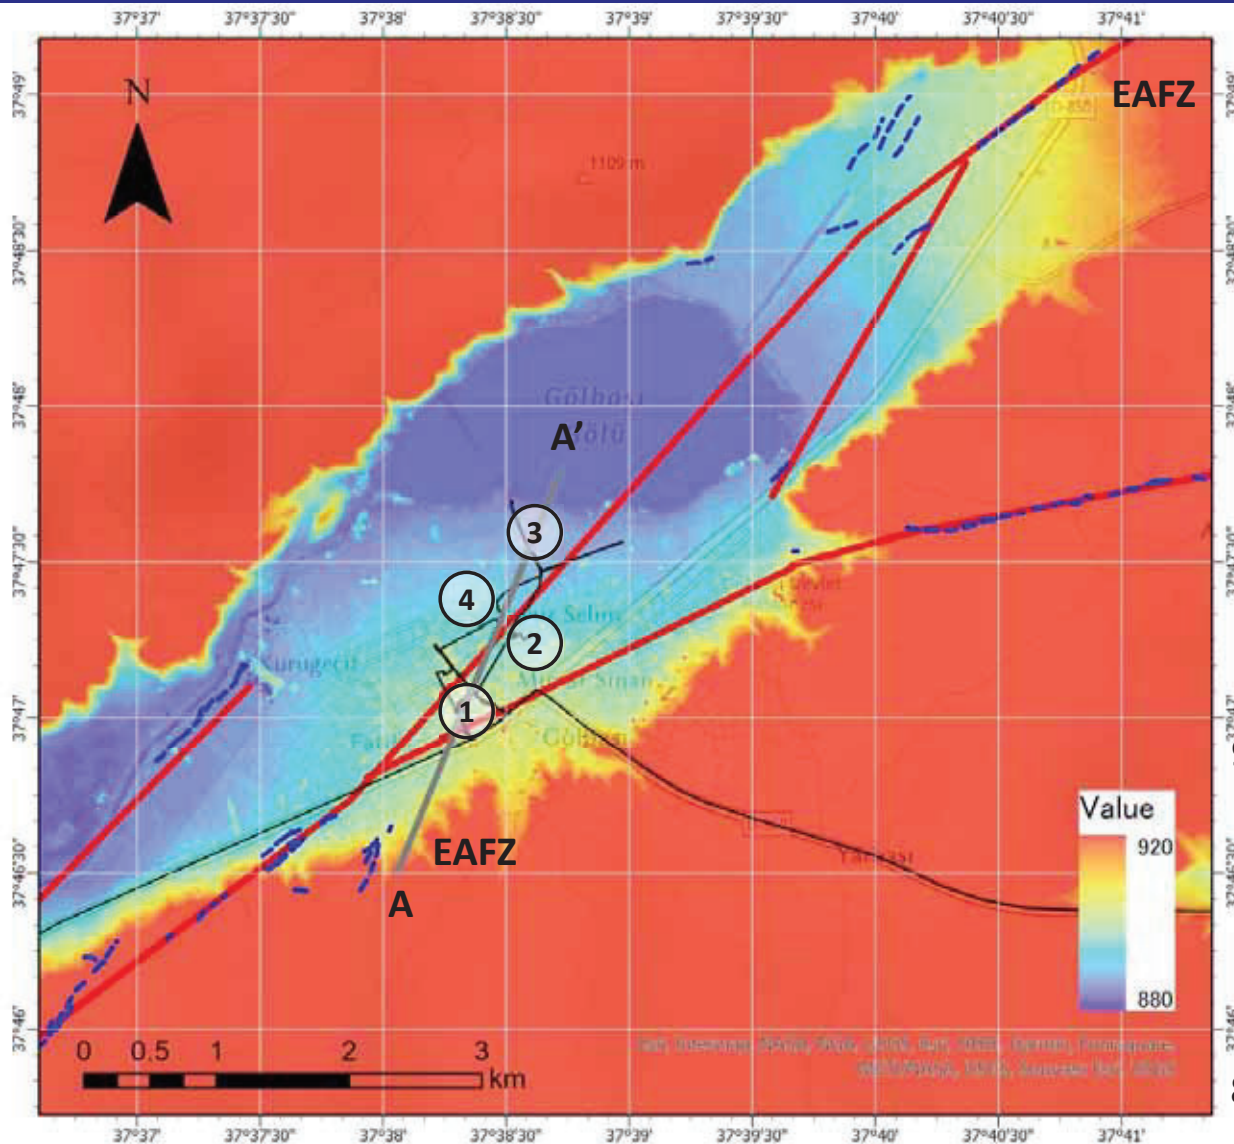
Gölbaşı

- ① Structural damage due to seismic motion/
fault displacement
- ② Building settlement and tilting due to
liquefaction
- ③ Lateral spreading of the ground
- ④ Settlement and tilting of buildings due to
loss of bearing capacity

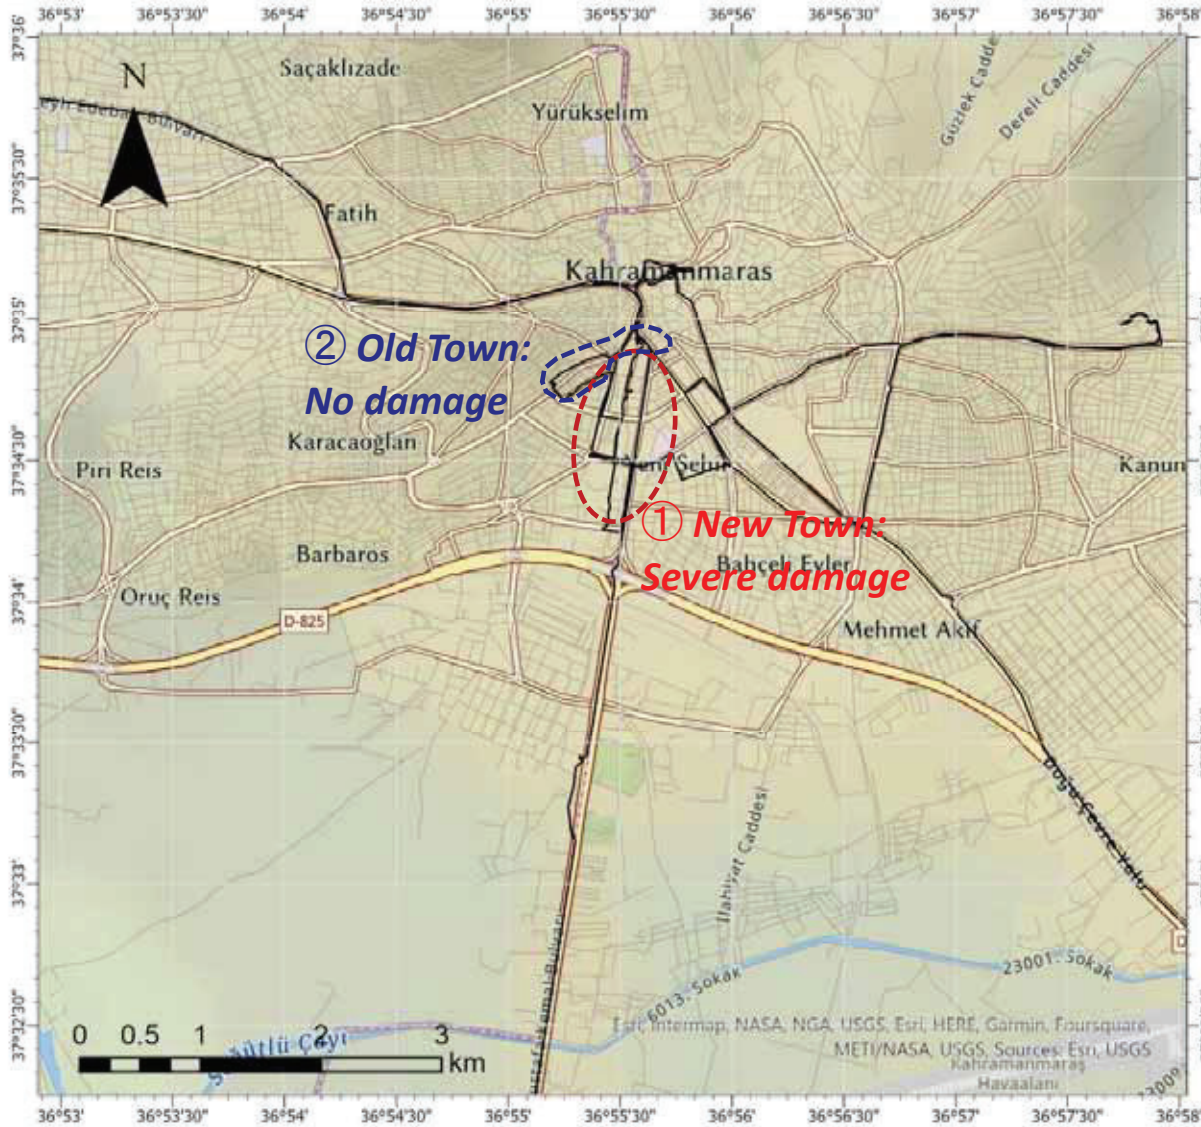
Kahramanmaraş

The **New Town** of Kahramanmarash was constructed by landfilling the bottom of a hilly valley.

Dredged soil from the river that flowed to the south of the city area was used for the landfill construction.

The **New Town** area was originally used as **agricultural land**.

- ① **The collapsed buildings were concentrated in the New Town.**
- ② **No collapse on older residential buildings on the hillside.**

The amplification and frequency of seismic motion in the valley floor plain may have affected the building structure.

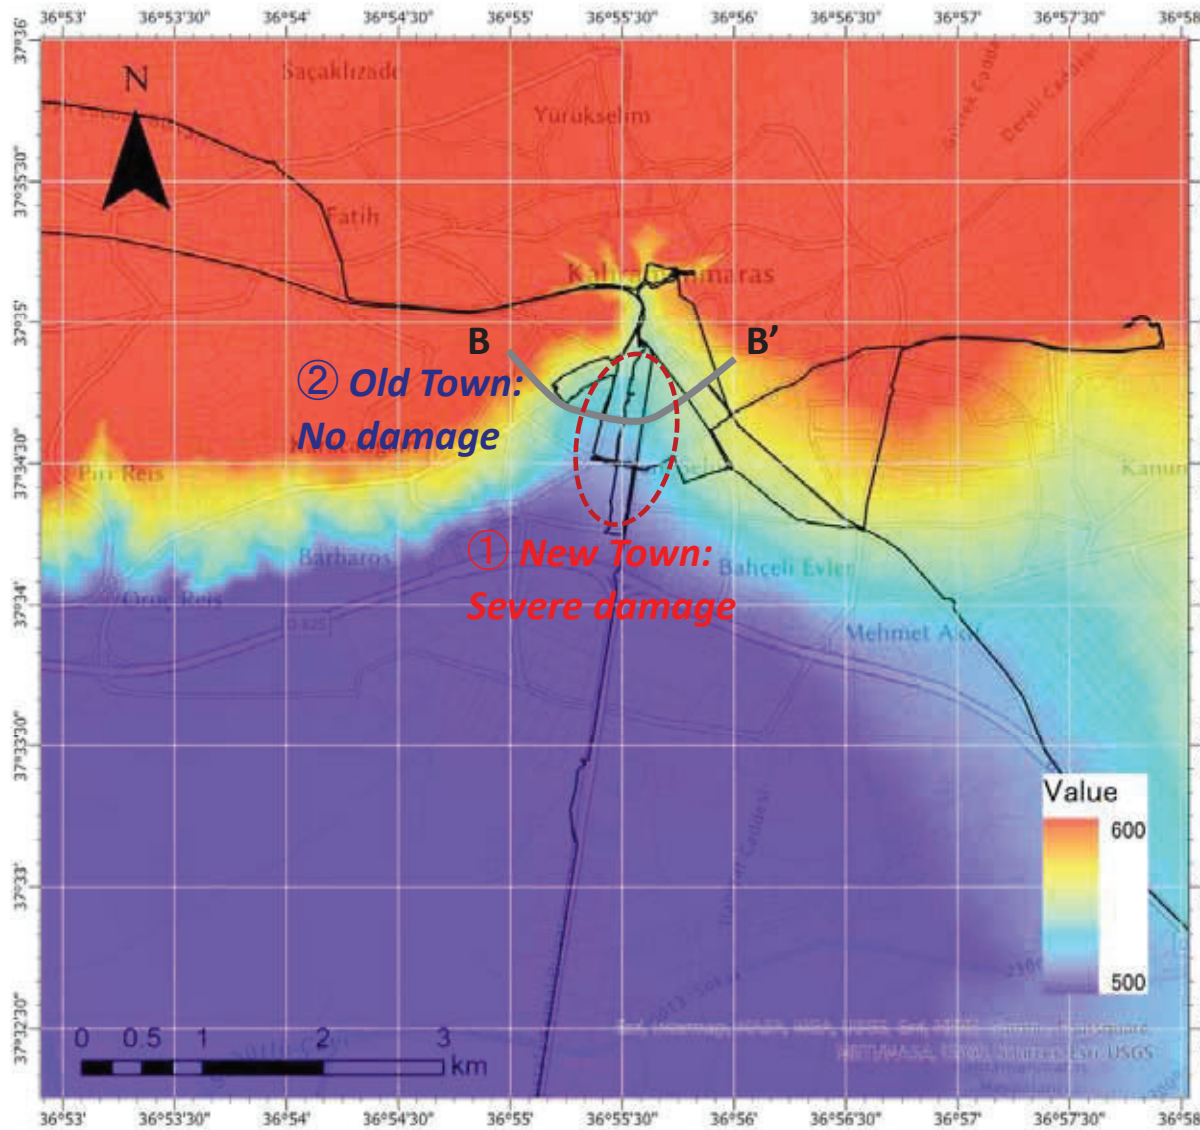
Kahramanmaraş

- ① The collapsed buildings were concentrated in the New Town.
- ② No damage to buildings in older residential areas on hilly terrain

- Seismic duration: approx. 90 sec.
- Three powerful tremors in one hour
- Many buildings collapsed after the first quake

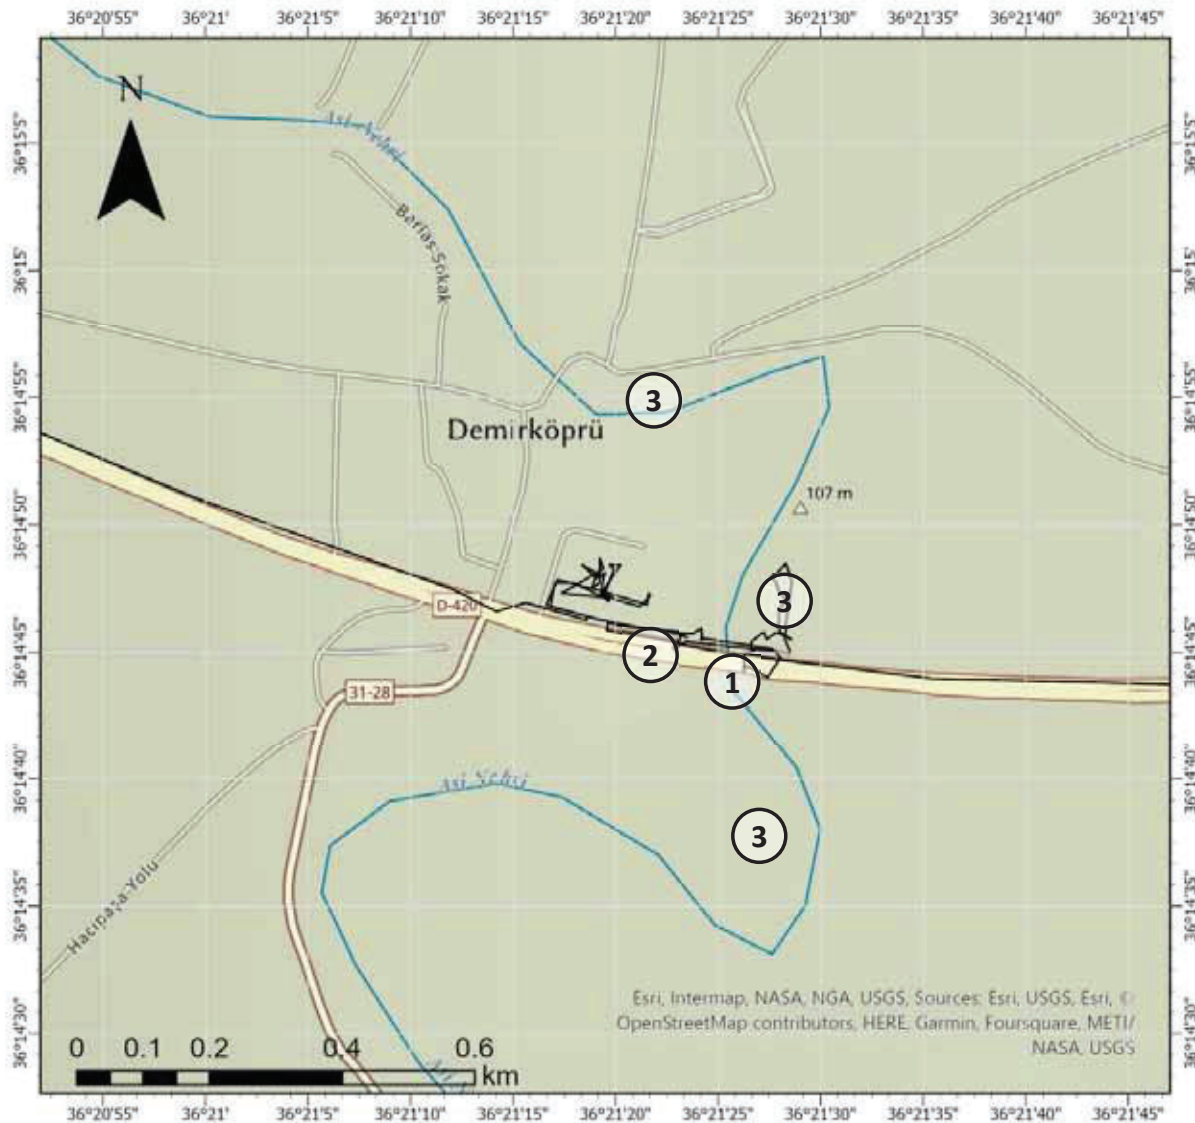
Demirköprü is a small village surrounded by the meandering area of the Asi-Nehri River.

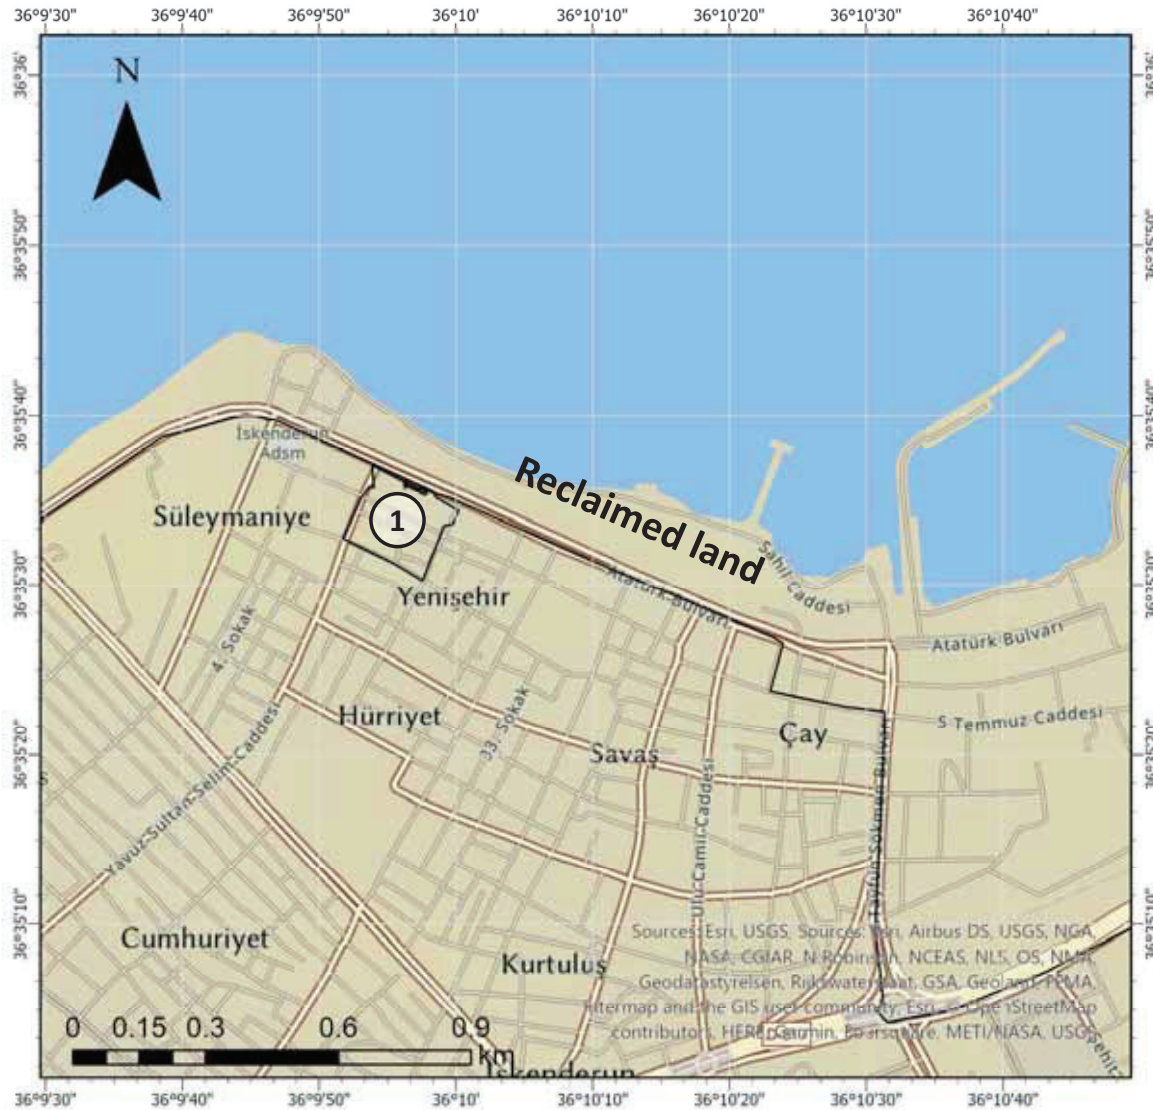
The coastal district of İskenderun appears to have been reclaimed and developed 60 years ago.

New mosque along the coast is reported to be a pile foundation structure.

Why the difference in damage caused by liquefaction in this coastal area?

The difference between reclaimed and natural ground could have made a significant difference.

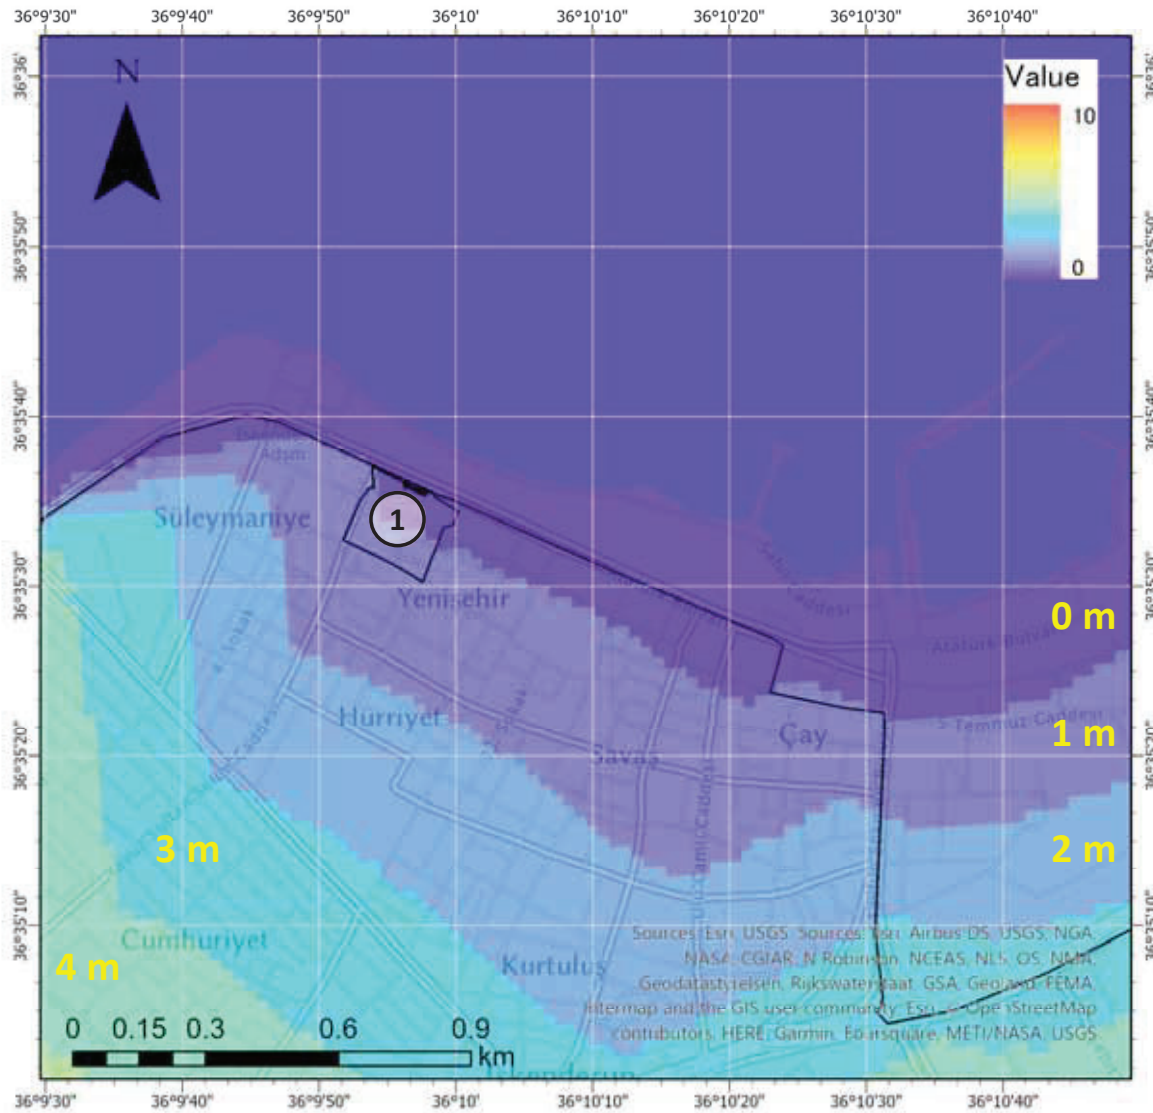
The coastal district of İskenderun appears to have been reclaimed and developed 60 years ago.

New mosque along the coast is reported to be a pile foundation structure.

Why the difference in damage caused by liquefaction in this coastal area?
