Dike and stopbank breaching due to overtopping

Ninger Kong

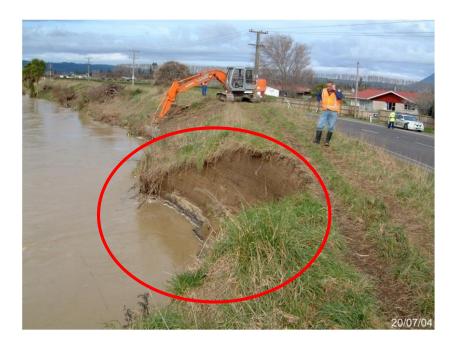
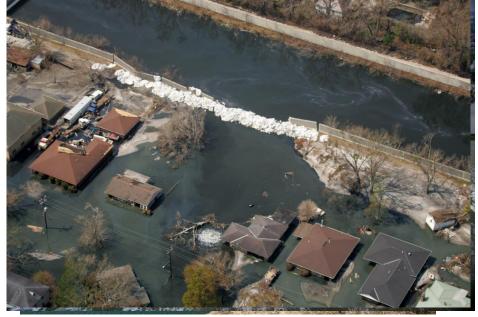
Collapse of the water side slope of a stopbank due to scouring, Kōkōhinau Bend, 2004. The storm surge produced by Hurricane Katrina overwhelmed numerous levees and caused failure of levees, New Orleans, 2005.

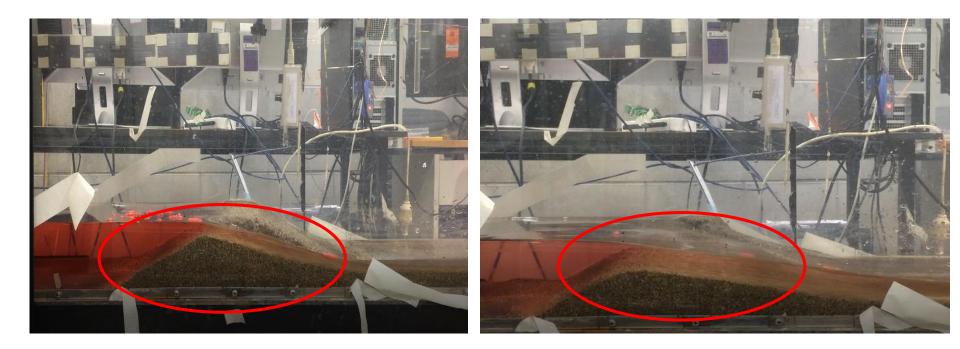
Spatial breach mode (0.5L/s)
